**National Register of Historic Places Registration Form**

**1. Name of Property**Historic name: Gerrard, John and Jennette, HouseOther names/site number: Jones Dairy, Taylorsville Heritage Center

**2. Location**Street & number: 1488 West 4800 SouthCity or town: Taylorsville State: UT County: Salt LakeNot For Publication: ☐ Vicinity: ☐**3. State/Federal Agency Certification**

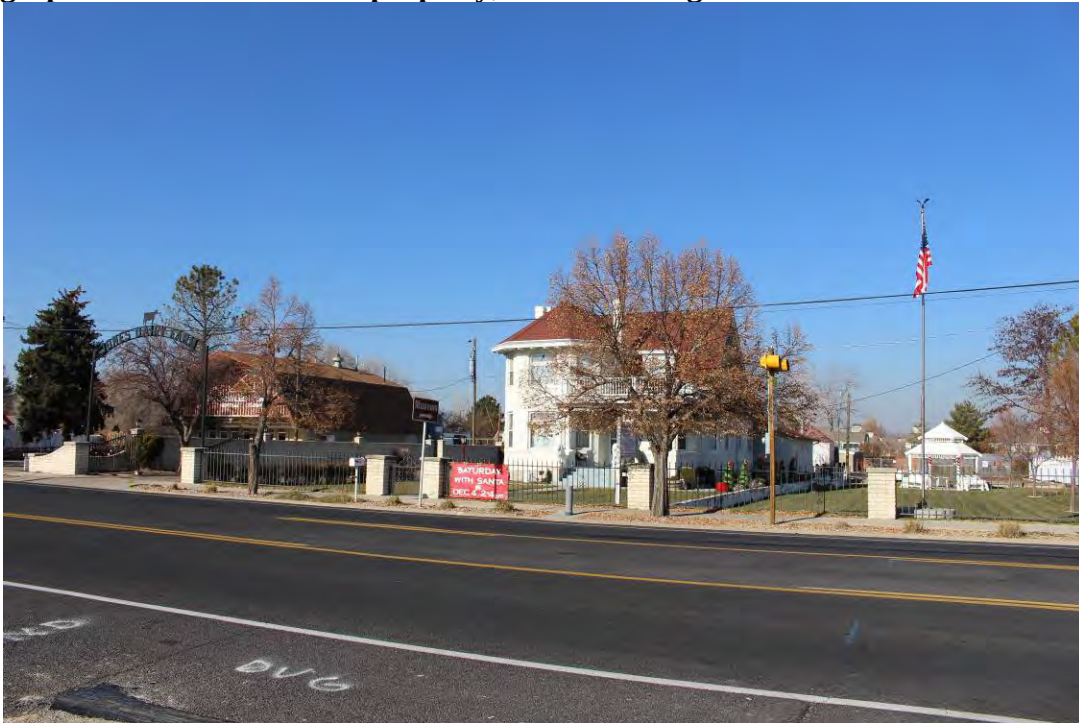
**Photograph 1 of 19. Overview of property; camera facing northwest**

The property is divided into three major functional areas—a domestic area, a retail/commercial area, and an agricultural area. The domestic area occupies the southeastern corner of the property and contains the dwelling, its associated garage, and its lawn and residential landscape. This portion of the property includes a series of symmetrically spaced tan, oversized brick pillars and a metal bar fence along the frontage next to the sidewalk and an entry “gate” characterized by a steel arch with a cutout of a cow and “JONES DAIRY FARM” spelled out in cutout lettering. The main driveway into the property passes under the arch. Within the domestic space of the property are several smaller scale features that further divide the space and separate it from the surrounding functional areas. For example, a low concrete retaining wall is located between the dwelling and the large lawn area to the east of it. The wall appears to date to the historical period. The east lawn, which hosts a modern gazebo structure, sits approximately one foot lower in elevation than the land on which the dwelling is located. Other features related to the spatial organization include a series of small hedges that (mostly) separate the dwelling and its front lawn from the asphalt-paved driveway that passes to the west of the dwelling and a modern oversized brick curb wall that separates the north edge of the east lawn from a parking area and the agricultural space to the north.

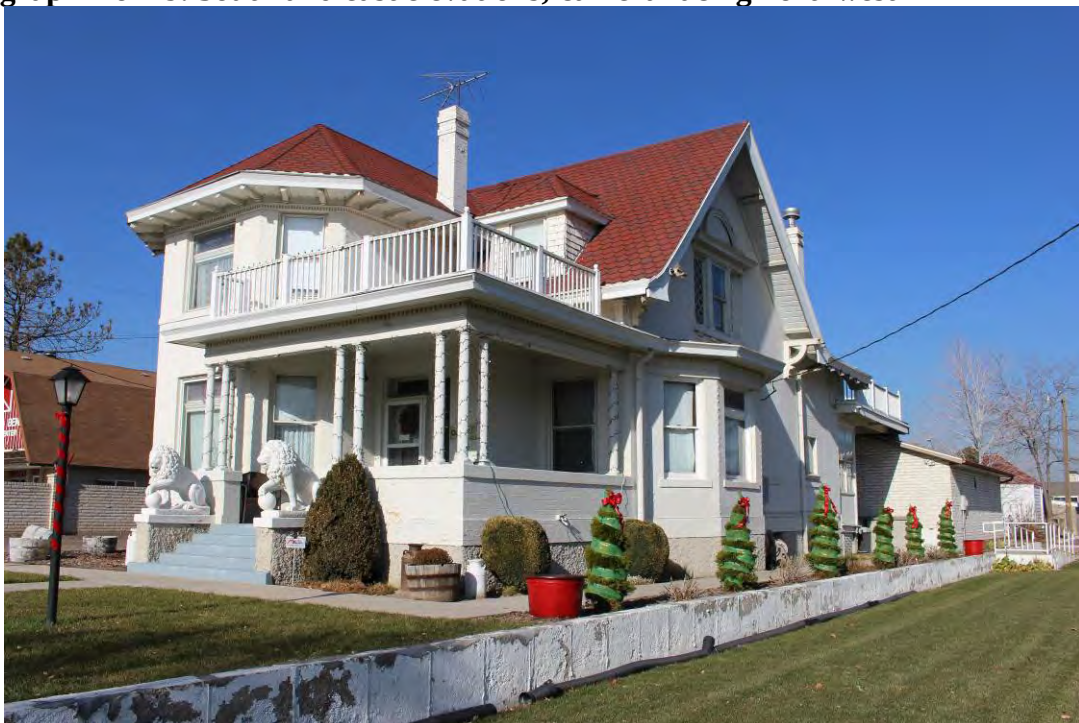
**Photograph 2 of 19. South and east elevations; camera facing northwest**

The south elevation is the primary façade of the dwelling. The elevation is characterized by a porch and portico occupying the east half of the elevation, between the bay and the edge of the building, and the bay itself. The first story of the porch exhibits a brick short-wall with concrete coping that wraps around the entire east edge of the porch and most of the south edge. At present, the short-wall exhibits a squared southeastern corner whereas older photographs of the dwelling (see Figure 1) depict a rounded corner in this location. A set of concrete stairs provides access to the porch from the ground level in front of the dwelling. Concrete short-walls clad in stucco flank the east and west edges of the stairs. They are capped with concrete coping and each hosts a statue of a lion. These statues are not original to the dwelling and were added sometime prior to the 1990s. Sets of Tuscan columns rest on top of the porch wall and support the portico, which comprises a balcony/deck accessed from the upper story of the dwelling. Pairs of columns are found on each side of the porch stairs, while a single column is found in the northeast corner of the porch and triple set of columns is found in the southeast corner. The columns are replacements. An older photograph of the building indicates the original columns had Ionic style capitals and were spaced closer together than the current columns. The balcony/deck of the portico extends several inches beyond the edge of the porch, providing limited protection from precipitation. The eaves of the overhanging deck are adorned with a header molding decorated with dentils. The balcony/deck is bounded on the east, south, and west by a painted aluminum balustrade that replaced the original balustrade, which was similar in appearance but slightly shorter in height and had wider brick newel posts than the current railing. Collectively, the alterations to the porch and portico features indicate they were at least partially reconstructed after the original construction. It is unclear when this alteration occurred, though photographs suggest it happened prior to the 1990s.

The east (side) elevation of the building is characterized by seven window openings. Four of the openings are located in the first story of the elevation while one is located in the upper story, and two more are located in the basement/foundation wall. The openings in the first story include three found in a shallow three-sided projecting bay that replicates the appearance of the two-story bay/tower on the primary façade and is located immediately north of the porch. The window openings in this bay replicate those found on the front bay/tower. The remaining window in this story is located near the north end of the elevation. This opening currently holds an aluminum-framed slider window in a modified opening. The original opening is still visible and is distinguishable by a narrow concrete sill and wide concrete lintel that extend beyond the current window, which exhibits a brick sill. The remaining portion of the opening around the current window has been filled in with smooth brick painted white to match the rest of the building. The upper story window opening is found in the wall of a steeply pitched cross-gable in the roof; the bottom corners of the gable exhibit decorative knee braces. The opening holds a Palladian style three-part window with a concrete sill decorated with dentils and a pronounced and coped header topped with a half-round design created by stepped molding. The central window currently comprises a wood-framed one-over-one double-hung window while the flanking windows on each side are wood-framed multi-pane (with diagonal muntins arranged to create a series of diamond-shaped panes) casement windows. The final two window openings in this elevation are found in the basement/foundation wall north of the projecting bay window. One of the openings holds a three-pane (side-by-side-by-side) wood-framed hopper or awning window, and the other now holds a louvered vent.

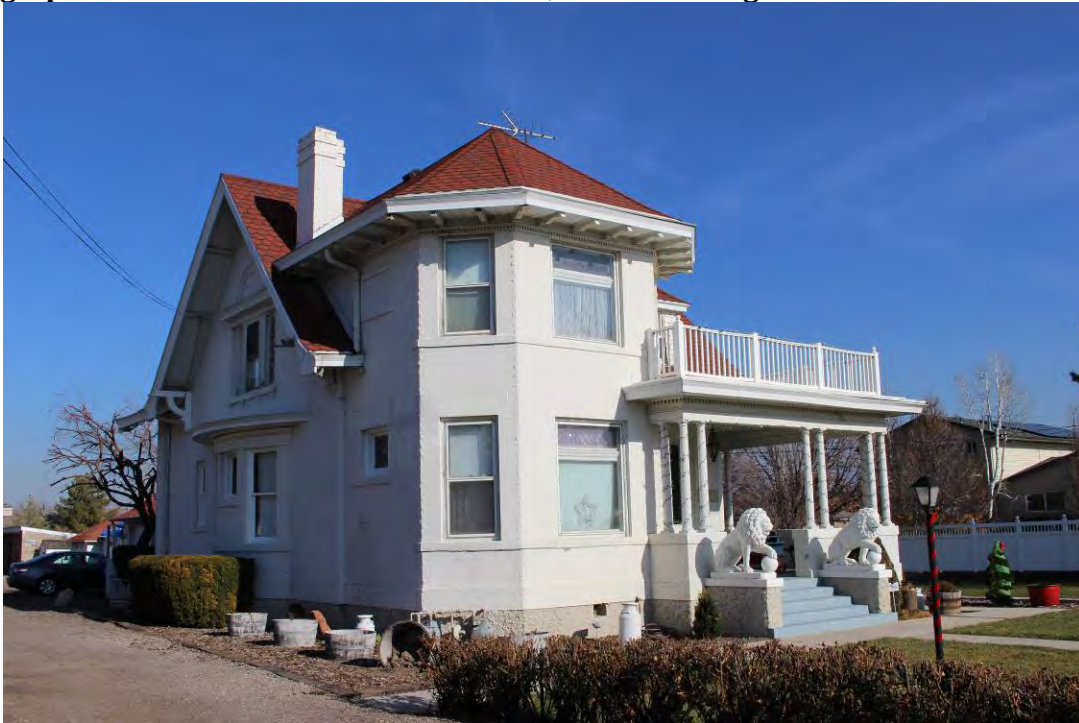
**Photograph 3 of 19. South and west elevations; camera facing northeast**

The west (side) elevation of the dwellings is similar in architectural detail to the east elevation, including the upper story Palladian style window in the gable wall. The notable differences between the two elevations are that the bay window in the west elevation is rounded instead of faceted, the window openings are different sizes, and there are no window openings in the basement/foundation wall. Six window openings are present in the west elevation beyond the aforementioned Palladian window. Three of the openings are located in the projecting bay. Two more are arranged with one north of the bay and one south of the bay in the first story of the elevation. The remaining opening is located in the upper story of the elevation in what is essentially the west wall of the two-story bay on the primary façade of the

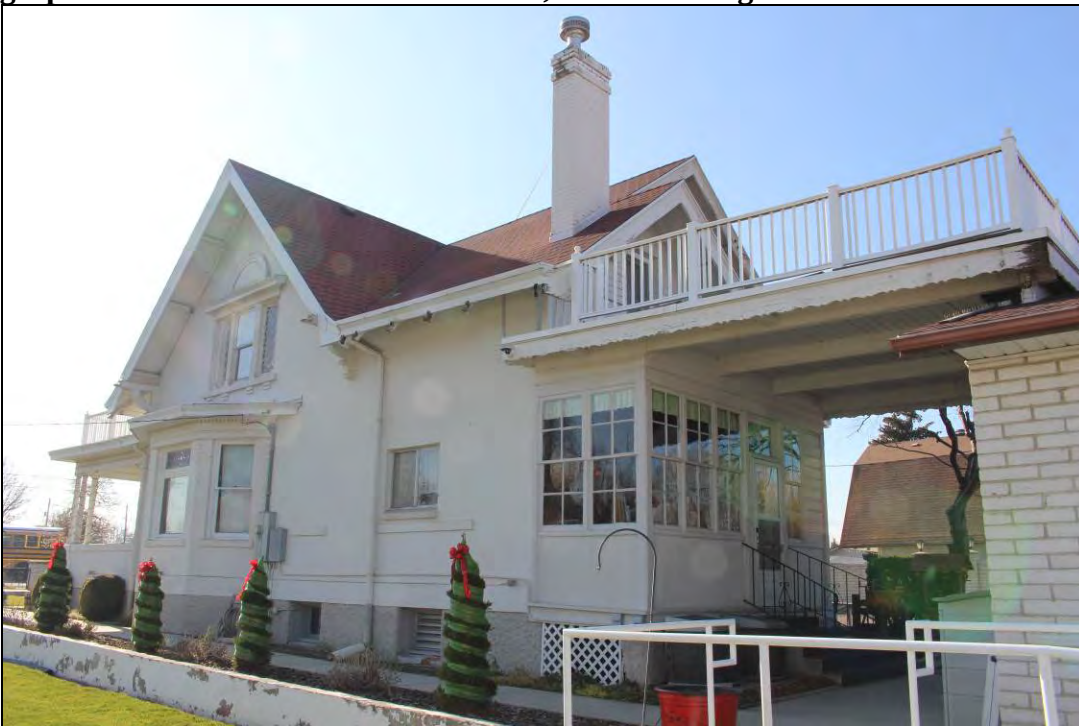
**Photograph 4 of 19. North and east elevations; camera facing southwest**

The north (rear) elevation of the dwelling is relatively complex from an architectural standpoint. The east half of the first story is occupied by an enclosed sleeping porch or summer kitchen, which appears to be part of either the original construction or an in-period addition. The porch/kitchen structure is wood-framed. Wood-framed four-over-four double-hung windows form effective window walls that occupy most of the north and east elevation of the porch/kitchen. The remaining walls are clad in a combination of tongue-and-groove and drop siding. A single pedestrian doorway, which serves as the rear entry into the dwelling, is located in the north elevation of the porch/kitchen feature. The porch/kitchen is found under a large balcony/deck that extends from the upper story of the dwelling to a detached garage located north of the dwelling. The garage was constructed in 1974, and the north edge of the balcony rests on the roof of the garage. This suggests the balcony was constructed during or after 1974, outside the period of significance. The balcony is accessed by a doorway found under a projecting gable in the upper story of the elevation. The doorway appears to have been created by modifying an existing window opening. Three other notable details—all window openings—are found in the north elevation of the dwelling. One opening is located in the upper story gable wall, west of the balcony, and two are located in the first story. The opening in the gable wall holds a rectangular (horizontal orientation) couplet window. The casement window is wood-framed and has diagonal muntins forming a diamond pattern in the panes. The remaining two window openings in this elevation are both rectangular in shape (long axes oriented vertically), and both hold aluminum-framed 1-over-1 double-hung windows. One of the openings is situated near the west end of the elevation while the other is located in the west wall of a shallow projecting bay to which the enclosed sleeping porch/summer kitchen is attached.

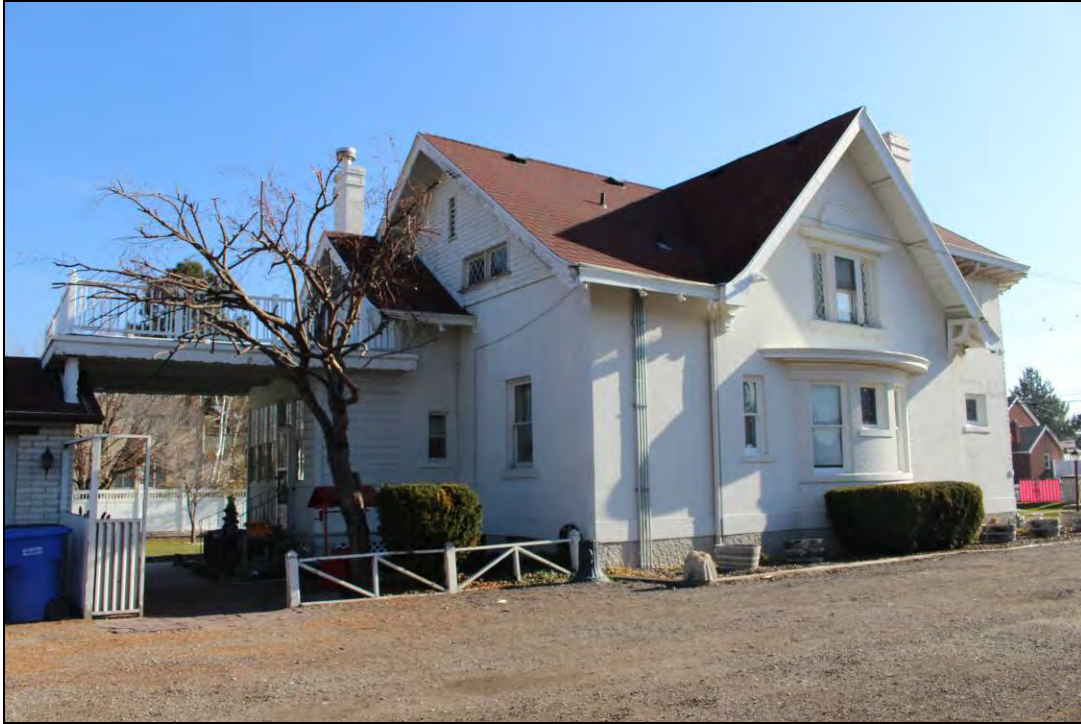
**Photograph 5 of 19. North and west elevations; camera facing southeast**

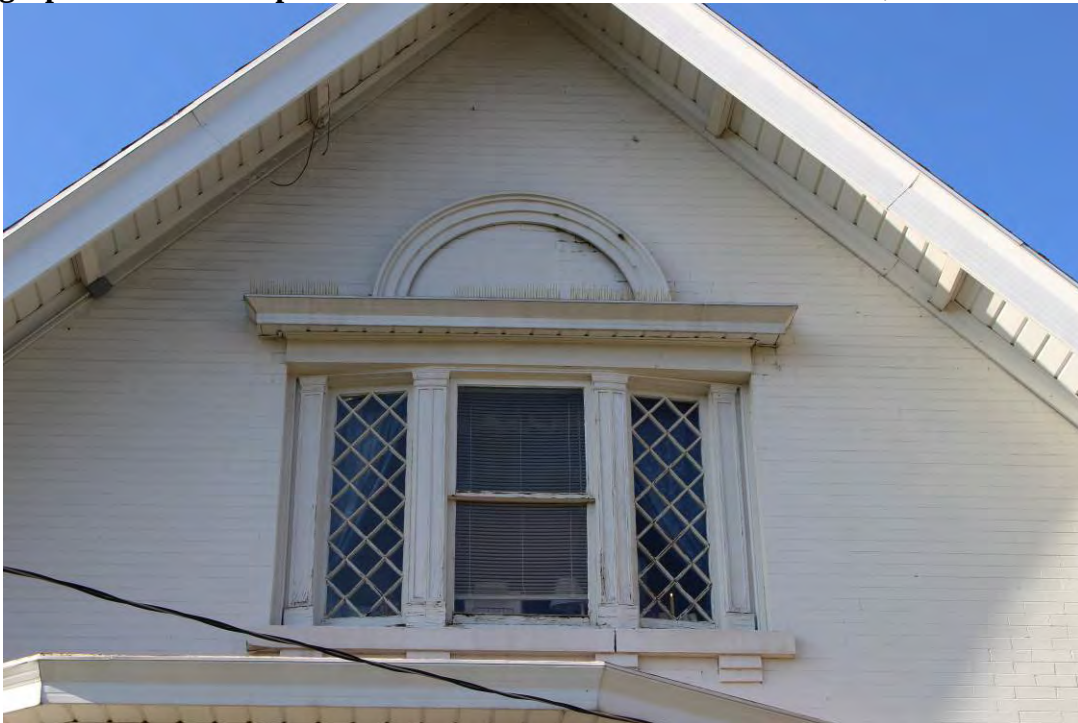
**Photograph 6 of 19. Example of Palladian windows from east elevation; camera facing west**

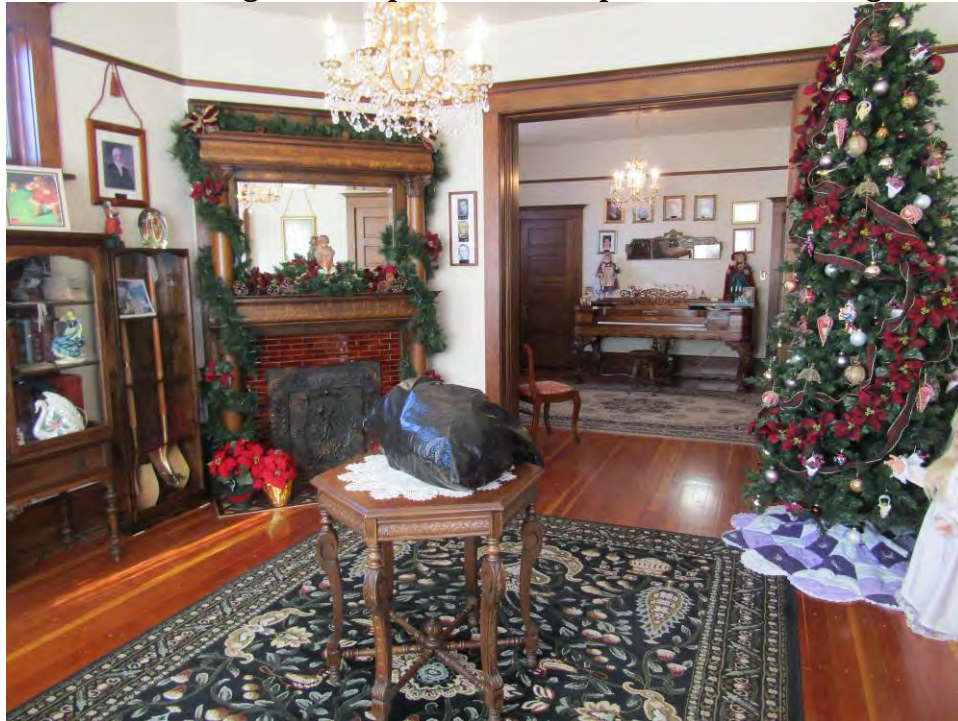
**Photograph 7 of 19. Dwelling interior, parlor with fireplace; camera facing northwest**

Perhaps the most prominent interior historical feature of the dwelling is the fireplace located in the parlor of the first floor. The fireplace is situated in the northwest corner of the room adjacent to a pair of pocket doors leading into the hall. The fireplace includes an elaborate quarter-sawn oak mantel and upper section/topper with a cut-glass mirror. The mantel shelf and header are supported by Ionic columns clad in quarter-sawn oak veneer. The fireplace surround features amber-colored tiles, and the firebox is blocked with an embossed iron insert. The hearth is adorned with a combination of the same amber tiles as the surround, which are framed by similar tiles, green tiles, and mottled amber and white tiles arranged in a diamond pattern.

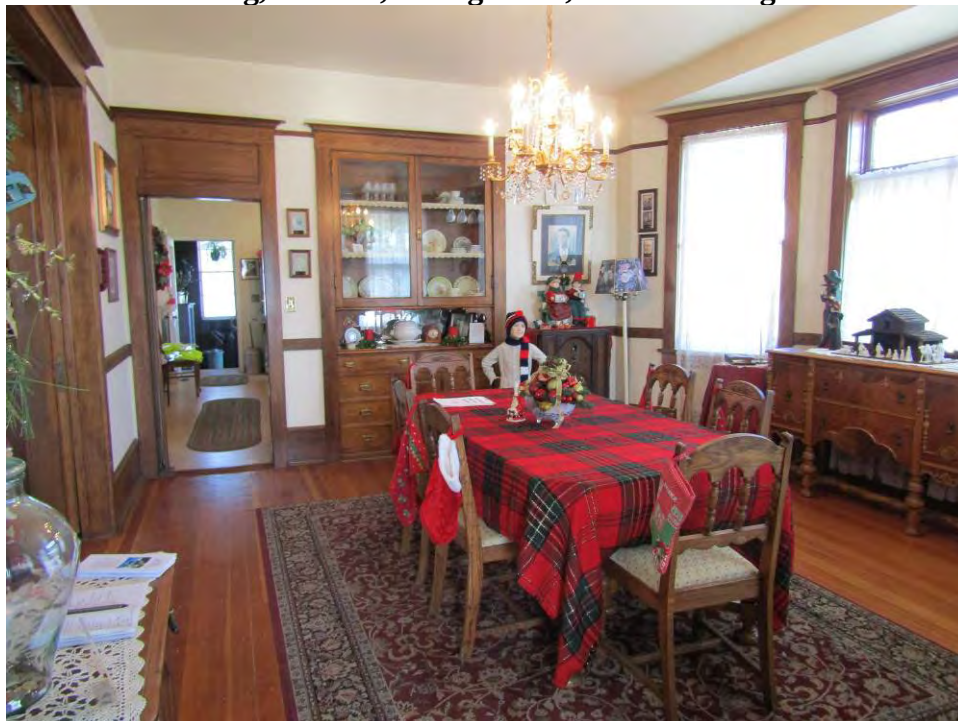
**Photograph 8 of 19. Dwelling, interior, dining room; camera facing north**

Historical finishes are present throughout the interior. Hardwood (likely maple) floors are found in every room except the kitchen (vinyl sheet flooring) and bathrooms (ceramic tile). The walls throughout are generally lath and plaster. Upstairs rooms are accented with painted base boards and trim moldings around doorways and most of the window openings. The walls of the first floor, which was clearly designed to be a more formal space where guests could visit, are accented with stained pine chair rail, tall base boards, and trim moldings. Doors on this floor, which include a combination of swinging doors and pocket doors, also are constructed from stained pine, as are the stairs and bannister of the stairwell. A number of built-in cabinets constructed of stained pine and oak or unknown wood that has been painted were found in the dwelling, including in the dining room and first floor full bathroom. Historical push-button light switches are found throughout the dwelling, though a few modern flip switches also have been installed. Several historical hanging light fixtures and chandeliers were noted as well, though it is unclear which of these may be original to the construction and which were added later.

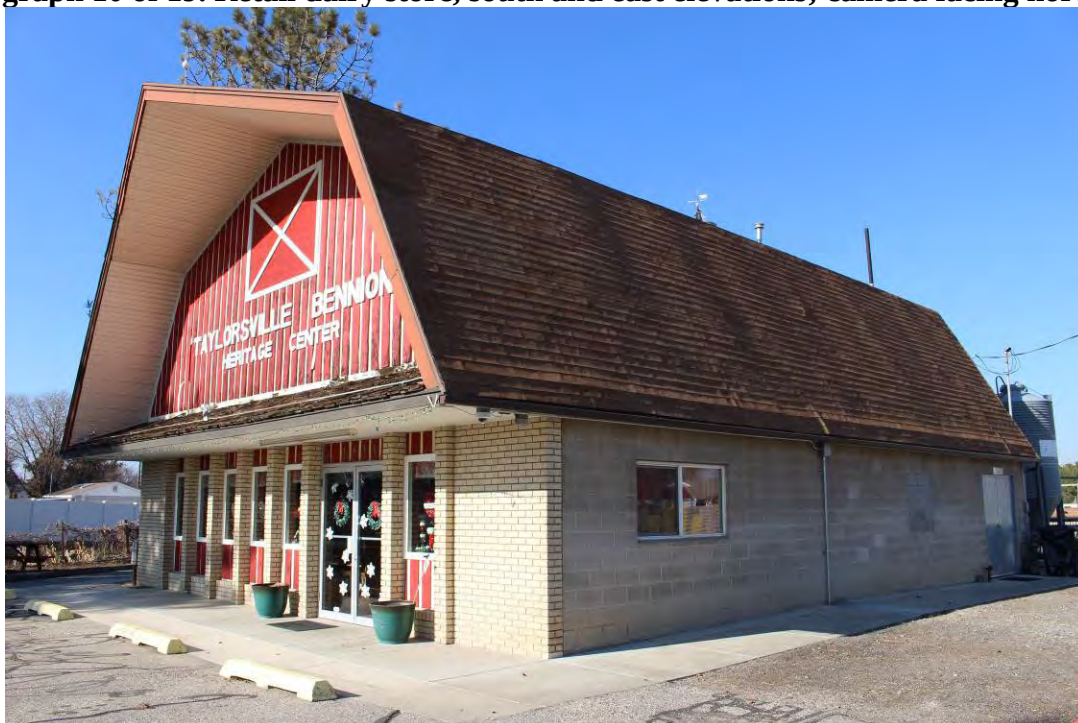
**Photograph 10 of 19. Retail dairy store, south and east elevations; camera facing northwest**

The store building is constructed of concrete block with smooth brick veneer on the primary façade (the south elevation), board-and-batten siding on the gable wall of the primary elevation, and vinyl or aluminum siding on the gable wall of the rear elevation. The building rests on a concrete slab foundation and has a gambrel roof with a deep eaves and a pent roof section (on the primary façade). The gambrel roof, which is clad in asphalt tiles, lends a Dutch Colonial Revival aesthetic to the building and was likely intended to be reminiscent of the Improvement Era Barn form that was common on dairy farms in Utah during the early 1900s. The main body of this building has a simple rectangular footprint. A small rectangular concrete block addition of unknown age was constructed off the rear (north) elevation of the building.

Beyond the previously noted architectural details, the retail store building is relatively unremarkable. The storefront (i.e., the south elevation) is characterized by a series of window openings and a retail (glass) doorway. The window openings and doorway are separated from each other by brick pilasters. All of the windows in this elevation appear to be modern aluminum-framed fixed sash windows. The east and west side elevations are few window openings, most of which hold modern slider windows. One window opening in the east elevation has been infilled with concrete block. A double-door pedestrian entry is located at the north end of the east elevation and likely served as the original rear entry to the building prior to the construction of rear addition. The rear addition exhibits three window openings on both the east and west elevations, all of which hold aluminum-framed slider windows. A double-door entry is located in the north elevation.

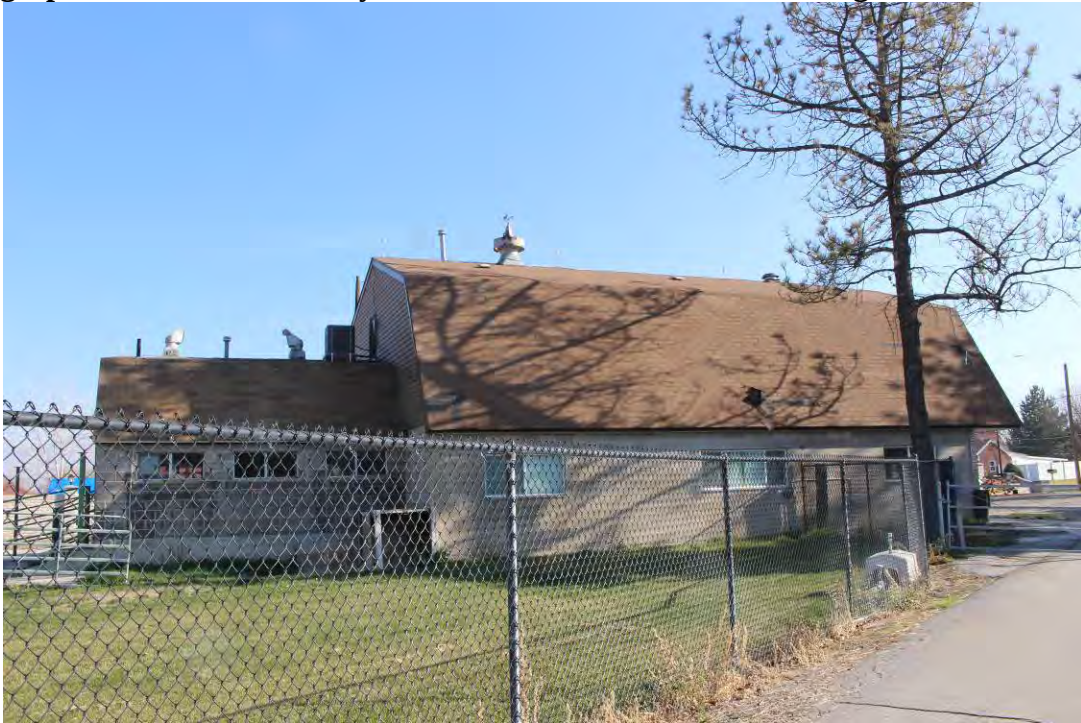
**Photograph 11 of 19. Retail dairy store, west elevation; camera facing east**

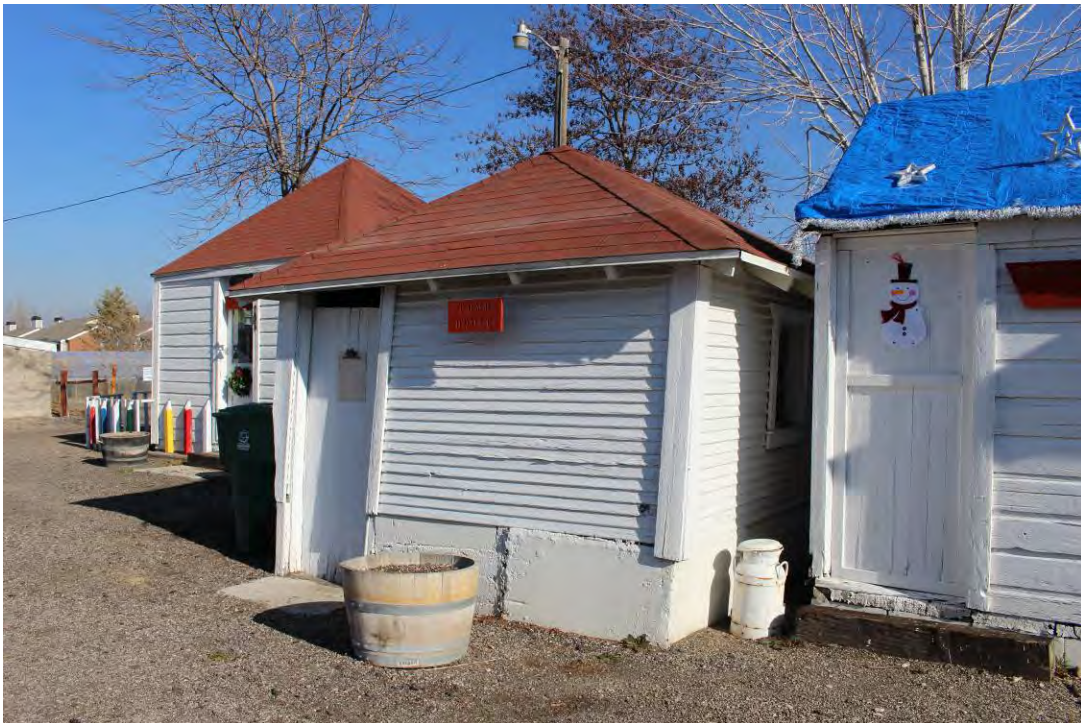
**Photograph 12 of 19. Pump house, west and partial south elevations; camera facing northeast**

The pump house, constructed at the same time as the house, is a wood-framed structure clad in historical clapboard siding. It has a shallowly pitched hipped roof clad in red asphalt tiles and exhibiting exposed rafter tails and rests on a combination concrete slab and concrete short-wall foundation. A pedestrian doorway is located at the north edge of the west elevation, which is the building's primary façade. There

are only two windows in the building and no other notable architectural details. The window openings are located in the east and south elevations (at center) and hold wood-framed 6-pane casement windows.

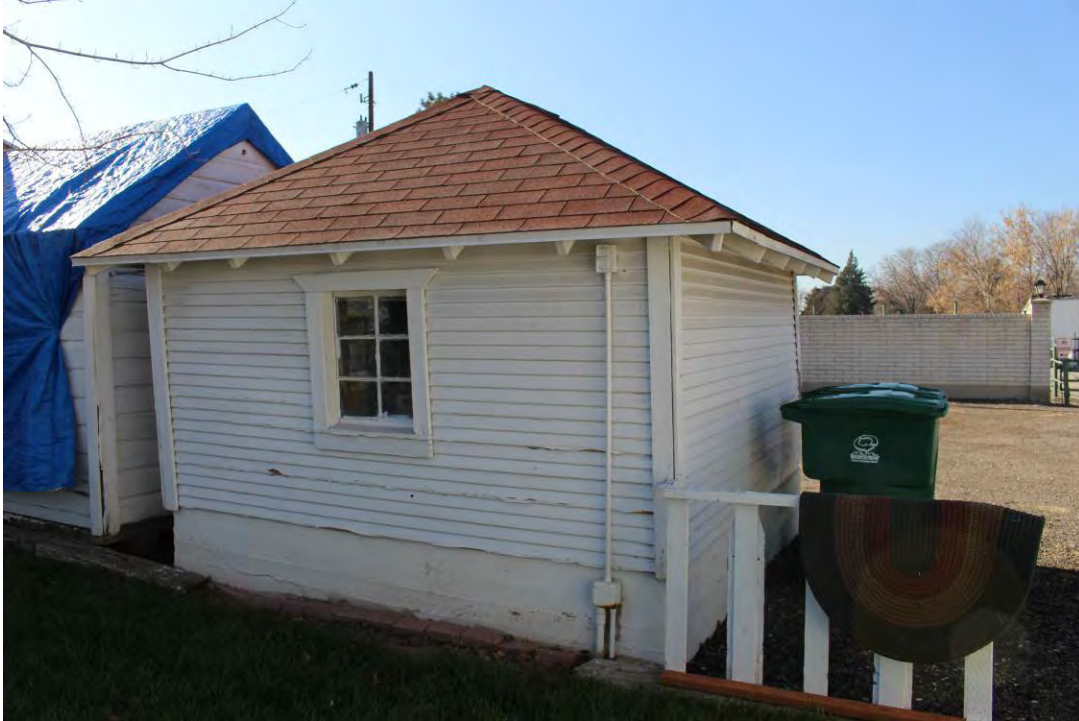
**Photograph 13 of 19. Pump house, north and east; camera facing southwest**

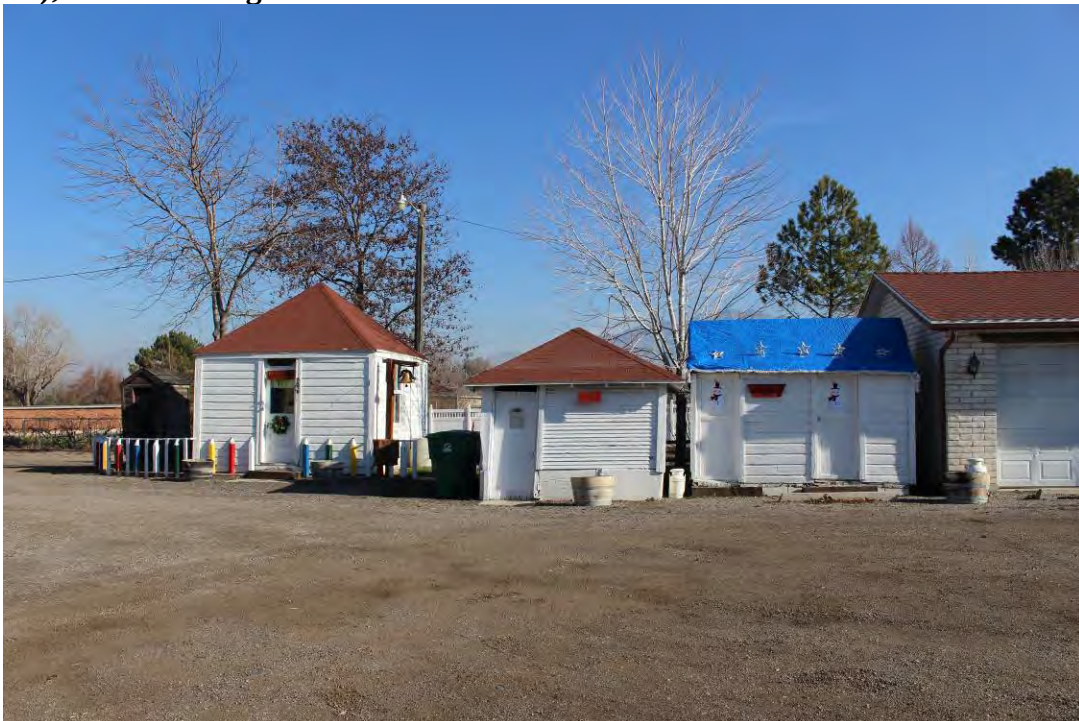
**Photograph 14 of 19. Example of non-contributing relocated buildings (except pump house at center); camera facing east**

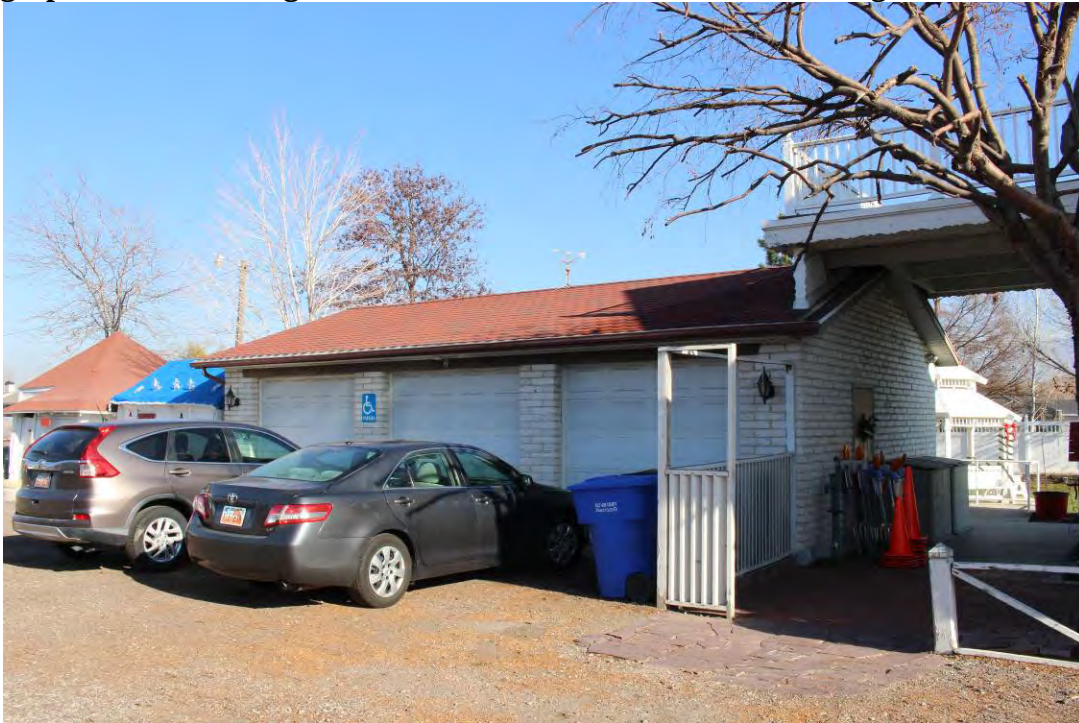
**Photograph 15 of 19. Garage, west and south elevations; camera facing northeast**

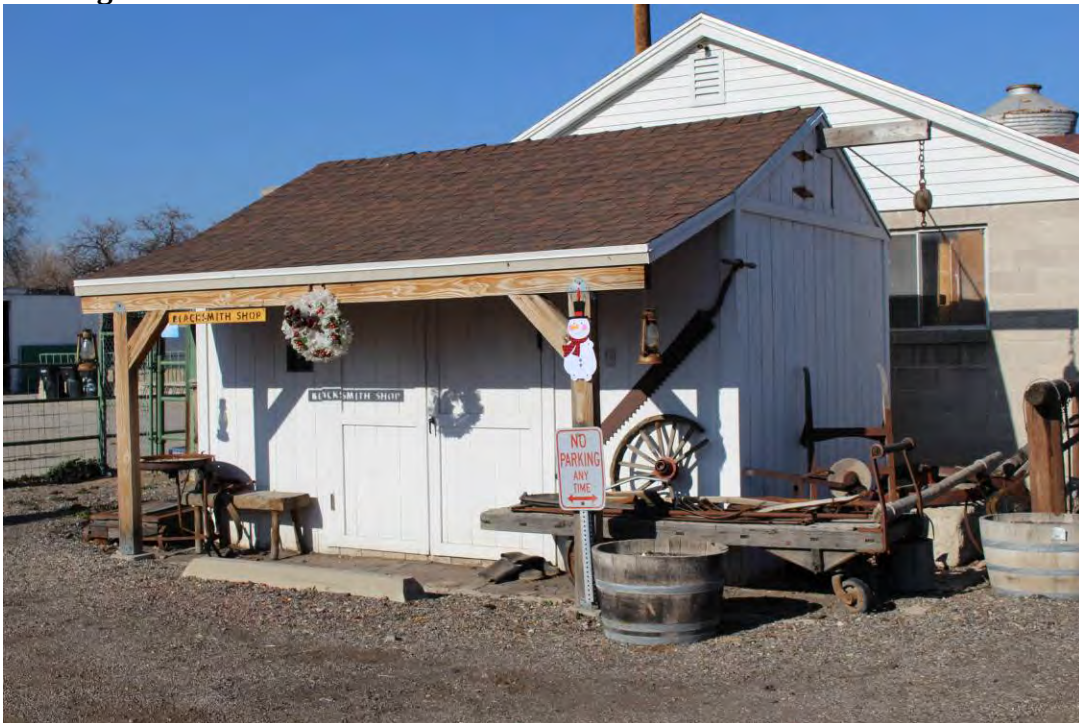
**Photograph 16 of 19. Shed converted to blacksmith shop display, south and east elevations; camera facing northwest**

This outbuilding is a small, wood-framed shed clad in T1-11 wood sheet siding. It has a side-gable roof with no eaves and a pair of double shed-style doors in the south elevation. A full-length porch was added to the building as part of converting it to an interpretive display of a historical blacksmith shop. The building is visible in a 1964 aerial image, which indicates it was added to the property during the period of significance. Although present during the period of significance, this shed is considered non-contributing to the property due to the apparent changes to it as part of its current use as an interpretive display.

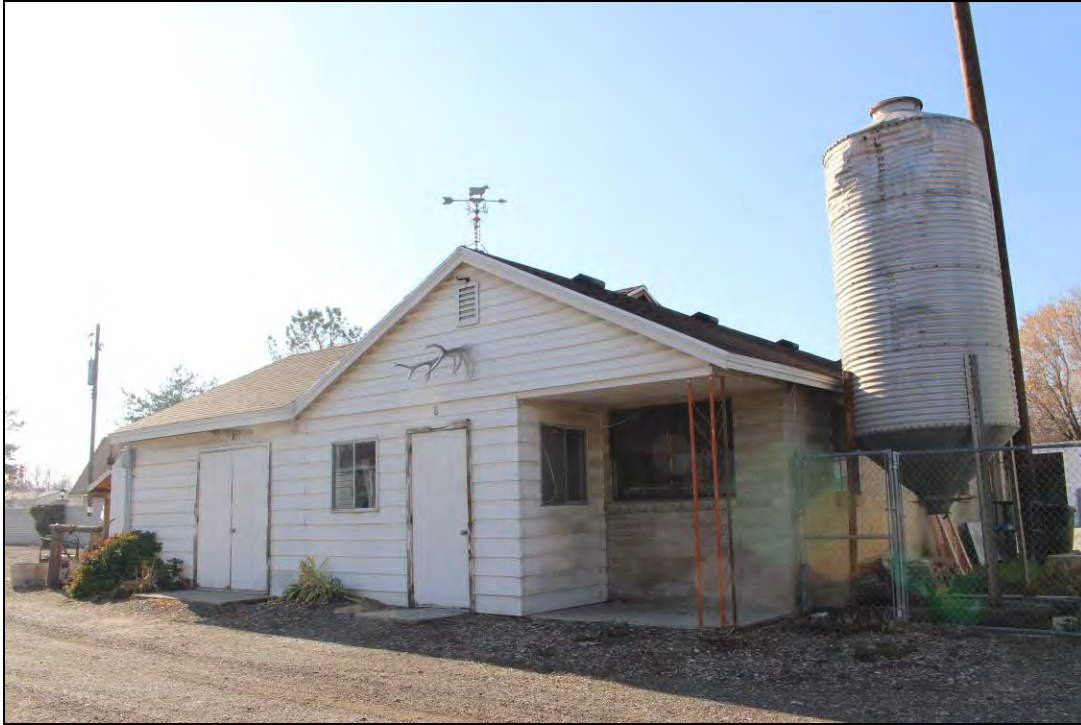
**Photograph 17 of 19. Milking shed, north and east elevations; camera facing southwest**

This building is a cross-wing form building that appears to have served as a milking shed or similar functional facility for the dairy operations at the property. Although an exact date of construction for the building could not be determined, it appears most likely from aerial images and other property history information to have been constructed between 1950 and 1964.

The building abuts the east edge of the concrete-paved cattle pen, and access from the pen into the building was provided through a doorway in the west elevation of the building. The building sits on a concrete slab foundation and has a moderately pitched side-gable roof with a cross-gable projection over a corner "porch" feature in the primary (east) elevation. The style of the building is best described as Early Ranch, with a combination of a Ranch style roof and footprint and Minimal Traditional style in the extremely close eaves, overall lack of exterior adornment, and scroll-work metal porch support posts. At the time of documentation, the exterior walls of the building were clad in a combination of concrete block, concrete brick, wide aluminum siding (presumably historical) and narrow vinyl siding. Exterior alterations appear to include the addition of the vinyl siding to the gable walls, replacement of at least some of the original windows with aluminum-framed sliders, and possible changes to fenestration to remove a doorway in the corner porch area—the porch slab and corner post remain in place, but there is no doorway in the porch area. Based on these alterations, the milking shed is considered non-contributing to the property.

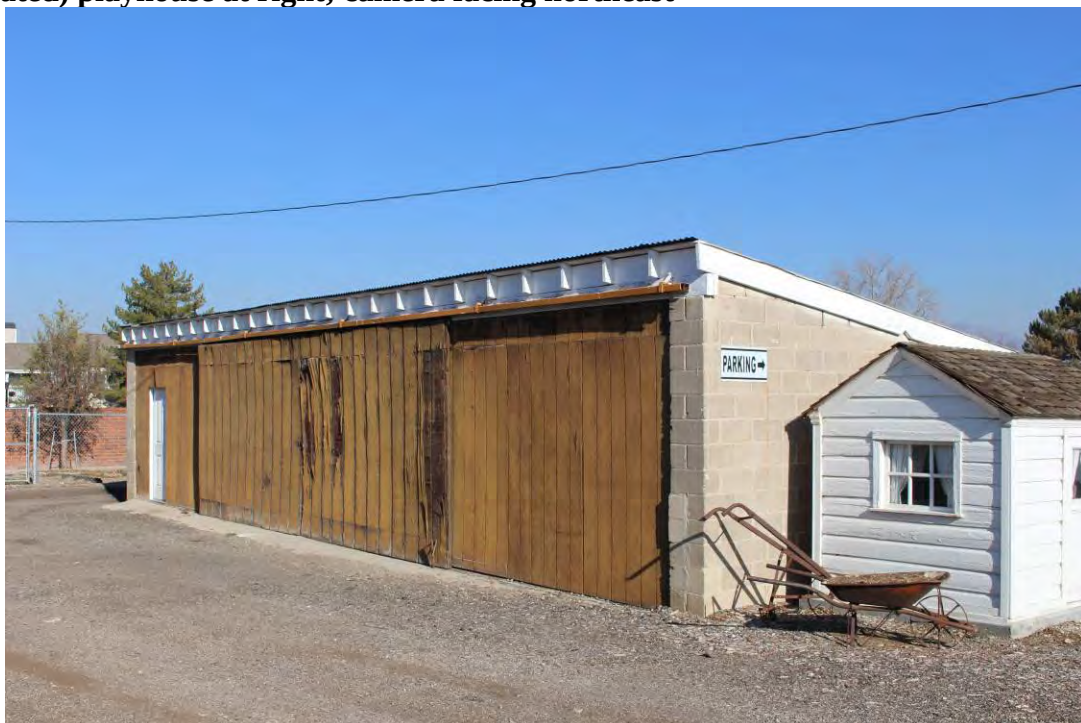
**Photograph 18 of 19. Workshop building, west and south elevations, with non-contributing (relocated) playhouse at right; camera facing northeast**

The workshop building is located in the north-central part of the property. Previous documentation of the property suggested a ca. 1974 construction date for the building, but it is clearly visible in a 1964 aerial image. The building is a lean-to form concrete block structure enclosed on the west elevation by a series of T1-11 wood sheet panels, some of which also serve as bay doors. A pedestrian doorway, which appears to be a modern door insert, is located at the north end of the west elevation. The roof of the building exhibits exposed rafter tails and is covered in corrugated metal sheeting. Generally speaking, the building

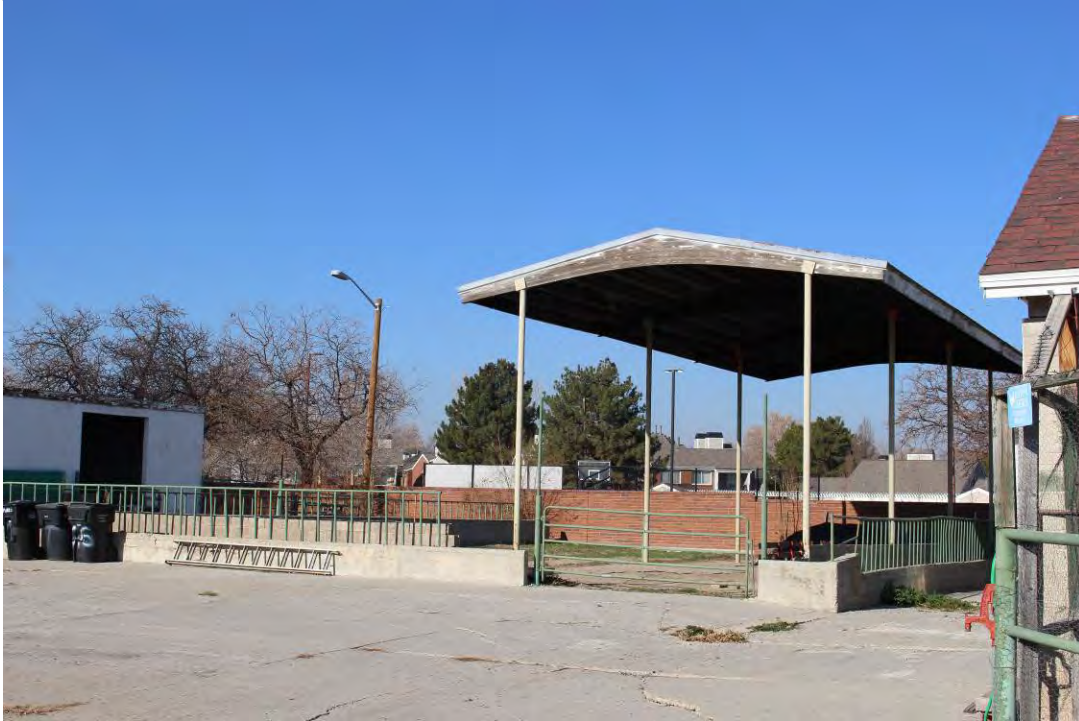
**Photograph 19 of 19. Livestock shed canopy; camera facing north-northwest**

The shade canopy is an open-air structure located west of the hay barn in a feeding pen within the cattle yard. The structure comprises a shallowly pitched gable roof supported by a series of steel pipe posts. There are no walls to the structure, which appears from aerial images to have been constructed sometime between 1937 and 1964. The structure is architectural unremarkable and does not contribute to the overall significance of the property.

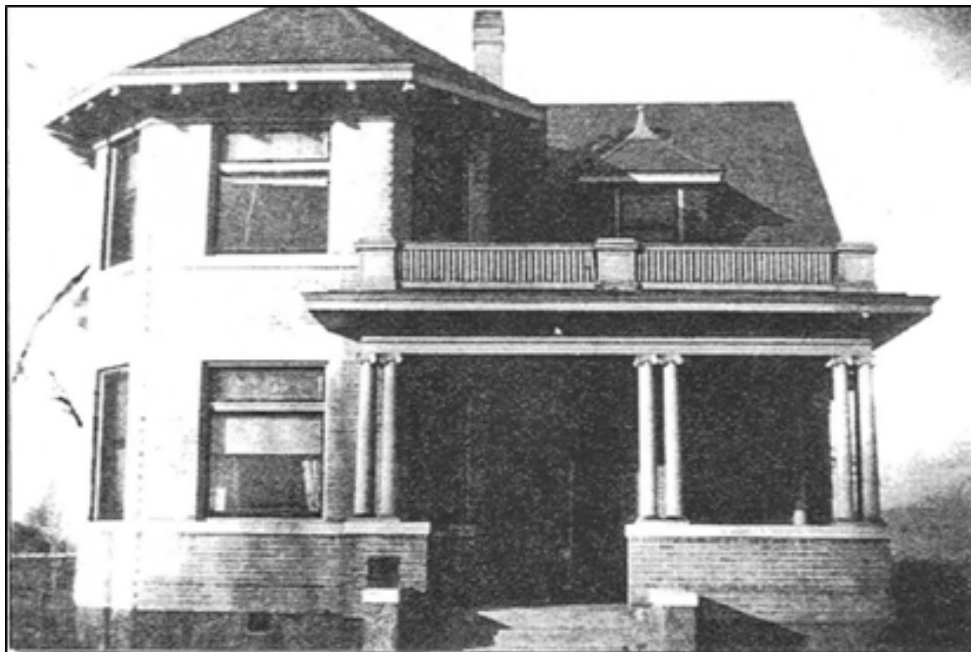
**Figure 1. Undated historical photograph showing the front porch before remodel. Courtesy of Taylorsville Historic Preservation Commission.**

Although the exterior of the Gerrard House dwelling has been altered somewhat over time, it still retains a high degree of integrity in its materials, design, and workmanship. The alterations are generally minor, and many occurred during the period of significance. The most substantial modern era structural changes appear to be the replacement of the original front balcony railing that is still reminiscent of the original wood and brick railing and the addition of the rear balcony/deck during or after 1974.
