United States Department of the Interior National Park Service National Register of Historic Places Registration Form

Historic name: <u>Sunnyfield Barn</u> Other names/site number: <u>N/A</u> Name of related multiple property listing: <u>N/A</u> (Enter "N/A" if property is not part of a multiple property listing

Street & number: 2103 North 5500 East

City or town: Eden
 State: Utah

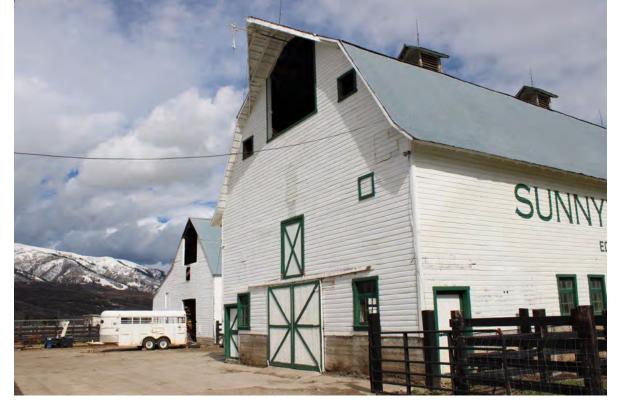
3 of 35 View of the south from north side of Farm Shop building. Camera facing northwest.

The north elevation is a gable end (Photos 3 & 4). On the ground floor, there are three doors. A Dutch door is located on the left side. A large entry with two sliding doors is in the center with the rail mounted on the outside. Another Dutch door is on the right side. Immediately above the large sliding doors is a door to the loft. On the upper portion, near the top of the steepest roof portions, there are two open windows of equal dimensions, one on the far left and the other on the far right. At the top of the wall, near the peak of the roof, is a small open window centered behind the pulley, which is covered by a roof overhang.

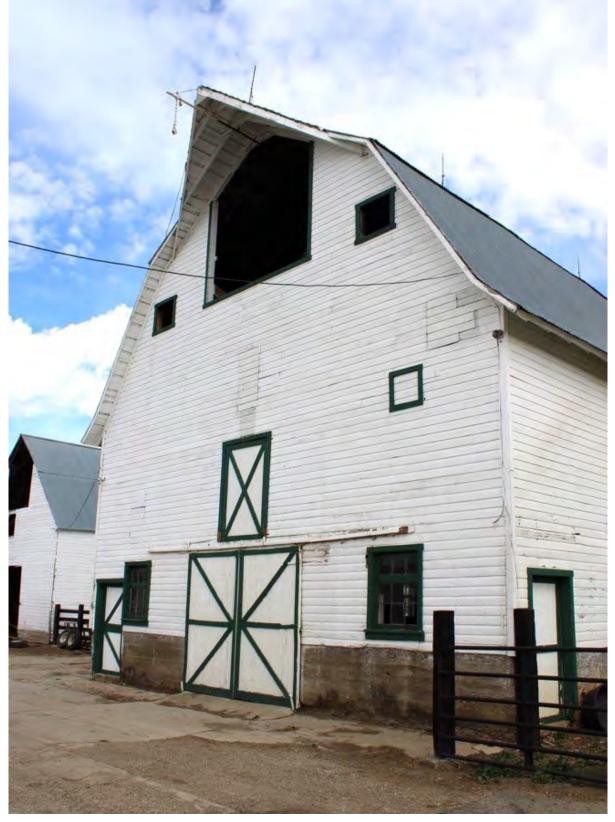
Sunnyfield Barn Name of Property 4 of 35 Alternate view of south exterior wall. Camera facing northwest.

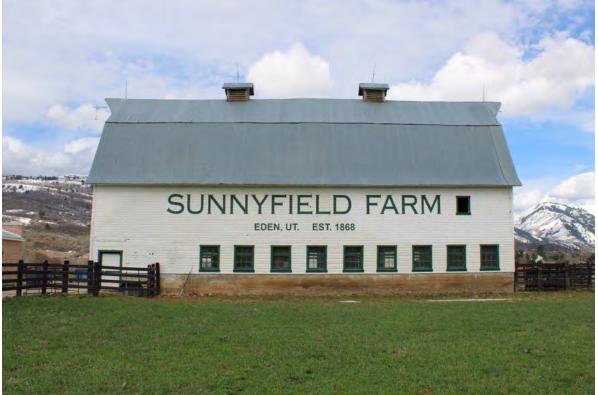
This elevation is the most visible as it faces the road (Photo 5). A wood Dutch door is placed on the ground floor near the left side of the wall. Just above the top of the concrete foundation on the main level there are nine evenly spaced windows. If the elevation were to be divided into quarters, the windows would be found in three-quarters of the wall toward the right. Each window is identical with wood framing and nine lites each. On the top portion of the wall are painted the words "SUNNYFIELD FARM" in large, dark green letters with "EDEN, UT. EST. 1868" painted in smaller lettering below that. To the right of that is a square unglazed window.

Sunnyfield Barn Name of Property 5 of 35 East elevation. Camera facing west.

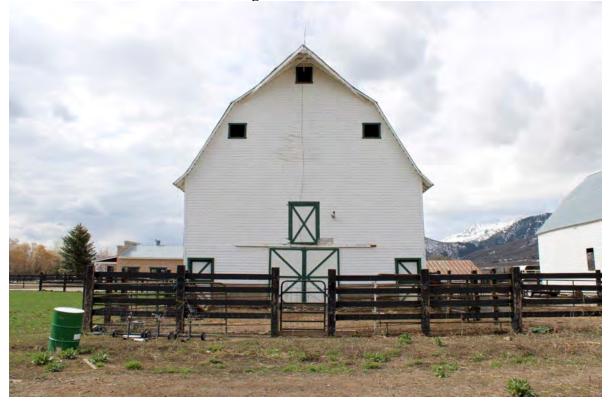
The south elevation is the other gable end (Photo 6). On the ground floor, a wood Dutch door is located on the left side with a nine-pane wood sash window immediately to the right of it. A large opening with dual sliding doors similar to those found on the north elevation are in the center. Centered between the center opening and the right edge of the wall is another nine-pane wood sash window. Roughly a foot above the left window is what appears to be a former rectangular opening that has since been covered with siding too match the rest of the wall. Above the sliding doors is another hinged door to the loft, matching the one found on the opposite end. About a foot above that door is a second rectangular opening covered in siding. To the right of that, almost aligned with the right ground floor window is a framed square with siding in the middle. Above and to the right is a third patched opening with uneven siding covering what was probably an opening into the loft. Also, similar to the north wall, there are two framed openings near the steepest portion of the roof, one on the left and one on the right. Centered between those and extending to the roof is a large opening for loading hay into the loft. Above the opening is an overhang extending farther than that on the north side with a pulley arm that reaches out past the overhang.

6 of 35 North elevation. Camera facing south.

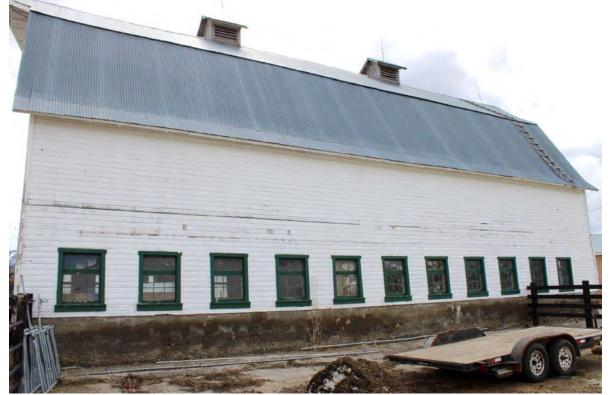
Just above the concrete foundation wall is a horizontal row of 11 equally spaced windows (Photo 7). Each window is similar to the other wood-sash nine-pane windows on the barn. Above the windows is a solid wall with no significant features.

Sunnyfield Barn Name of Property 7 of 35 West side of the barn exterior. Camera facing east.

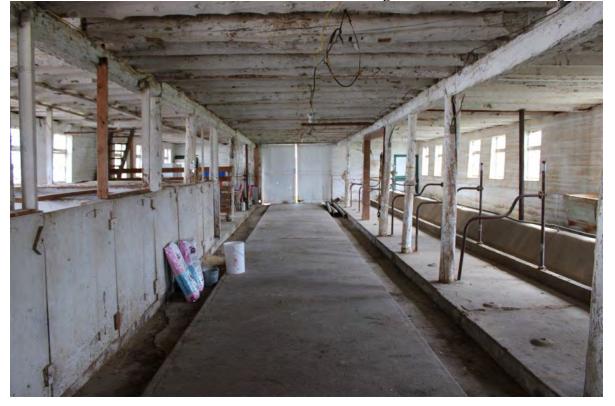
8 of 35 View from the south end of the center aisle on the ground floor. Camera facing north.

The ground floor functioned primarily as a place for milking cows. The entire floor is poured concrete. Narrow walkways run along the outside edge and connect to the wide walkway running the length of the building. This walkway separates the ground floor interior into thirds (Photo 8). Along each side of the main walkway, shallow channels formed in the concrete floor run along the length of the barn, originally used to collect waste for easy removal toward the north end. On the west side is a row of calving pens that extend to about halfway down the building (Photos 14, 16 & 17). Just past that, to the north, is a steep, wooden staircase along the west wall that leads up to the loft (Photo 15). North of that, the floor is relatively open and currently used for storage (Photo 13). On the east side is the milking area separated by metal stanchions used for securing the cows. Along the east side of the milking area is a concrete trough for feeding the cows (Photos 8, 9, 10 & 13).

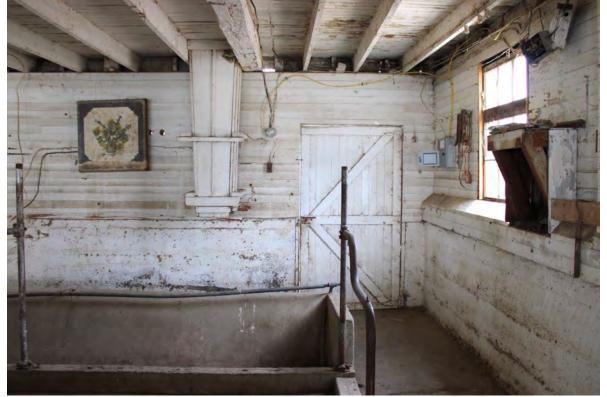
Sunnyfield Barn Name of Property 9 of 35 Southeast corner of the ground floor. Camera facing east.

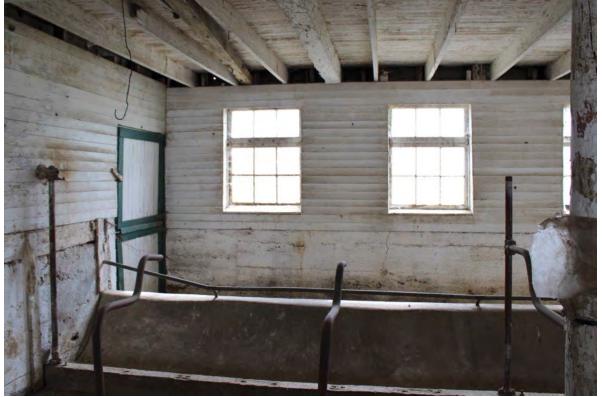
10 of 35 Northeast corner of the ground floor. Camera facing east.

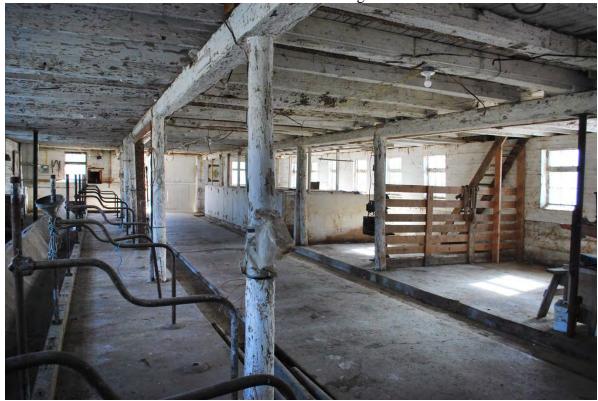
Sunnyfield Barn Name of Property **13 of 35** View from the northeast corner. Camera facing southwest.

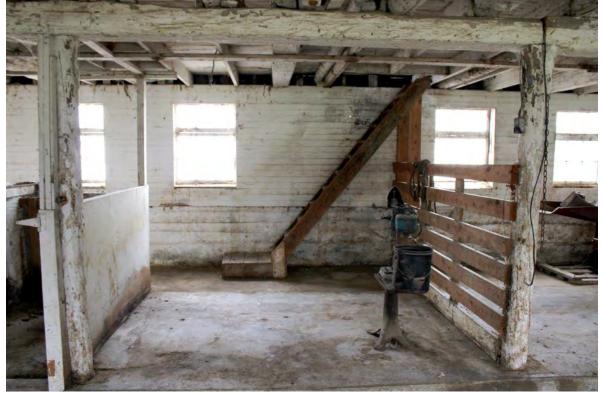
15 of 35 Staircase in the middle of the west wall leading up to the hay loft. Camera facing west.

The loft is accessed only by the narrow staircase near the center of the west side of the barn (Photo 15). The loft area was used to store hay and the Jackson fork, trolley and pulleys used to load hay into the barn are still intact (Photos 26 & 27). Just like the ground floor, the space has the same dimensions as the building. Posts and beams extend about ten feet above the floor. All the interior walls in the loft are unpainted with studs exposed except in the corners, which have sheets of plywood attached to the studs.

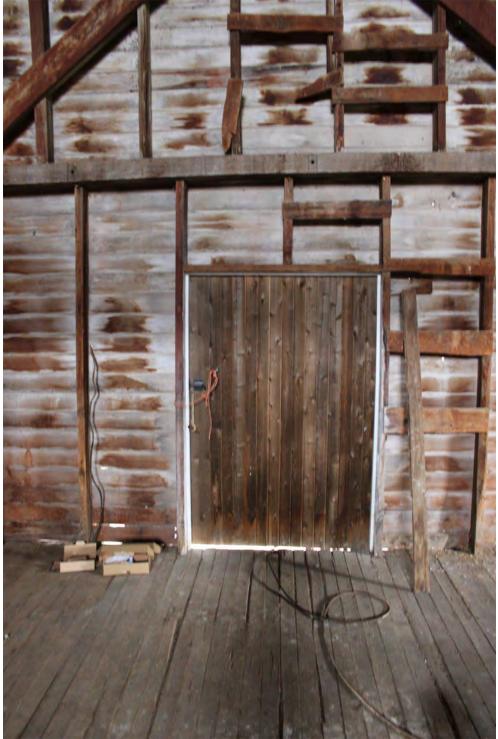
Sunnyfield Barn Name of Property 24 of 35 Center of north wall in hay loft. Camera facing north.

In the center of the north wall, a wood door swings outward from floor level opening to the outside (Photo 24). A ladder with rungs attached to the wall studs lead up to a small wooden platform (Photo 25). Above the platform is an opening in the wall that extends to the ceiling. Also near the platform is the north end of the hay trolley and the Jackson fork.

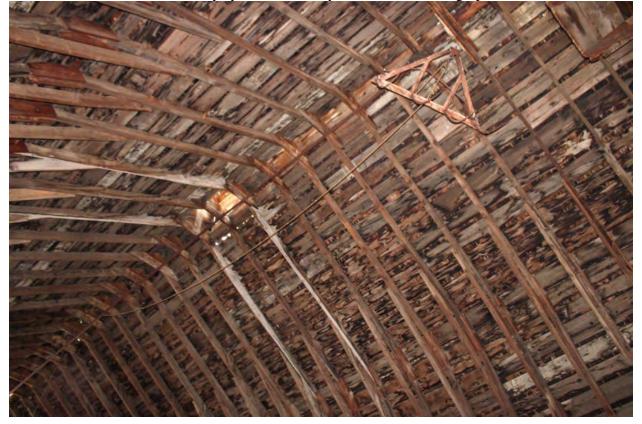
27 of 35 Jackson fork and trolley system in the hay loft. Camera facing upward and southwest.

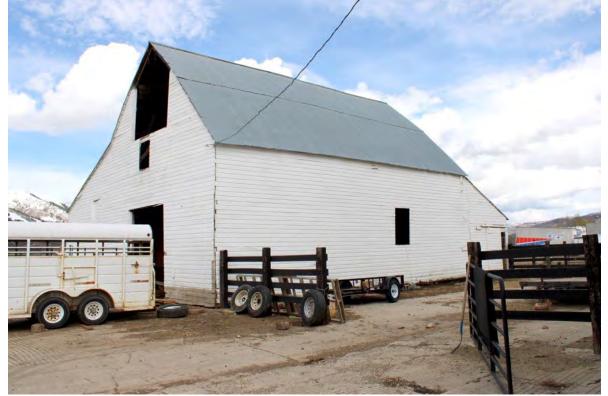
29 of 35 Smaller barn built around 1914, west of the main barn. Camera facing northwest.

Directly west of the main barn is a smaller, wooden English barn (Photos 29 & 30) that is believed to have been built in or around 1914 according to a recent newspaper article. It covers a footprint of about 53 feet by 43 feet and is painted white with a metal roof. Since this was built before the contributing 1927 barn and isn't connected to the significance of the main barn, this is considered to be a noncontributing building.

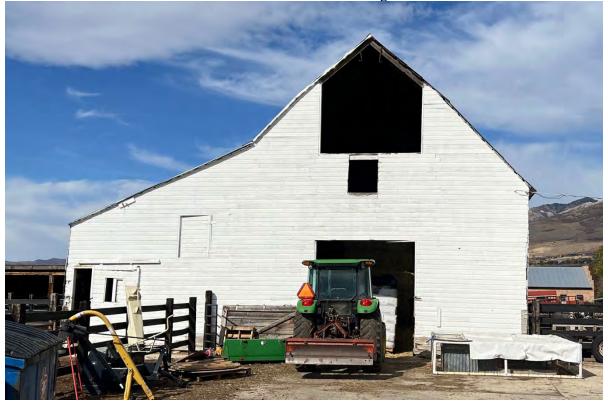
30 of 35 South elevation of the smaller barn. Camera facing north.

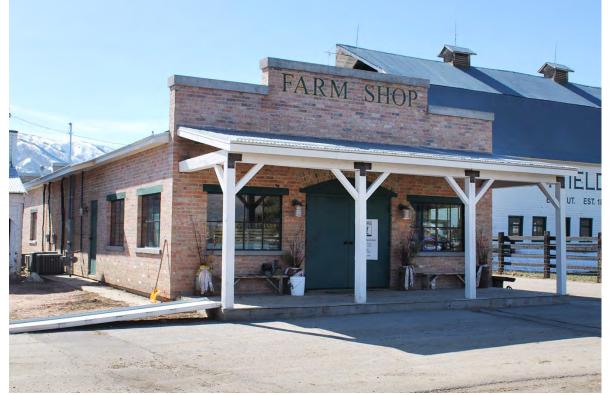
Sunnyfield Barn Name of Property **31 of 35** South and east elevations of Farm Shop. Camera facing west.

Name of Property This brick building was constructed in 1975 as a milk house and is now used for Sunnyfield Meats business operations with a retail shop on the east end (Photo 31). The building's footprint is about 87 feet long by 28 feet wide. The exterior walls are unpainted.

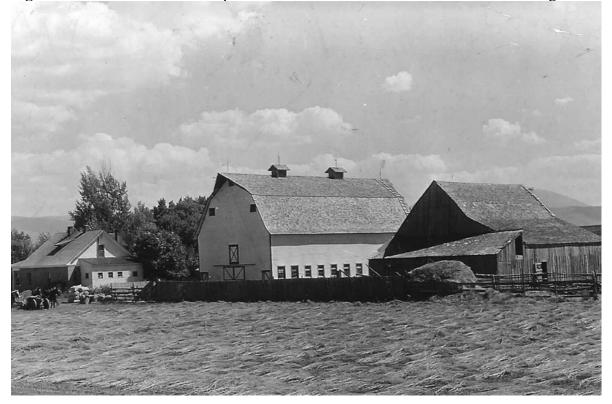
Figure 1 of 1 Undated historical photo of the barns and former house. Camera facing southeast.

The setting of the site remains very similar to when the barn was constructed – farms and pastureland still dominate the area. The original materials are still visible in the foundation, walls, doors, windows and interior elements. However, from the only known historical photo

(Figure 1) we see the roofing has changed from wood shingle to corrugated metal. Workmanship methods are evident in the concrete foundation and wood beams and joinery.

The roof is a gambrel style with corrugated metal roofing. An undated historical photo shows the roof covered in what appears to be wood shingles. Overhangs extend from the north and south ends over the pulley arms used for bringing hay up into the loft. On top of the metal roofing, at the south end of the west side, there is a wooden ladder leading up to the apex. Two matching cupolas are equally spaced on the peak of the roof, dividing it into thirds. The rectangular cupolas are unpainted with vents on the east and west sides and topped with a gabled roof and lightning rods.

A red brick house was once located east of the barn (Figure 1). Its construction date is uncertain, but it is known to have existed in 1959. The house was demolished in 2018 along with a small garage located between the house and Sunnyfield Barn. That same year, many large trees around the house and along the road were also removed. The area where the house and garage were located is now part of a larger pasture area. The Sunnyfield Barn is now fully visible from all along 5500 East, which it wasn't before the removal of the large trees and the house.
