# National Register of Historic Places Registration Form

historic name Thompson Family Farmstead

city or town Spanish Fork  vicinity

The Thompson Family Farmstead is a 23.84-acre farmstead located at 7421 S. River Bottoms Road, just outside the municipal boundary of Spanish Fork, Utah County. The farmstead is a multi-resource property that includes a stone house (built 1899-1901), a large barn (1910s-1930s), and nine contributing outbuildings. The landscape includes a hay field, a pasture, and a flower/vegetable garden. The pastures and garden are north of River Bottoms Road and are associated with the house and outbuildings. The hayfield (a contributing site) is located south of the road and one half is currently maintained as a firefly habitat. The farm property also includes a number of contributing agricultural structures: a section of the Mill Race Canal, a natural spring reservoir, irrigation ditches/pipes, three corrals, two stanchions, two cattle feeders, a loading ramp, and several hundred feet of historic fencing with gates. All existed prior to or were built within the period of significance between 1899 and 1973. The only non-contributing additions to the property bu

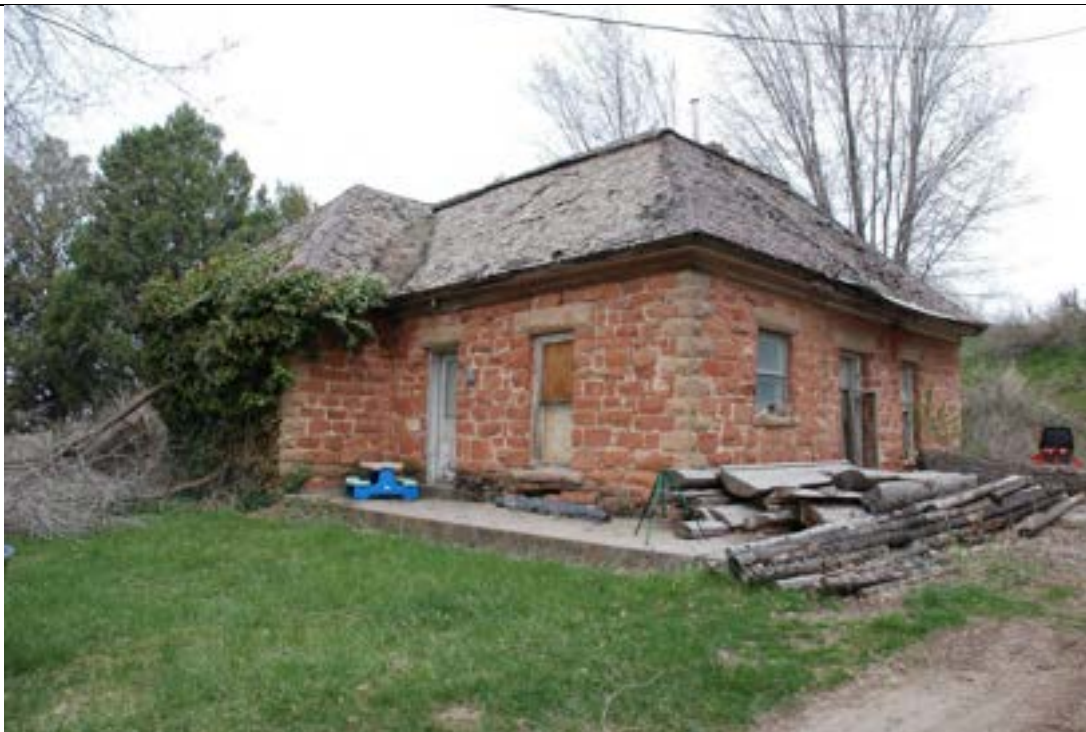
**Photograph 7**

*Thompson Family Farmstead*, south and east elevations of house. Camera facing northwest.

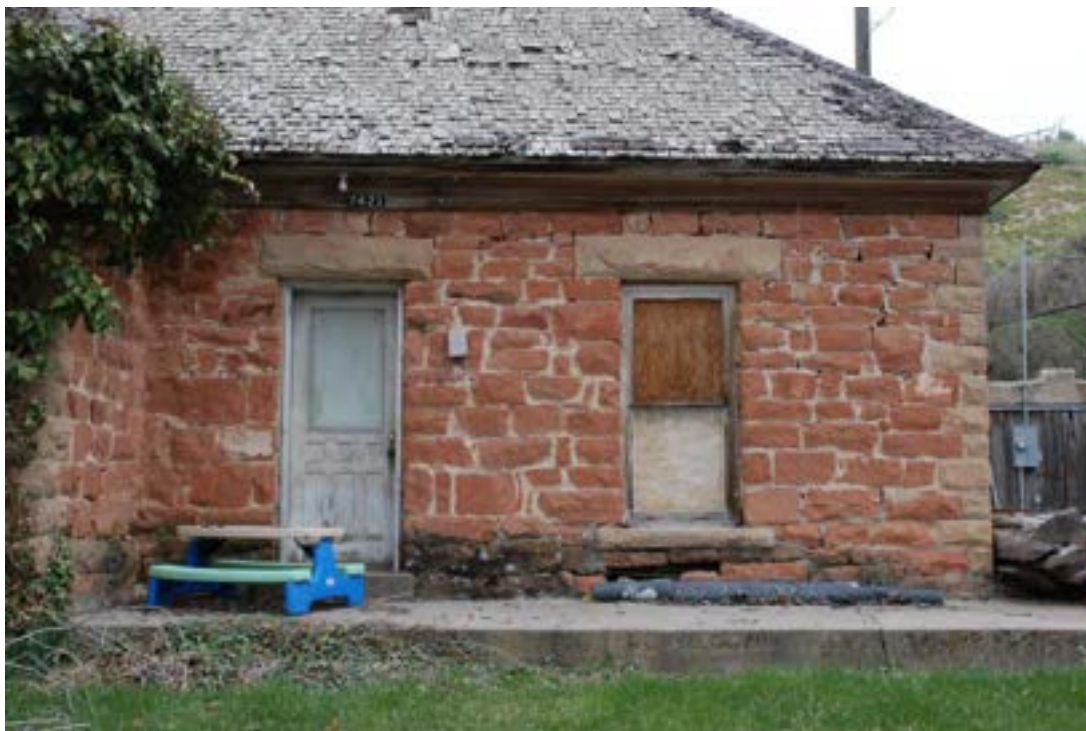
**Photograph 8**

*Thompson Family Farmstead*, south elevation, porch details. Camera facing north.

The façade (south elevation) features the main entrance with one tall, narrow window on the porch [Photograph 8]. The original half-glass Victorian paneled wood door is intact; but the transom is missing. The door was likely raised when the new porch deck was poured. The double-hung wood sash window is also original, although missing glass in the upper sash. Underneath a mass of vines, the projecting west wing features a similar window. The vines also cover the south half of the west elevation [Photographs 9-10]. This elevation features double-hung wood windows flanking a blocked door. The windows have broken aluminum storm windows. The rear (north) elevation has two double-hung wood sash windows, one has a broken storm, the other has a missing storm and is covered with plywood. The masonry of the rear elevation is the most random with a mix of red and light brown sandstone [Photograph 11].

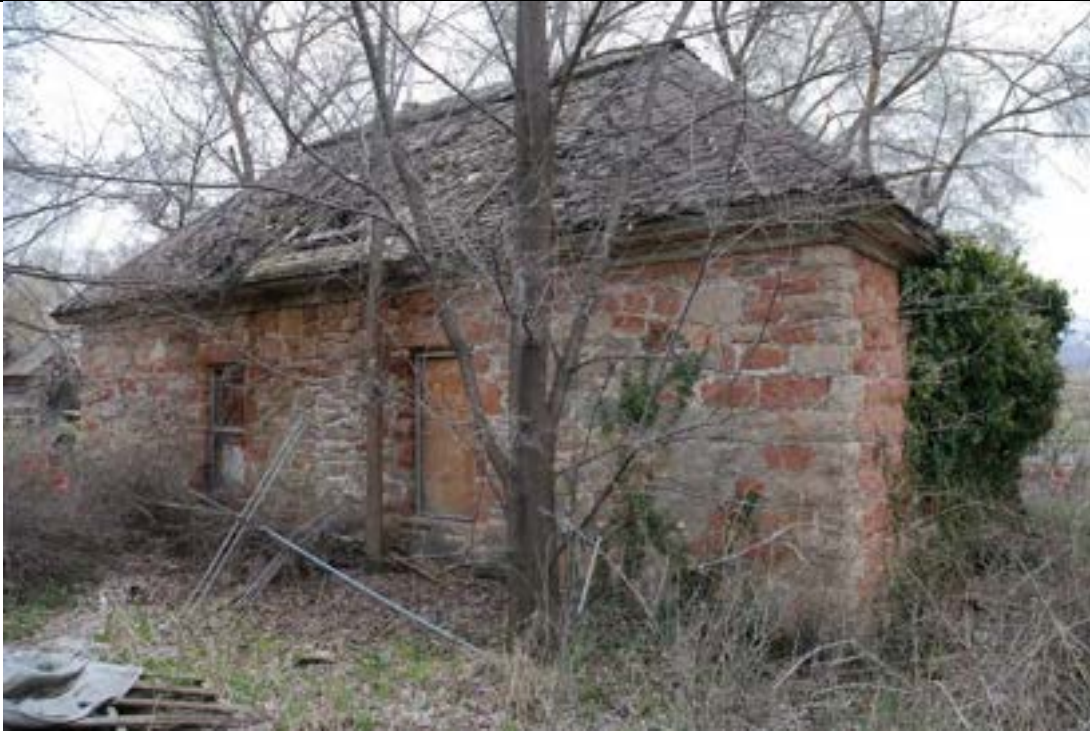
**Photograph 11**

*Thompson Family Farmstead*, north elevation of house. Camera facing southeast.

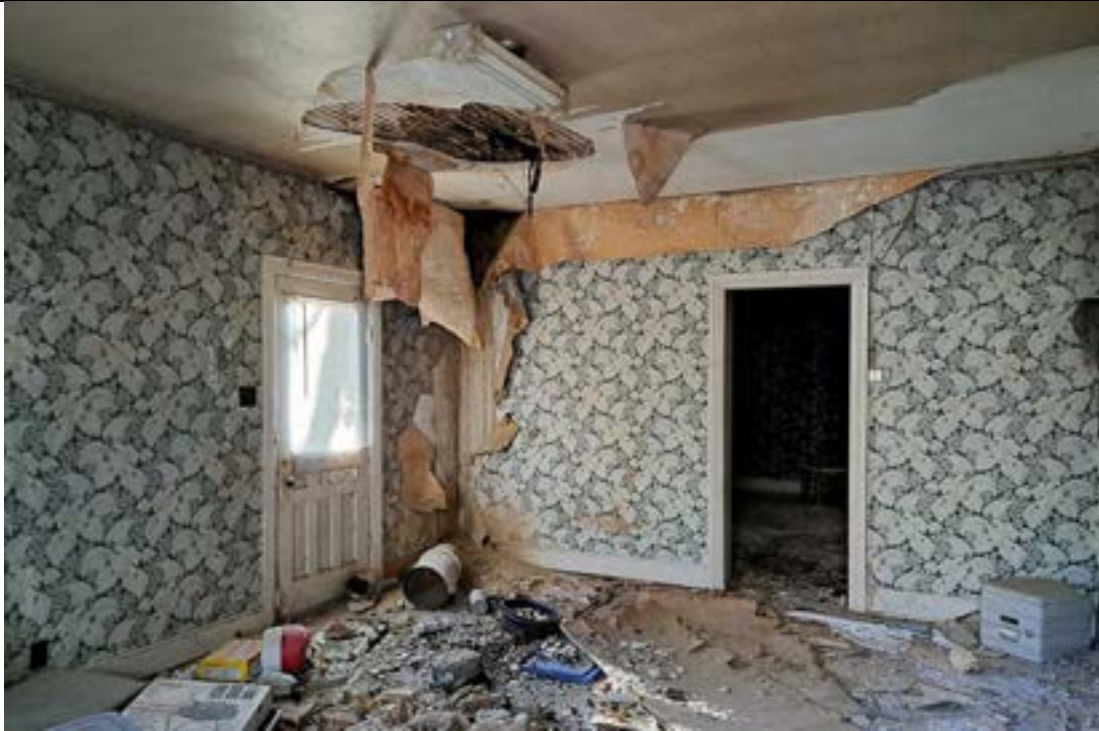
**Photograph 13**

*Thompson Family Farmstead*, house interior, dining room. Camera facing southwest.

On the interior, the Thompson house has 930 square feet divided into four main rooms. The front door opens into the dining room with the kitchen at the east end [Photograph 13]. The dividing walls are adobe brick covered in wallpaper. The ceilings are lath & plaster. There is significant water damage to the finishes at the top of the walls. The wallpaper and kitchen cabinets date from the 1940s or 1950s. The parlor/living room is to the west and the floral wallpaper is from the same era as the dining room [Photograph 14]. There are stove pipe flues in both the dining room and the kitchen, but no stoves. There are two bedrooms along the north wall, each with a door connecting to the front room, and a second opening connecting them to each other. The wallpaper in the bedrooms looks slightly older and the water damage is more severe. A bathroom was located in the northeast bedroom (built in 1977, removed in 2001). The door and window casings and baseboards are in good condition. The attic is not finished nor was it used historically. The stairs to the root cellar under the east addition were filled-in around 2001. Both the exterior and the interior of the house have excellent historic integrity from the period of significance, which ends in 1973.

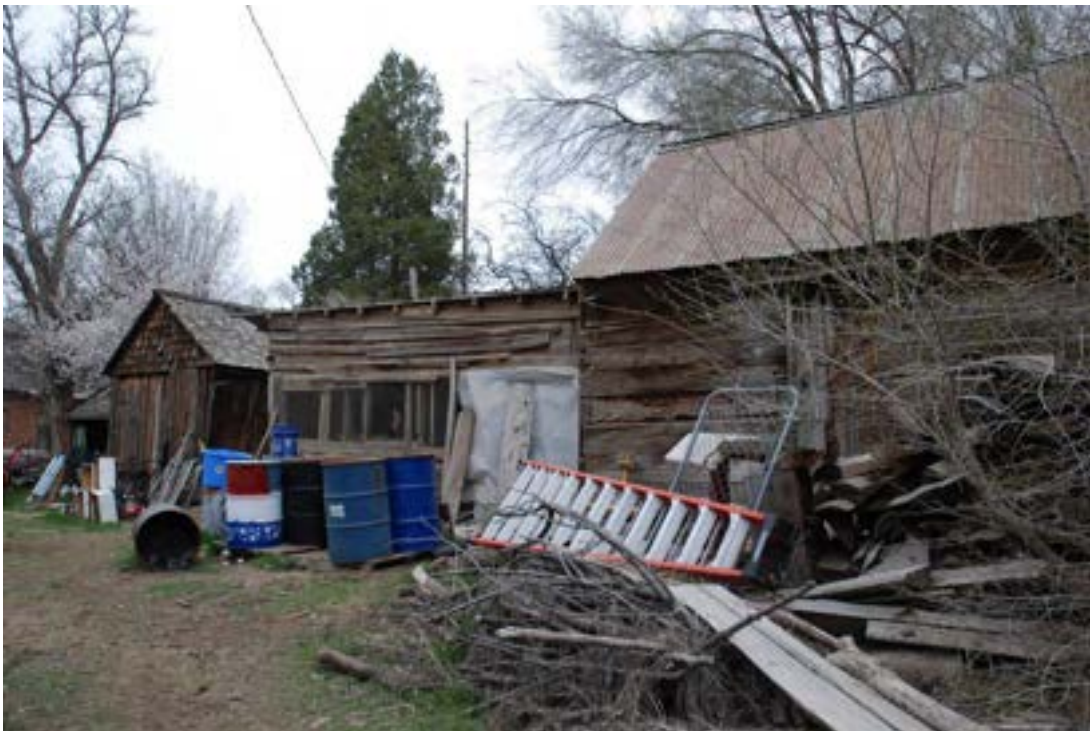
**Photograph 24**

*Thompson Family Farmstead*, outbuilding group. Camera facing north.

Between the stone outbuildings and the barn are a series of wood frame outbuildings that are loosely connected [Photograph 24]. This linear arrangement is rare in Utah, but is reminiscent of connected outbuildings in New England, although there is no interior access through the outbuildings. The north elevations of these buildings are banked against a slope in the topography. They are presented below west to east (or left to right as one is facing them).

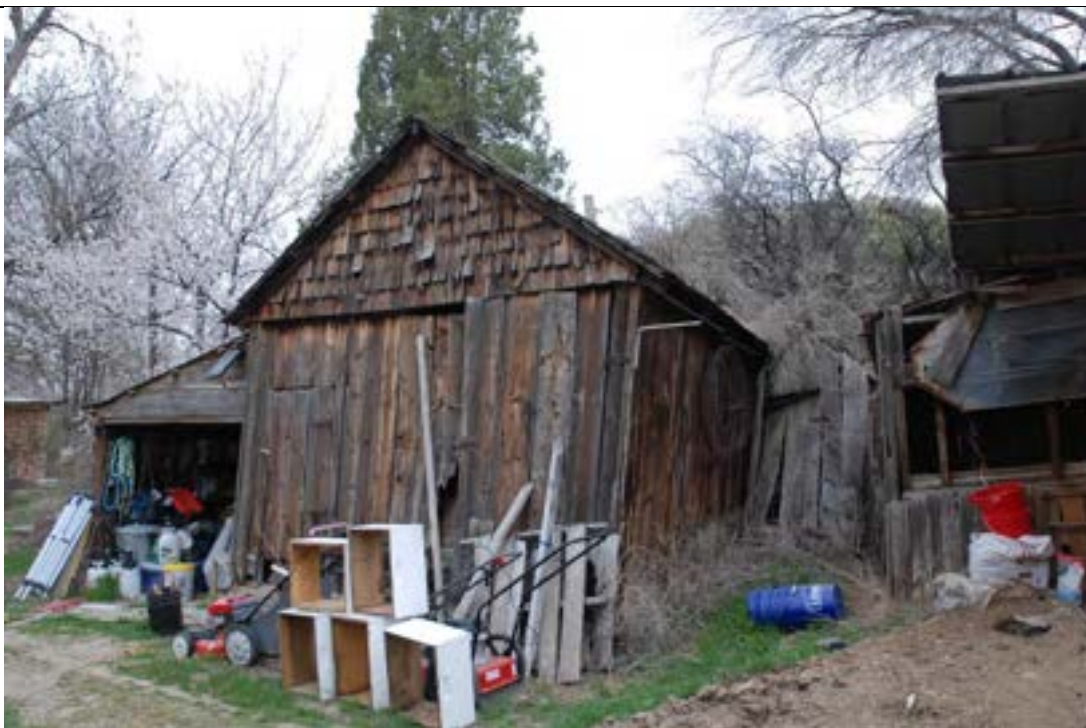
**Photograph 25**

*Thompson Family Farmstead*, coal shed and side shed. Camera facing northwest.

The circa 1910 coal shed is located approximately 90 feet east of the house [Figure 6]. The building is a wood frame building covered in vertical planks, sitting on a foundation of round logs and flat stones [Photograph 25]. The roof is a simple gable sheathed with original wood shingles. There are two doors facing south in one of the gable ends, one for unloading and one for retrieving the coal. The door hardware is iron. The gable trim is wood square-butt shingles. The building is currently used for storage, but there are still pieces of coal on the floor. Extending from the west elevation of the coal shed is a lean-to, known in the Thompson family as the side shed (circa 1920). The lean-to is open at the south end, the west wall is the coal shed's former exterior wall. The remaining shed walls are sheathed in horizontal planks. The shed-roof is covered in corrugated metal and the foundation is a concrete pad. This shed has been damaged by overgrown vines.

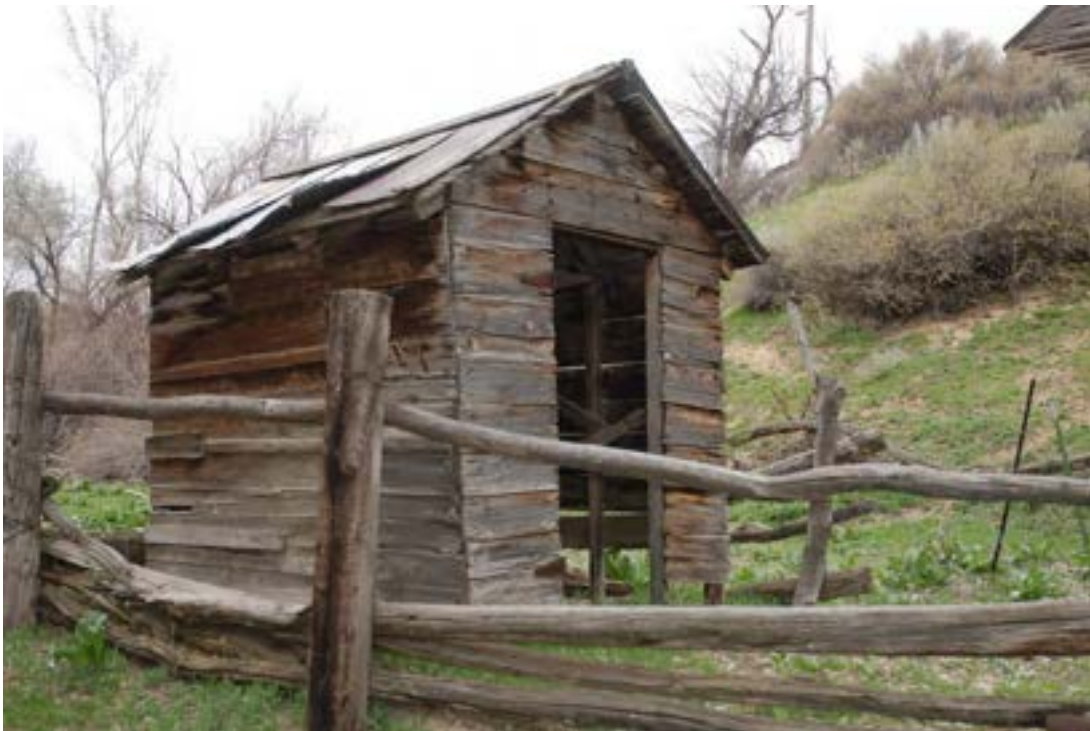
**Photograph 30**

*Thompson Family Farmstead*, south and west elevations of toolshed. Camera facing northeast.

A circa 1920 frame tool shed is located across the road from the loafing shed [Photograph 30].<sup>1</sup> This frame structure is covered in pieced together horizontal wood planks, with a few sections broken or missing. The simple gable roof is sheathed in plates of flat metal, although a few are missing exposing the wood plank roof deck. The door opening faces south with no door. The shed is surrounded by a log post & rail fence on three sides.

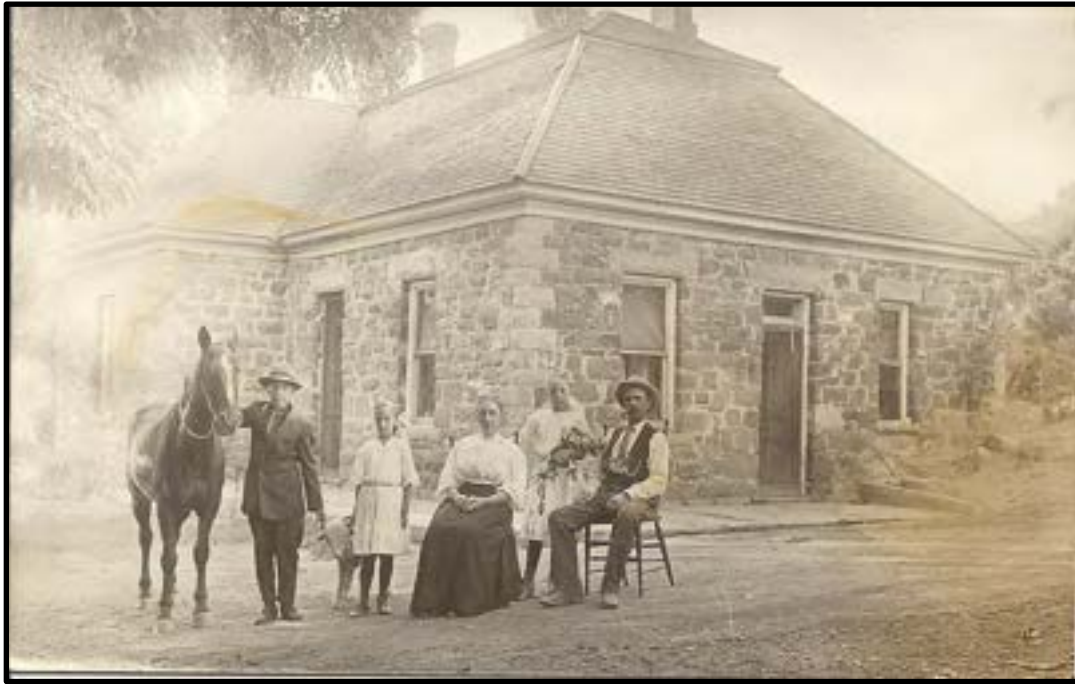
**Figure 1**

Elmore, Hannah, Alice, Lottie, and George Thompson in front of house, circa 1910.

The Thompson house is a one-story, red sandstone, Victorian cross wing type, built over a period of several years, primarily between 1899 and its completion in 1901 [Figure 1]. The period of significance begins with the construction of the house. The footprint of the house features a main block measuring 36 feet wide by 26 feet deep with a projecting wing measuring 16.25 feet wide by six feet deep [Photographs 7-8]. The foundation is of stone rubble and the walls are built from large rock-faced blocks of red sandstone. The masonry is laid in random ashlar; however, there are sections where the masonry is laid in more random rubble courses. The light-colored mortar is flush, with areas of patched and missing mortar joints. The house has accents of light-brown sandstone quoins, lintels, and sills. Both the main and secondary roofs are hipped with a gablet on the main ridgeline. The original wood square-butt shingles are visible in large sections where circa 1950s pink fish-scale asphalt shingles have fallen or been removed. Originally the house had two corbeled brick chimneys. Both have been shortened with later metal pipe vents installed (circa 1950s).

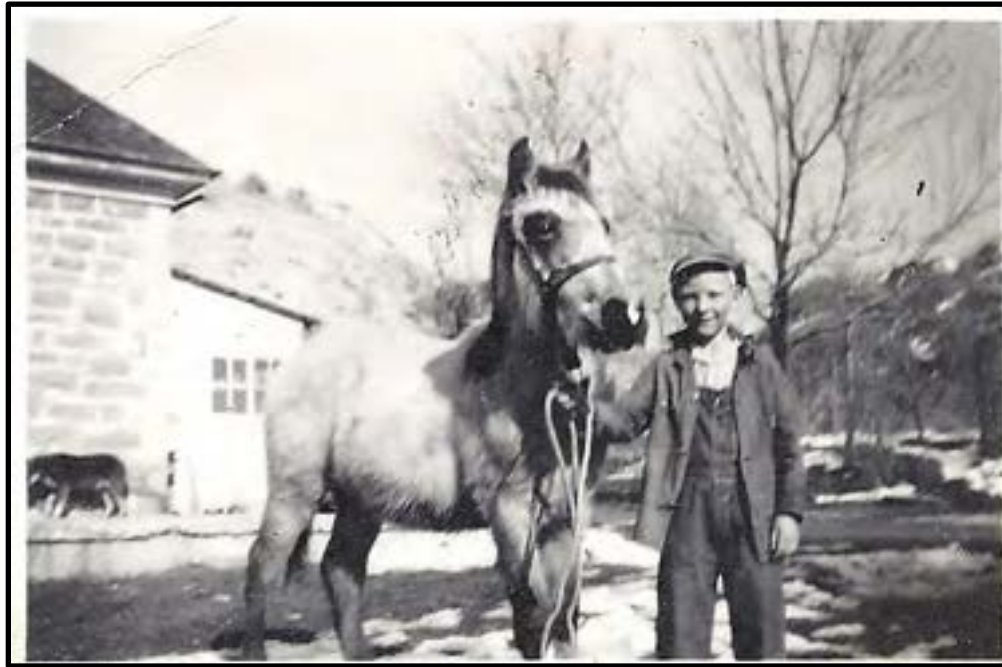
**Figure 3**

Blaine and horse, circa 1944.  
Courtesy Diane Garcia Family Photograph Collection.

The only modification to the exterior of the house is found on the east elevation where a small frame addition was built (circa 1930s) [Figure 3]. This shed-roof addition was later removed in 2001, but the south elevation shows the impact of the alteration [Photograph 12]. The south window was shortened when the kitchen was remodeled (circa 1950s). The lintel was retained and the sill was moved up. The central door appears to be the original five-panel door; however, like the front door, the transom was removed and the door raised. Several clues indicate that there was a major masonry repair to the north half of the east elevation (circa 1950s): a joint just south of the door, squarish coursed ashlar stones under the eave and in the wall, and finer mortar joints than appear in the circa 1910 photograph. The narrow double-hung wood sash window in the north half appears to be original.

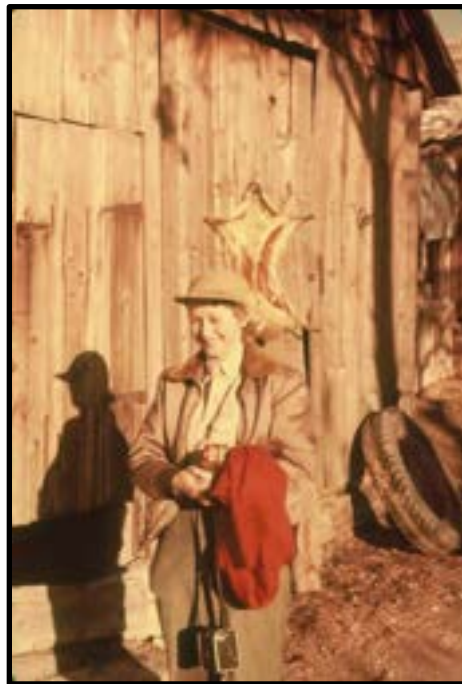
**Figure 6**

Betsy in front of the coal shed, 1954.  
Courtesy Diane Garcia Family Photograph Collection.
