National Register of Historic Places Registration Form

historic name Enniss Auto Service Station

street & town 11651 S. 700 East not for publication

city or town Draper vicinity

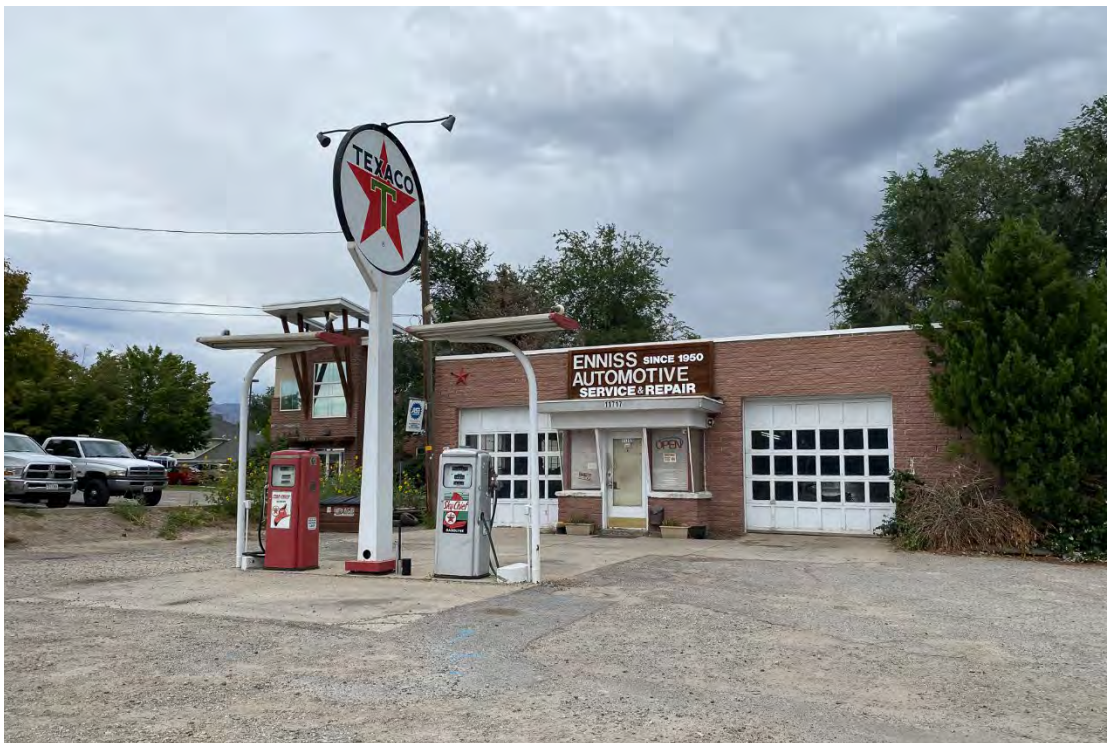
Photograph 1

West elevation of Enniss Auto Service Station with sign and pumps. Camera facing northeast.

The workshop building was covered in stucco, mostly likely when the service station was added to the west elevation in 1955 [Figure 2; Photographs 1 & 2].¹ The service station and office addition measures 38 feet by 28 feet with the wide end facing 700 East. The addition was offset 15 feet to the south to allow access to the north service bay of the shop building [Photographs 2 & 6]. The service station addition is constructed of concrete block on a concrete foundation. The roof is flat and built-up with a short parapet on the west and north elevations. A membrane roof was installed circa 2011 and drains to the south. The service station has a lower profile than the service bay section. The west elevation

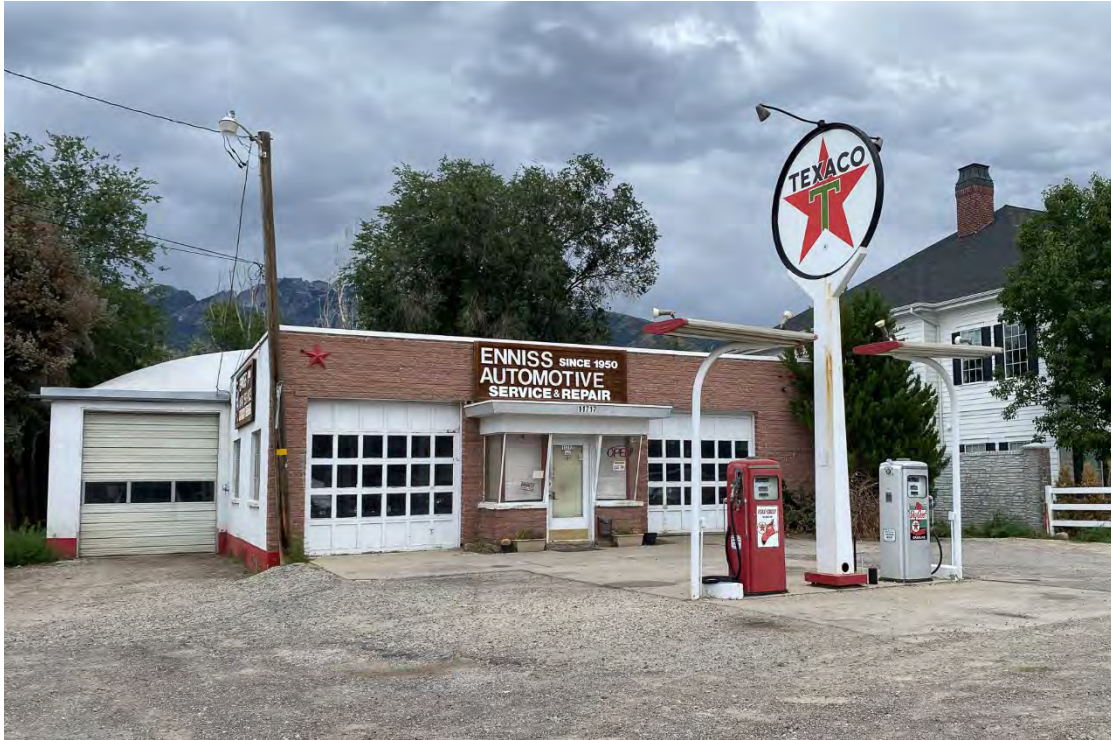
Photograph 2

West and north elevations of Enniss Auto Service Station. Camera facing southeast.

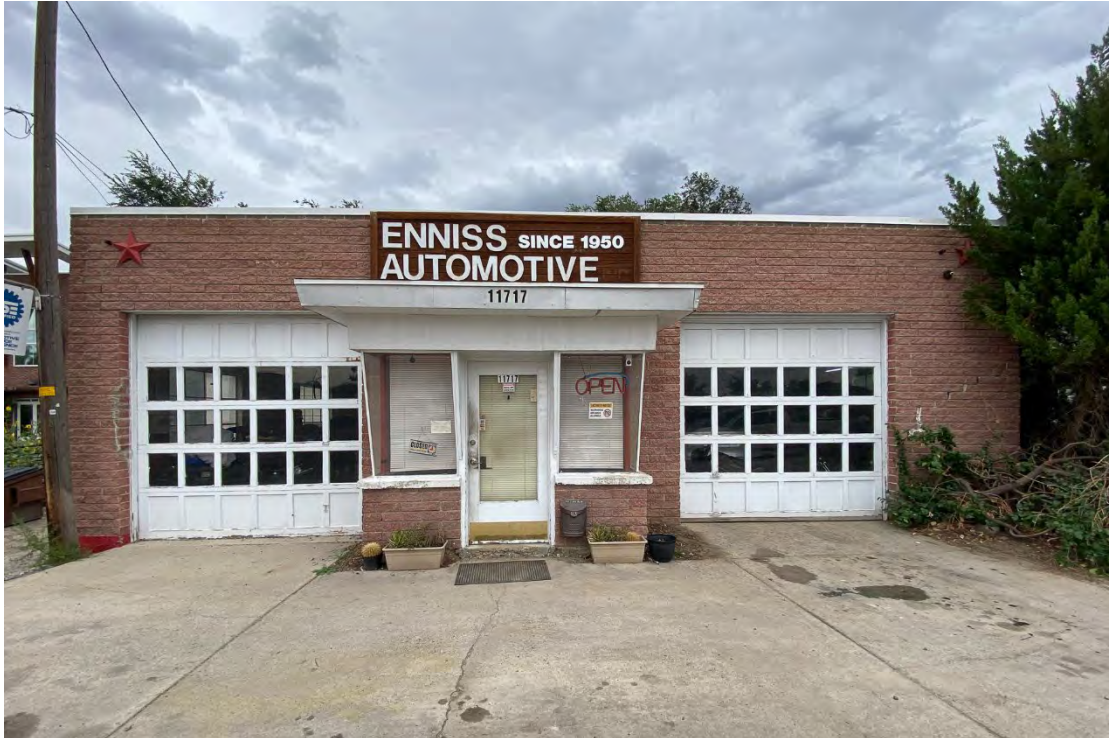
Photograph 4

West elevation, Enniss Auto Service Station. Camera facing east.

(façade) is faced with a dark pink rock-faced oversized concrete brick [Photograph 4]. The façade features a slightly off-center projecting entry that measures three feet by 10 feet [Photograph 5]. The entry is Post-War Modern in style with angled glass over the rock-faced brick base [Figures 2-5]. The entry roof is flat. The recessed front entry features the original three-quarter glass door. The entry is flanked by two service bays, both with the original wood panel doors. Each door has three rows of six lights. On the north and south side elevations the service station addition features two twelve-light metal sash windows [Photographs 6 & 8]. A 13-foot section of the addition is visible from east [Photograph 9]. The rest of the addition abuts the workshop building.

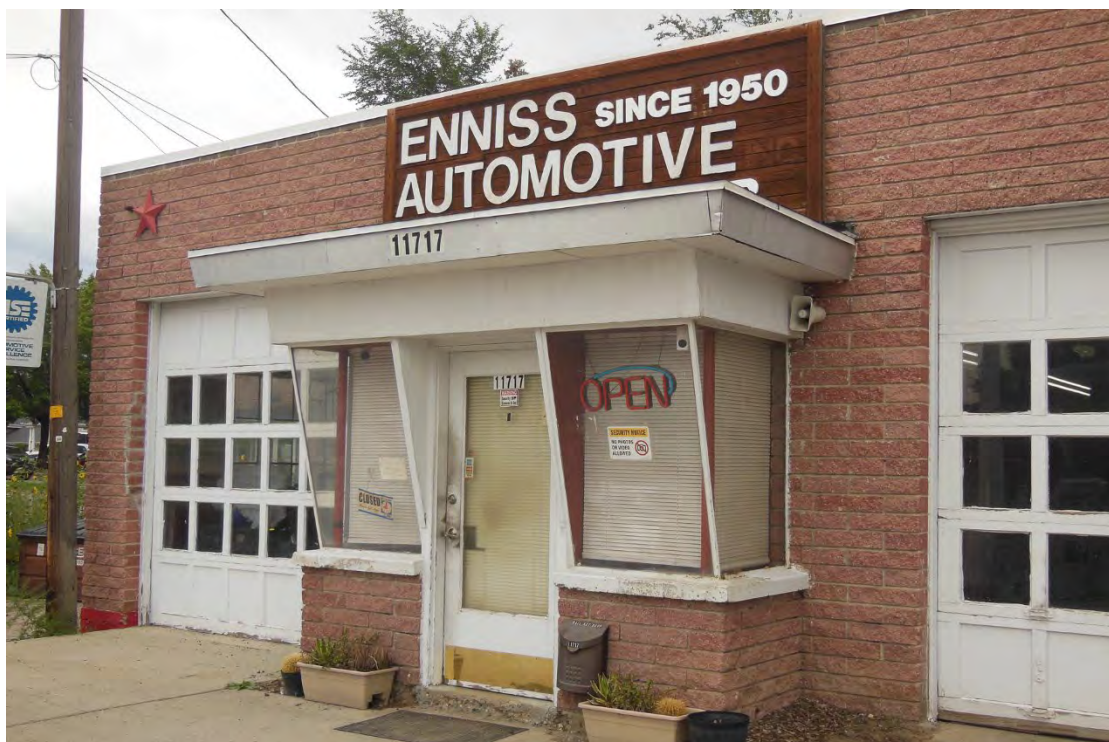
Photograph 5

West elevation, front entrance. Camera facing northeast.

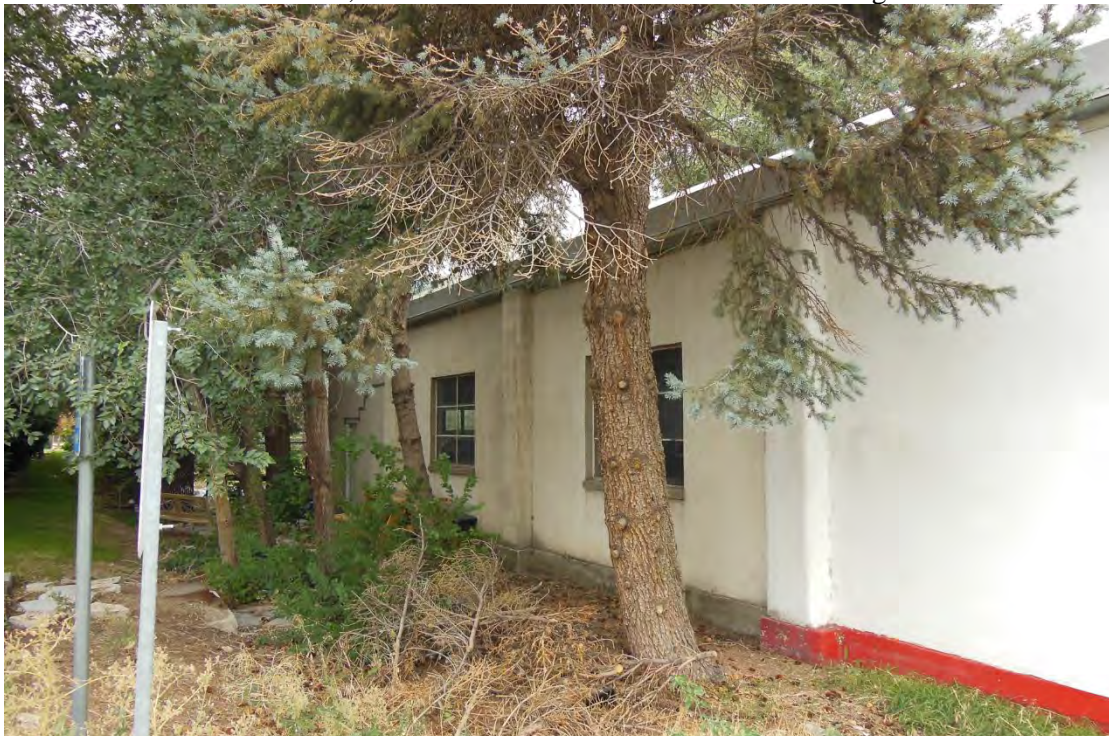
Photograph 7

North elevation of workshop, Enniss Auto Service Station. Camera facing southeast.

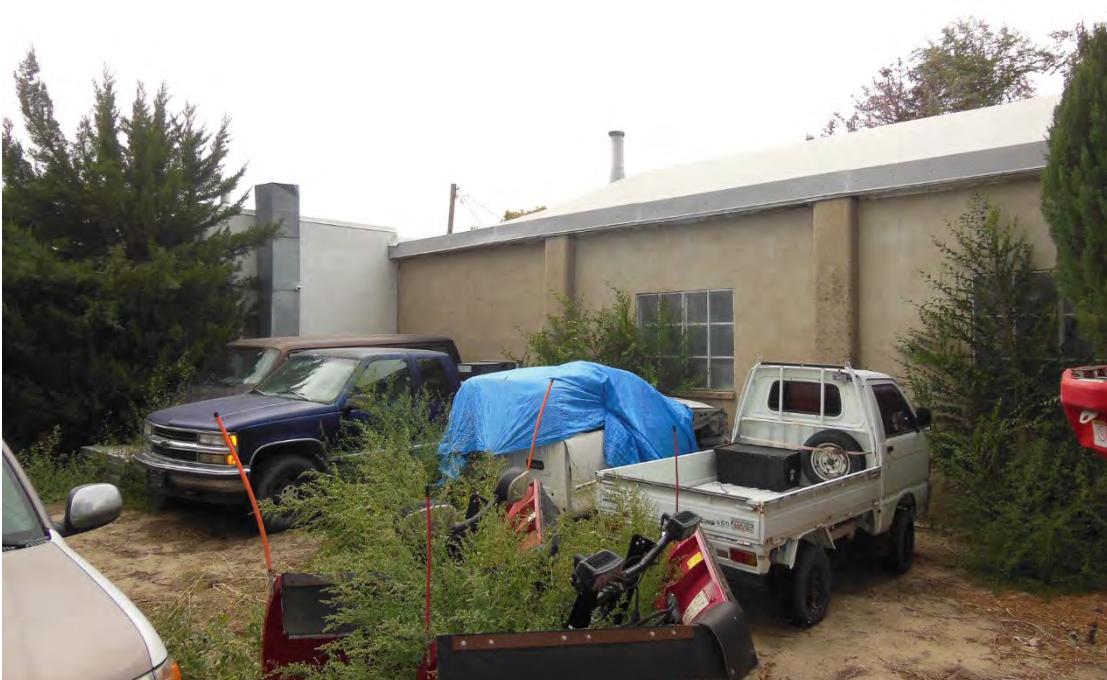
Photograph 9

South elevation of the workshop, Enniss Auto Service Station. Camera facing northwest.

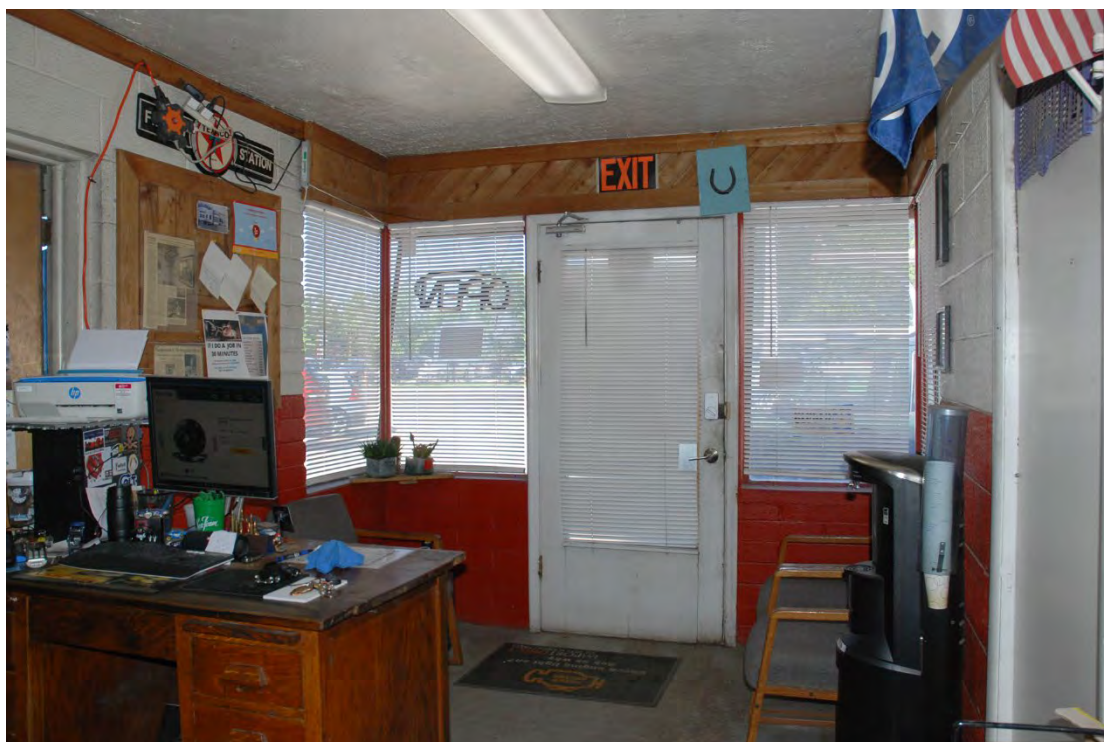
Photograph 11

Interior, front entry and office. Camera facing west.

On the interior, the building has approximately 3,500 square feet of space, divided between 2,400 square feet in the workshop and 1,100 square feet in the addition. The front entry features the original built-in cabinets and counters [Figure 7; Photograph 11]. The two service bays in the addition are open with some mounted lighting, ventilation, tools, and workbenches [Figure 8; Photographs 14 & 15]. The storefront area was originally more open. However, between the 1960s and 1970s, the owner reconfigured the storefront and central hall to provide areas for a reception desk and restrooms, with a narrower hall [Photograph 12]. One restroom was later removed and is now used for storage. The finishes of these partitions include both painted surfaces and diagonal paneling. At the rear of the addition, the space opens where the original door and window of the shop building are visible [Figure 9]. There are two steps down to the original half-glass, three-panel wood door of the workshop [Figure 9; Photograph 13]. The workshop window is blocked with wood and partially obscured by a partition to the south service bay, but the opening is still discernable. The addition's south service bay is accessed from a door near the front entrance and at the rear near the workshop window. The north service bay also features a door near the front, which is currently inoperable. There is no partition at the rear entry to the north bay.

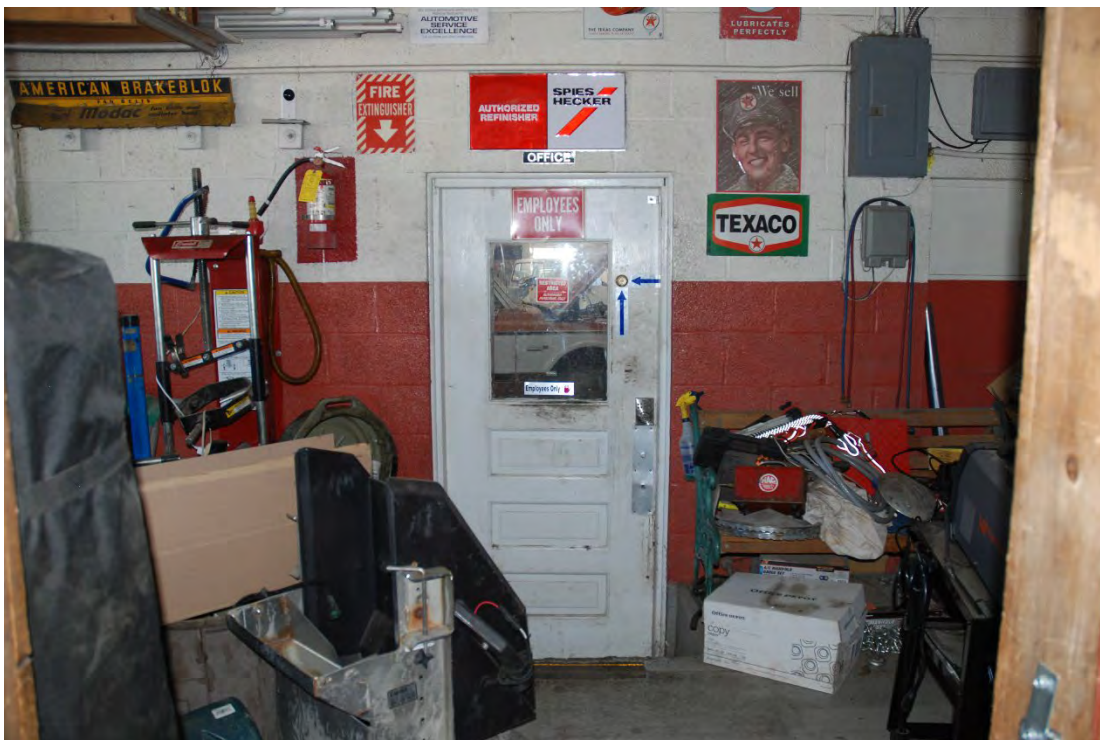
Photograph 13

Interior, workshop entrance (originally exterior, now on interior). Camera facing east.

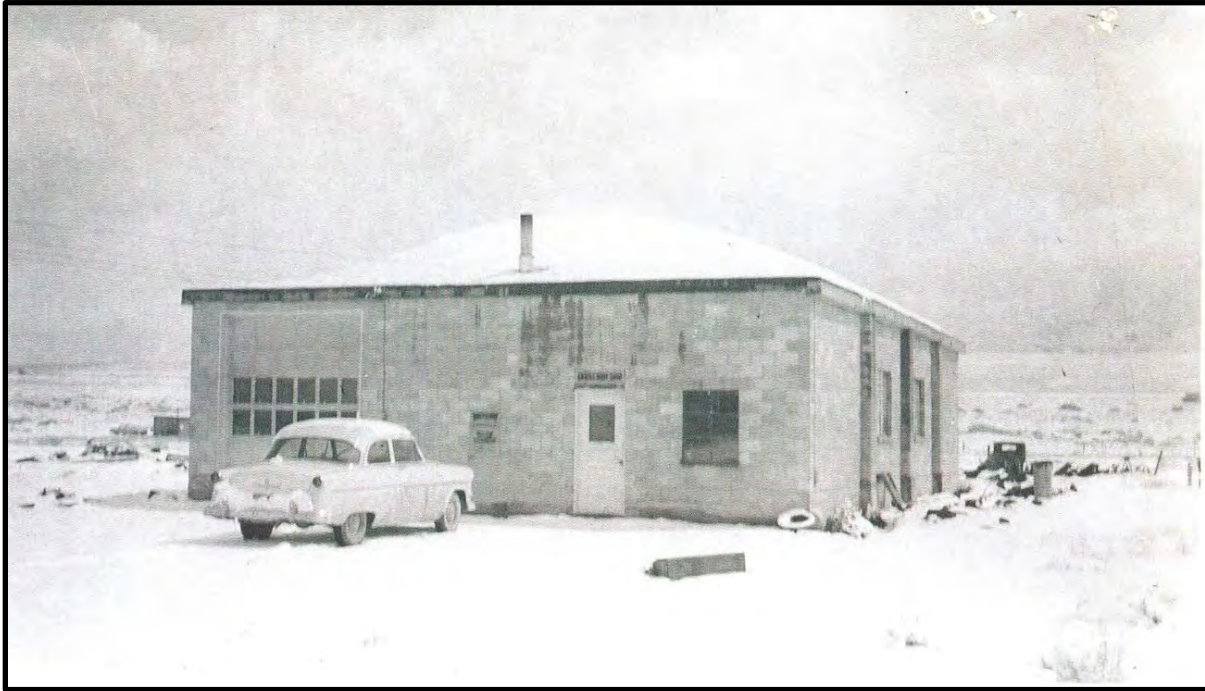
Figure 1

Enniss Auto Service Station, west elevation, circa 1955. Camera facing east.
Courtesy Salt Lake County Archives, tax assessor's photograph.

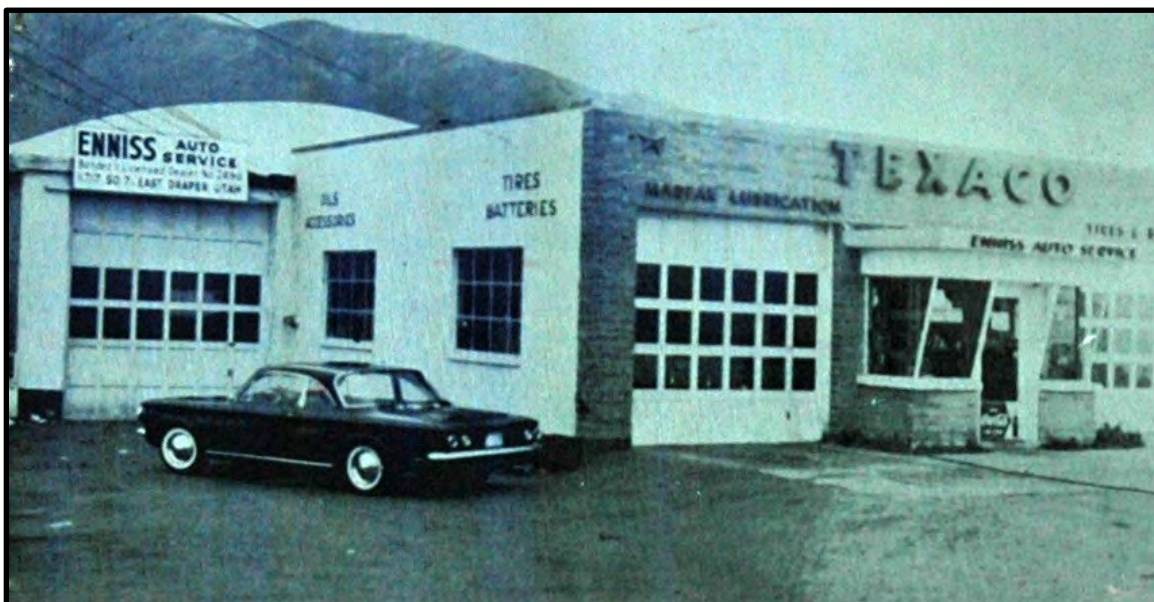
Figure 2

Enniss Auto Service Station, west and north elevations, circa 1962.
Courtesy Salt Lake County Archives, tax assessor's photograph.

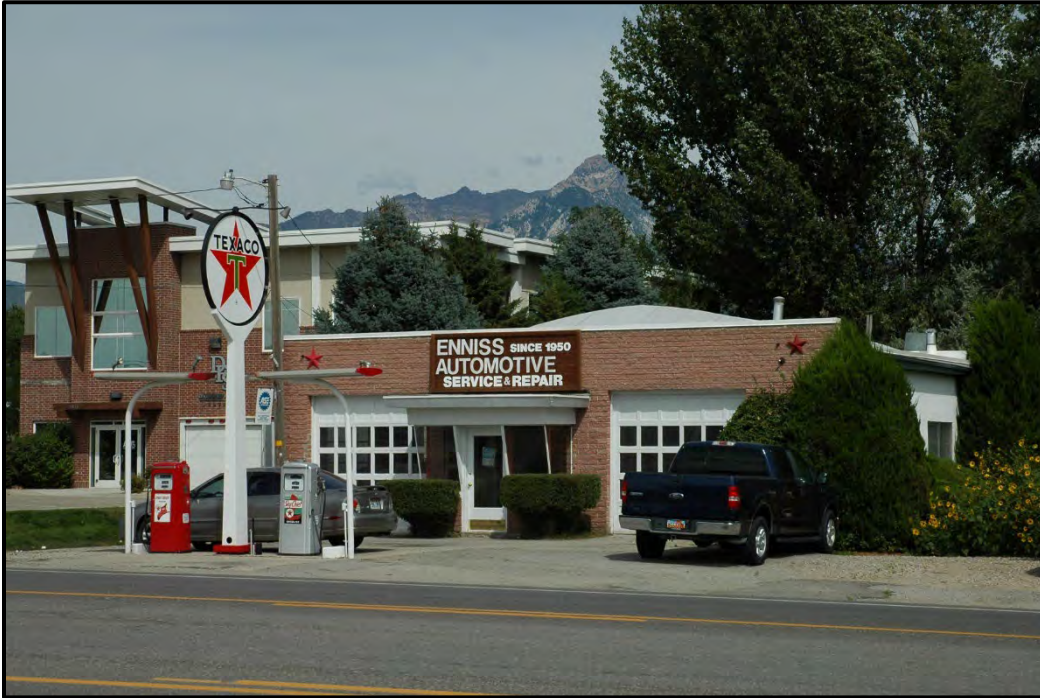
Figure 3

Enniss Auto Service Station, west and south elevations, photographed 2015.
Courtesy Korral Broschinsky and Utah State Historic Preservation Office.

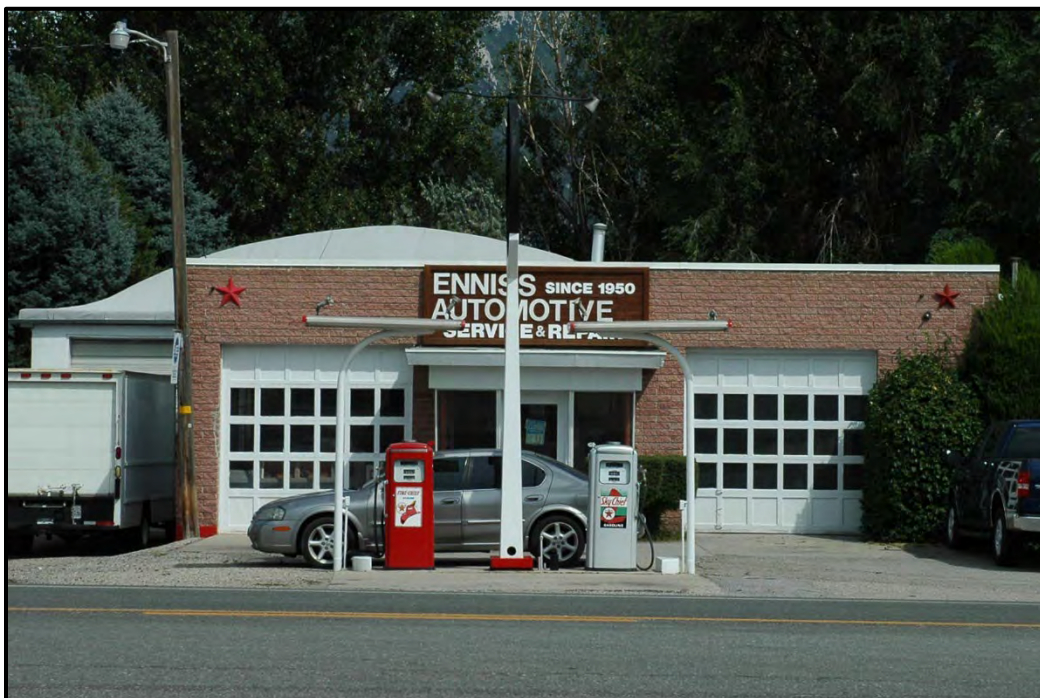
Figure 4

Enniss Auto Service Station, west elevation, photographed 2015.
Courtesy Korral Broschinsky and Utah State Historic Preservation Office.

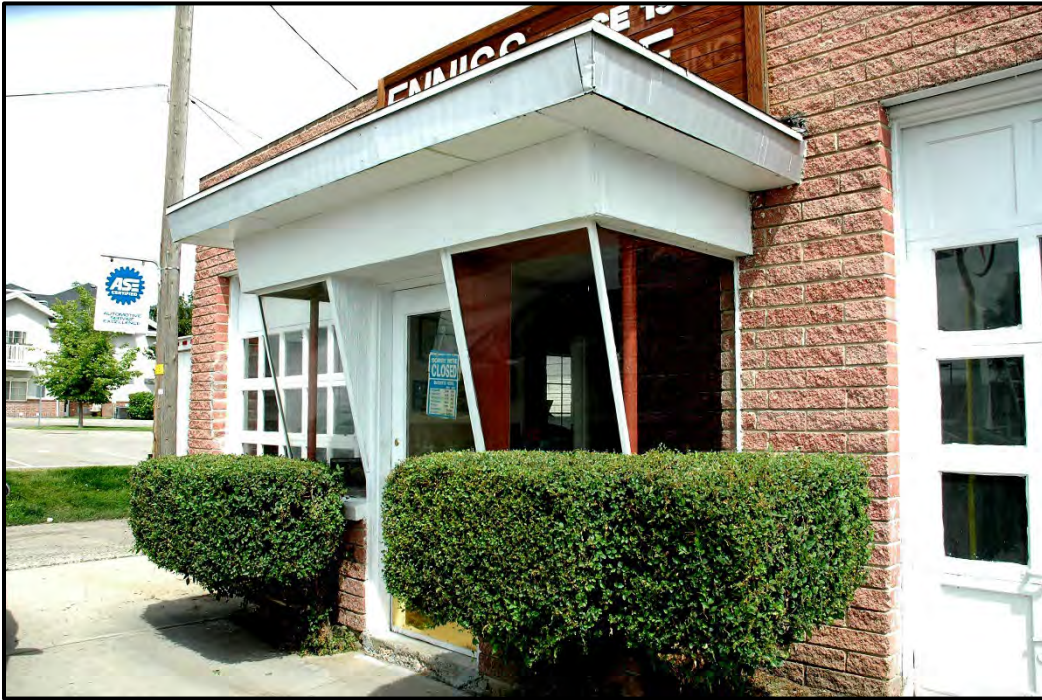
Figure 5

Enniss Auto Service Station, west entry, photographed 2015.
Courtesy Korral Broschinsky and Utah State Historic Preservation Office.

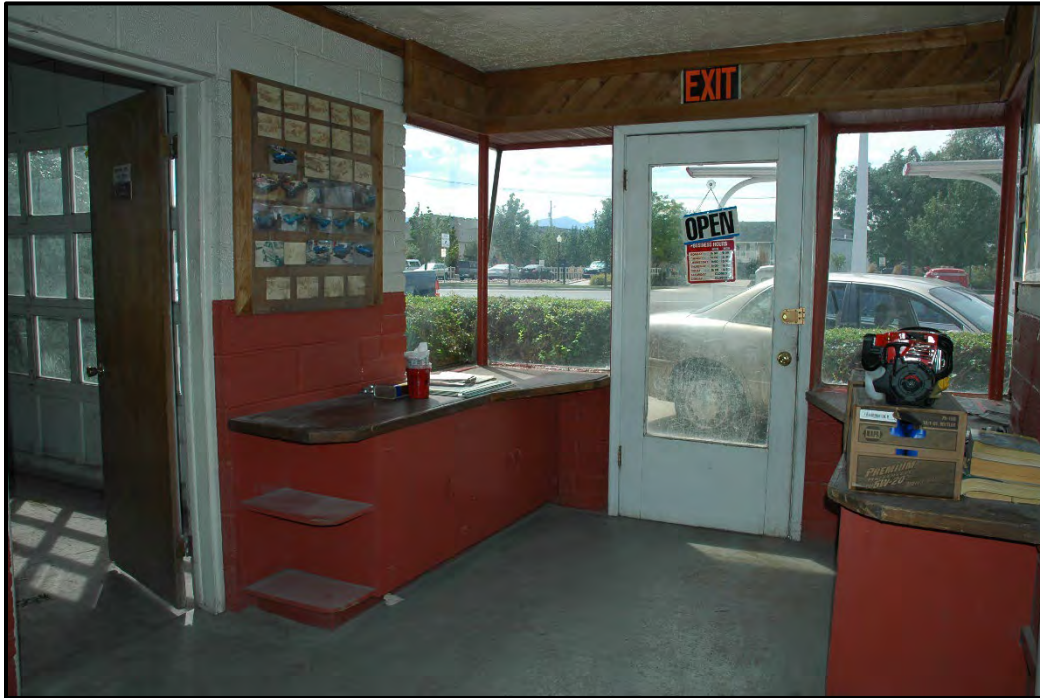
Figure 7

Enniss Auto Service Station, interior west entry, photographed 2015.
Courtesy Korral Broschinsky and Utah State Historic Preservation Office.

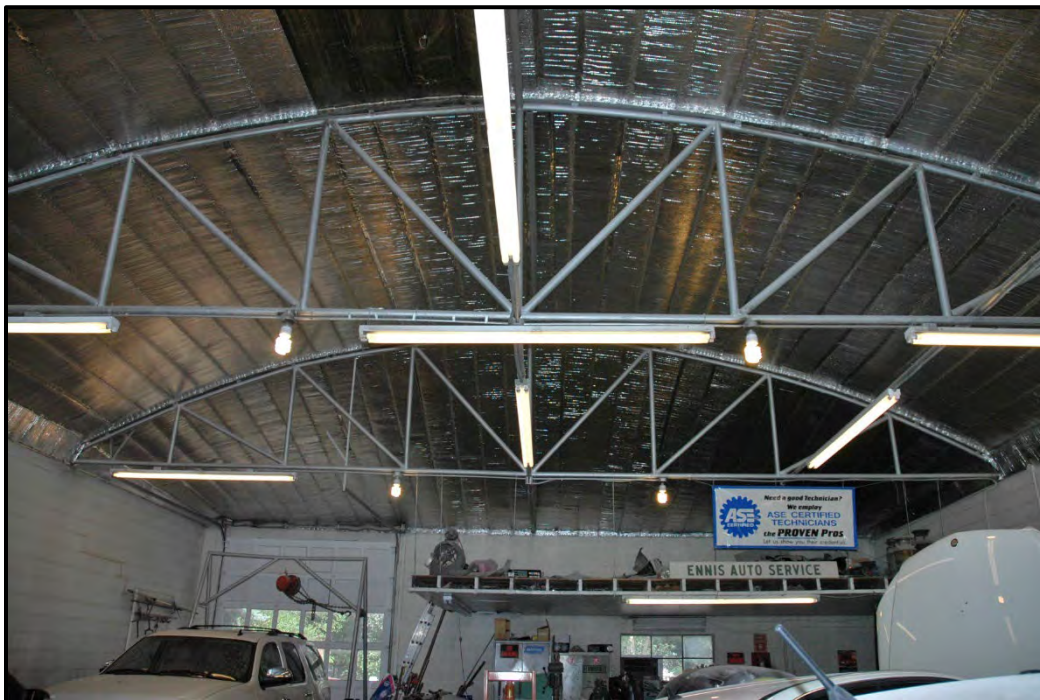
Figure 10

Ennis Auto Service Station, interior workshop trusses, photographed 2015.
Courtesy Korral Broschinsky and Utah State Historic Preservation Office.

In addition to laying the masonry, Enniss welded the pipes to make the bowstring trusses. The construction may have taken a long time since the Salt Lake County tax assessor noted the construction date as 1954. Enniss used the workshop to both repair and sell automobiles. The height of the workshop's service bay openings suggests he was also working on larger trucks and other agricultural vehicles. In 1955, he obtained a lease for a Texaco fuel franchise. However, because the Enniss Auto Service brand was well-established, the service station rarely used the Texaco name in city directories or advertisements.⁷ The Texaco sign and pumps were installed in 1955-1956. There is no canopy over the pumps, which suggests a fueling station that catered to trucks and tractors, as well as private vehicles. Enniss also sold and repaired automobiles at his service station at 9400 South and 700 East. By the 1960s, he also did repair work at a garage built on family property at 13014 S. 1300 East (extant, but not recognizable as a business).
