United States Department of the Interior National Park Service National Register of Historic Places Registration Form

Historic name: <u>Smith, Jesse Wells & Miriam, House</u>
Other names/site number:
Name of related multiple property listing:
Settlement Era Buildings of Farmington, 1847 to 1896
(Enter "N/A" if property is not part of a multiple property listing
2. Location
Street & number: <u>93 East 200 North</u>
City or town: <u>Farmington</u> State: <u>UT</u> County: <u>Davis</u>
Not For Publication: Vicinity:

Smith, Jesse Wells & Miriam, House Name of Property Davis County, UT County and State

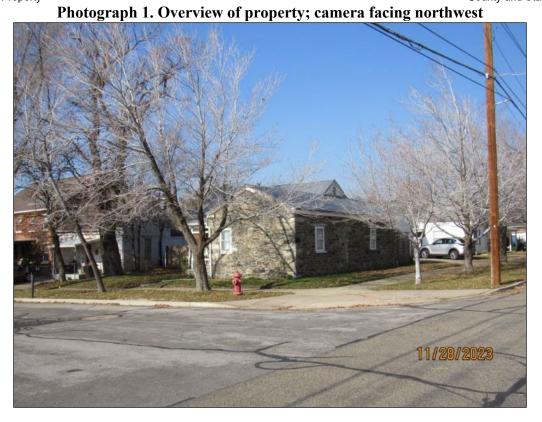
Photograph 2. East elevation (primary façade); camera facing west

The east elevation of the stone wing constitutes the original primary façade of the extant dwelling. This elevation exhibits two window openings and an enclosed doorway. The fenestration is symmetrical with the doorway being centrally located and the windows located to the north and south—the southern window opening is located slightly closer to the doorway than the northern one. Both window openings have thin wooden lintels and sills. The vertical openings are relatively small and rectangular in shape. They hold wood-framed, one-over-one, single-hung windows that are somewhat obscured by modern storm windows. The former doorway is, as noted, located at the approximate center of the elevation. It has been enclosed with mortared stone, but the outline of the opening is still clearly visible.

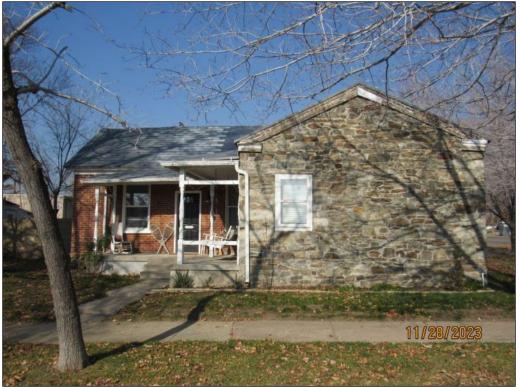
Photograph 3. South elevation; camera facing north

The south elevation of the addition is its principal façade. It exhibits a Victorian style cover over a raised concrete porch, two window openings, and a doorway. The fenestration is arranged symmetrically in the elevation. The door is centrally located and flanked on the east and west by one window opening. This arrangement places the eastern of the two windows directly adjacent to the wall of the hall-parlor wing. The vertical windows openings are relatively large and rectangular in shape. They have wooden sills but no obvious lintels and hold wood-framed, oneover-one single-hung windows covered by modern storm windows. The doorway is standard and generally unremarkable save for what appears to have been a transom window above it, the opening of which is now bricked-in.

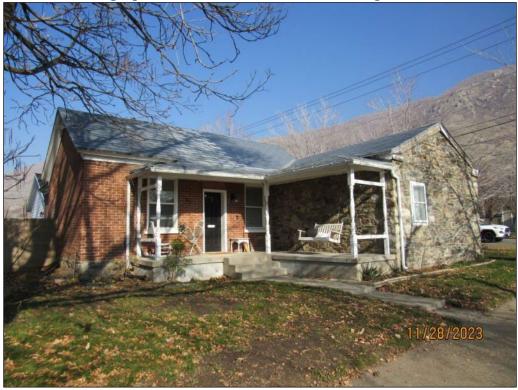
Photograph 4. South elevation; camera facing northeast

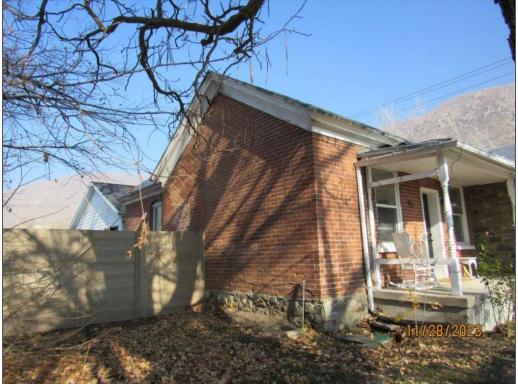
Photograph 6. West elevation; camera facing southeast

The east elevation of the east-west cell is obscured by the hall-parlor structure save for the peak of the gable wall, which is clad in wood shingle siding. The west elevation of the east-west cell exhibits no extant fenestration, and the only architectural details are the raking molding of the eaves. There is, however, evidence of a former window opening near the north end of this elevation that appears to have been enlarged into a doorway at one time and later filled in with brick. The west elevation of the north-south cell is characterized by a single window opening a short distance north of the junction with the east-west cell. This vertical opening is large, rectangular in shape, and has a concrete sill and a segmental arch brick lintel. It holds what appears to be a modern aluminum-framed, one-over-one single-hung window.

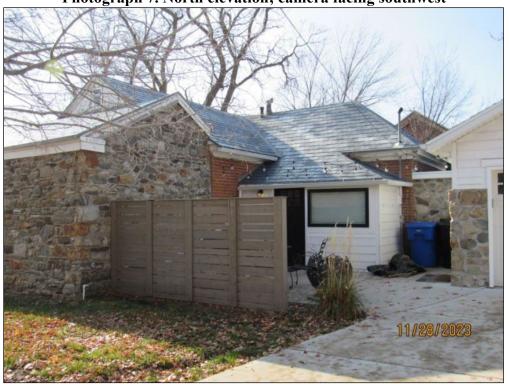
Photograph 7. North elevation; camera facing southwest

The north elevation of the north-south cell is largely obscured by a small shed type addition that fills the space between the dwelling and a recently constructed detached garage. The shed addition is quite small, has a lean-to style roof, and is clad in wide aluminum siding on the west elevation and mortared stone on the east elevation. The north elevation of the east-west cell is also largely obscured by what appears to be an enclosed Victorian style porch cover. This small hipped roof structure is clad in wide aluminum siding and appears to be of modern origin. Enclosing this porch appears to have necessitated infilling of a former window or door opening in the wall of the brick addition as there is evidence of new brickwork in this area.

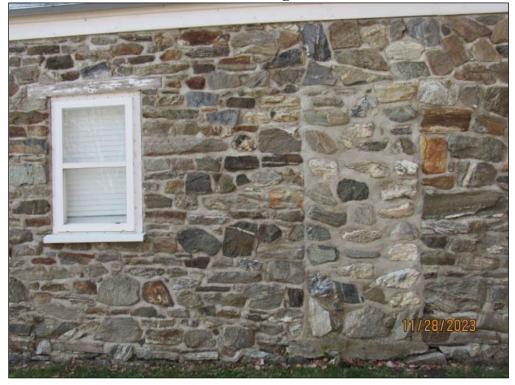
Photograph 8. Infilled original doorway and window opening in east elevation; camera facing west

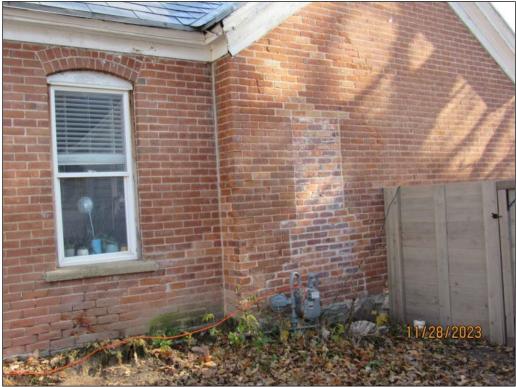
Photograph 9. Exempted doorway or window opening in brick addition; camera facing southeast

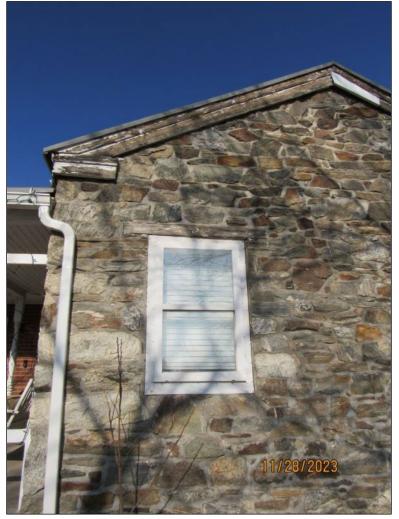
Photograph 10. Window and raking molding detail on south elevation of stone section; camera facing north
