# National Register of Historic Places Registration Form

Historic name: Miller, William H. and Helen, House

Settlement Era Buildings of Farmington, 1847 to 1896

Street & number: 147 North 100 East

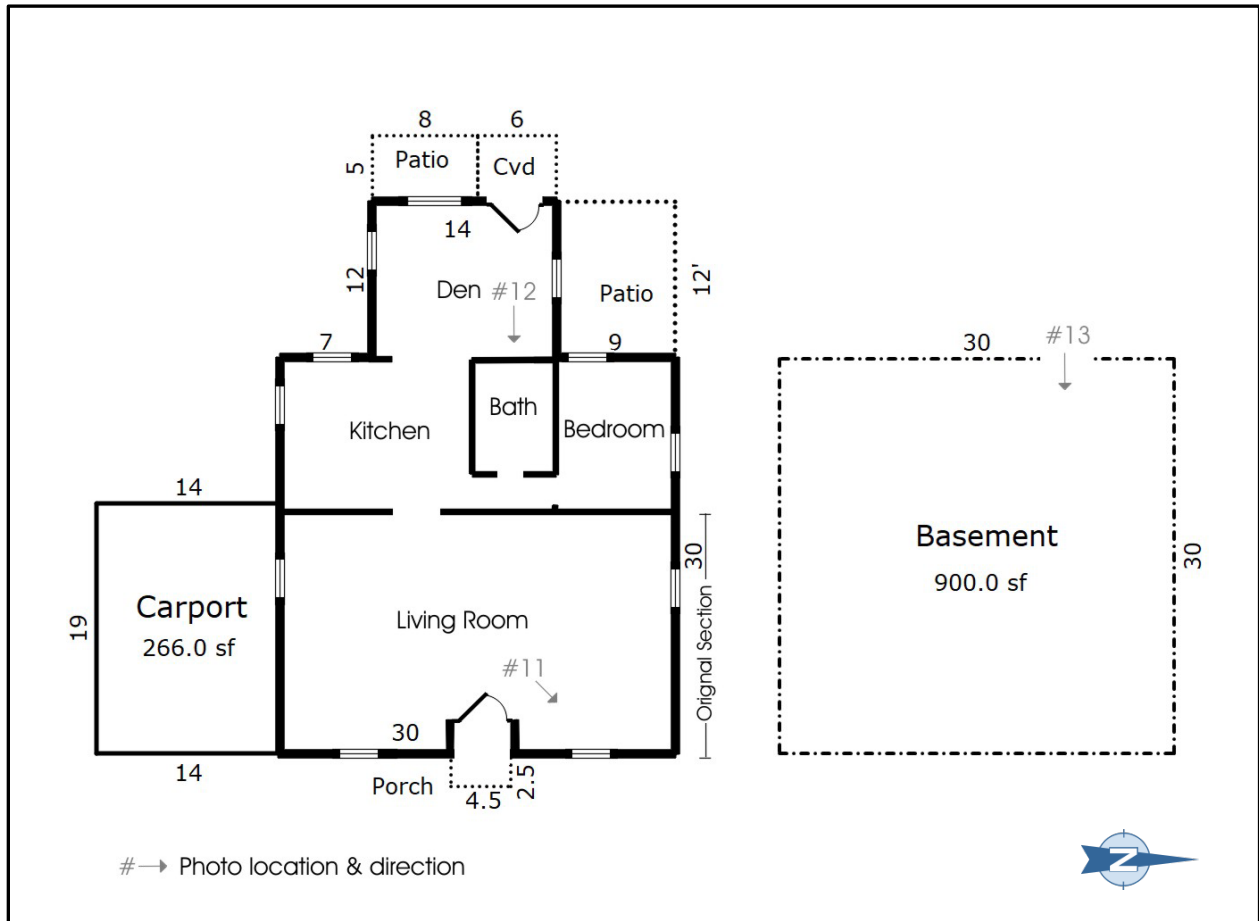
**Approximate floor plan derived from County Recorder's Office drawing**

The interior of the dwelling (Photographs 11–14) includes the main floor and a basement. The basement originally consisted of only a small root cellar that was accessed from inside the dwelling, but it has since been excavated further and partially finished to include a small den and storage and laundry rooms. The original mortared stone of the basement foundation is still present. The interior dividing walls are at least 2 feet thick.

The main floor of the dwelling includes four primary rooms and several closets. The eastern room is the living room, and it occupies the entire original hall-parlor section of the dwelling. While normally such rooms would be divided into a hall and a parlor, this dwelling has a single, long rectangular room. It is unlikely this was original to the design; an interior wall was likely removed at some point after construction.

Moving west from the living room, one enters the kitchen, which exhibits all modern finishes. Immediately north of the kitchen is a short hallway leading to a small bedroom. A bathroom is accessed from the north wall of the hallway. Immediately west of the kitchen is another room that is currently used as a small den. Its original use is unclear. The stairwell to the basement is located in the northwest corner of this room.

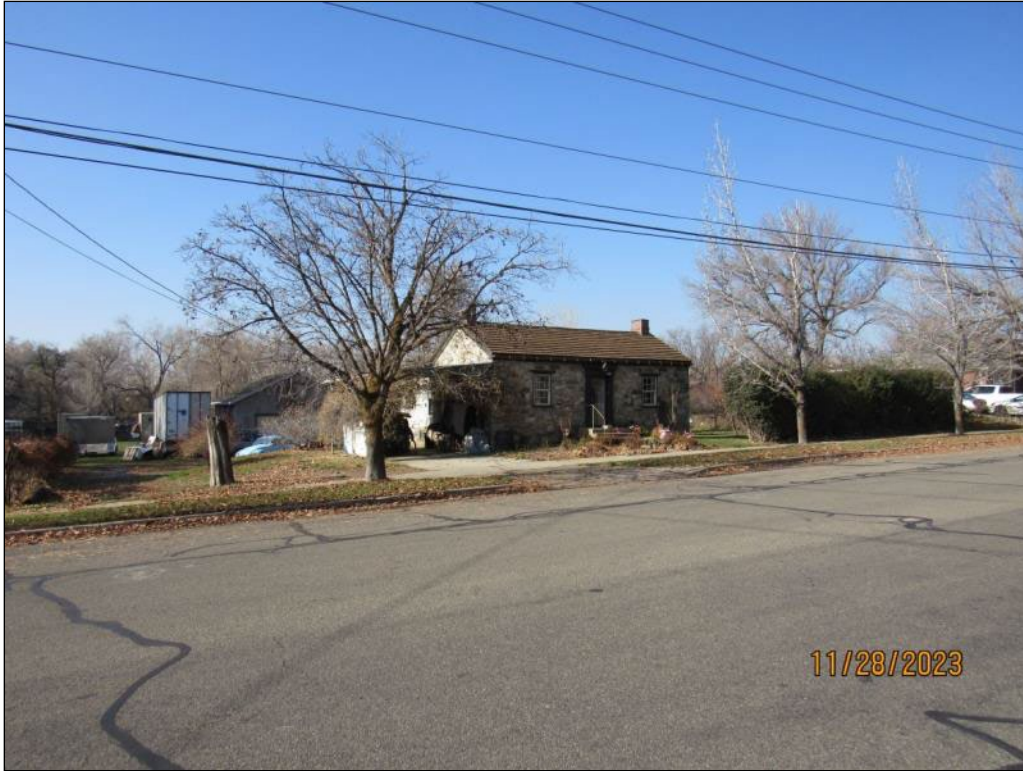
**Photograph 1. Overview of property; camera facing northwest**

The Miller House is a one-story single-family dwelling located roughly mid-block on the west side of 100 East in Farmington. It occupies a nearly on-acre parcel that contains livestock pens and shelters at the rear of the property, a detached garage and shed a short distance behind the dwelling, and a historical root cellar immediately north of the dwelling (Photograph 1). The dwelling has a shallow setback from the frontage road and sidewalk and has several mature trees scattered around the property—none of the landscaping appears to have been “designed” but is, rather, an accumulation of decisions over time.

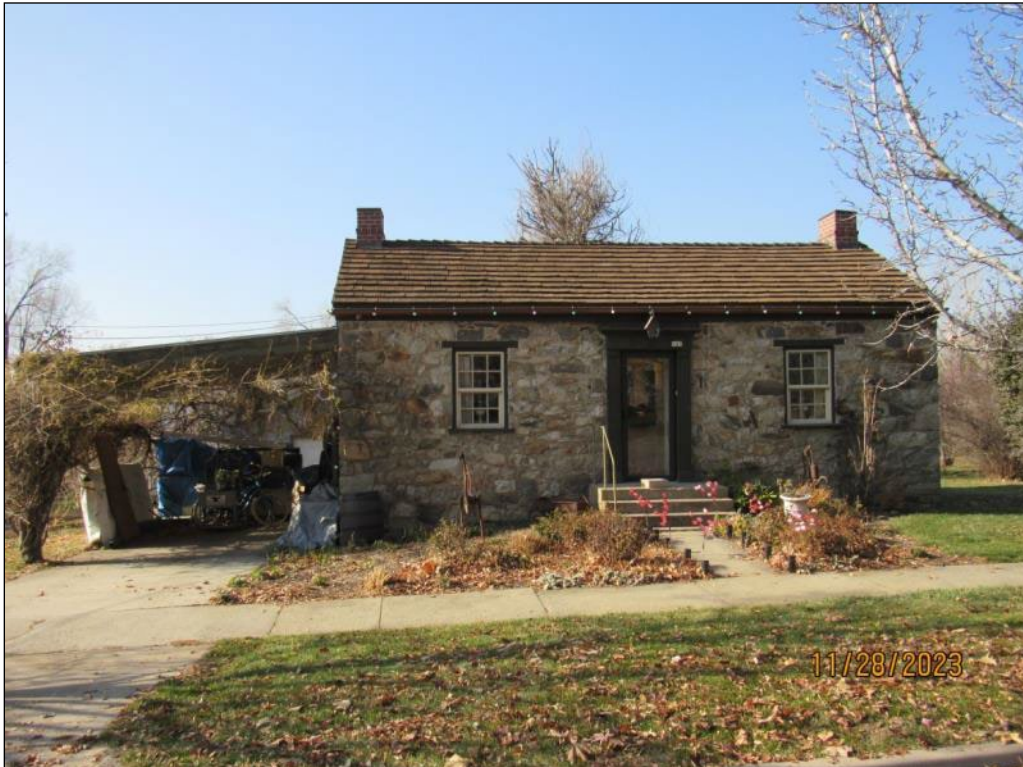
**Photograph 2. East elevation (primary façade); camera facing west**

The east elevation (Photographs 2 & 8) constitutes the original primary façade of the dwelling. This elevation exhibits two window openings and a doorway. The fenestration is symmetrical with the doorway being centrally located and the windows located to the north and south. Both window openings have wooden lintels and sills. The window openings are relatively small and rectangular in shape with the long axis oriented vertically. They hold modern aluminum-framed, 6-over-6, single-hung windows. The doorway is, as noted, located at the approximate center of the elevation. It is a very deep opening indicative of the thickness of the exterior walls of the dwelling. The doorway exhibits a Classical-style surround with a thick, flat pediment. A concrete walkway leads from the adjacent sidewalk to the doorway via a low concrete stoop accessed by three steps.

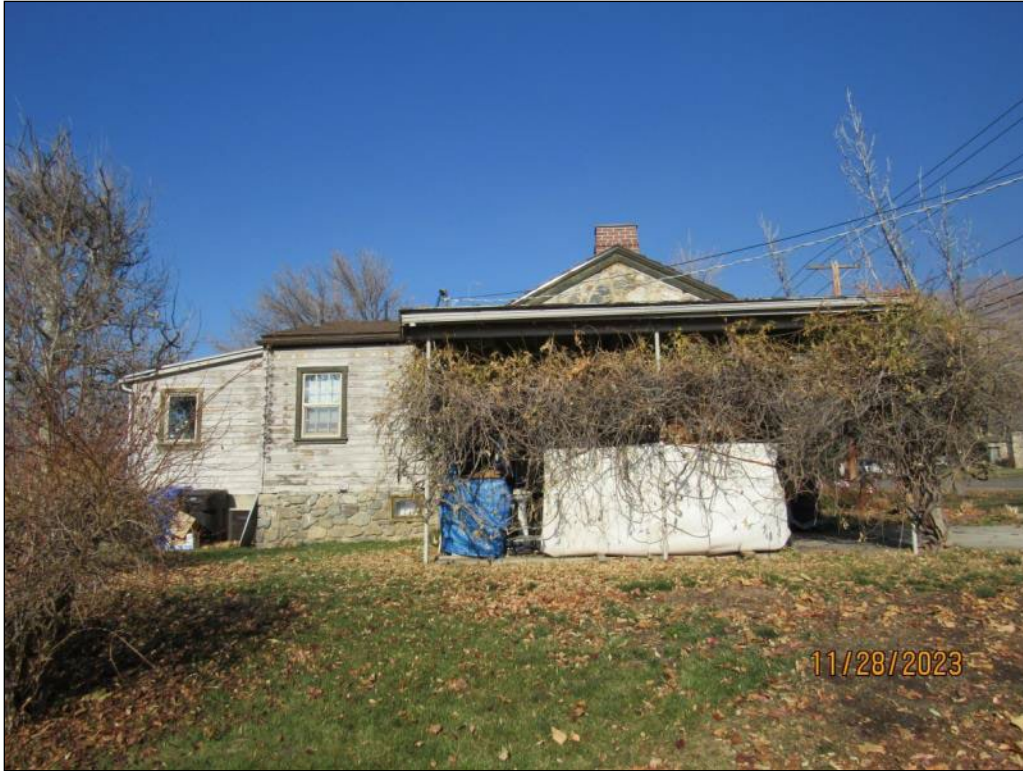
**Photograph 3. South elevation; camera facing north**

The south elevation of the dwelling (Photographs 3 & 4) includes the original dwelling and the two rear additions. A historical carport awning is attached to the south elevation of the original section. The carport awning comprises a wooden beam roof supported by metal pipe posts. The south elevation of the original dwelling is limited in its architectural detail to a single window opening located in the western half of the elevation. This opening is identical to those in the east elevation, and it holds the same type of modern window insert. The south elevation of Addition 1 exhibits two window openings. One is located in the main body of the addition and is identical in size and shape to those previously described for the original dwelling section. It holds the same type of 6-over-6 modern single-hung window. This addition rests atop a raised mortared stone foundation, which holds the second, and much smaller, window opening. This opening is rectangular in shape with the long axis oriented horizontally and holds a single-pane wood-framed hopper or awning window. The south elevation of Addition 2 also exhibits a single window opening. While similar in size and shape to the opening in Addition 1, this opening holds a single-pane fixed sash window.

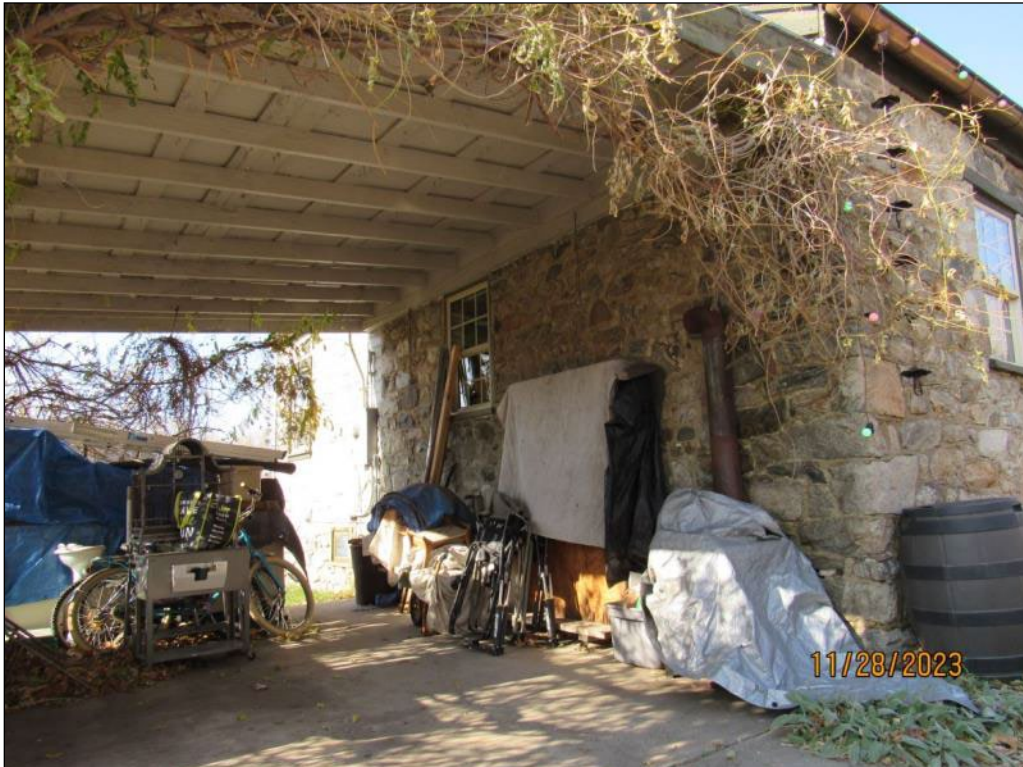
**Photograph 4. South elevation under carport cover; camera facing northwest**

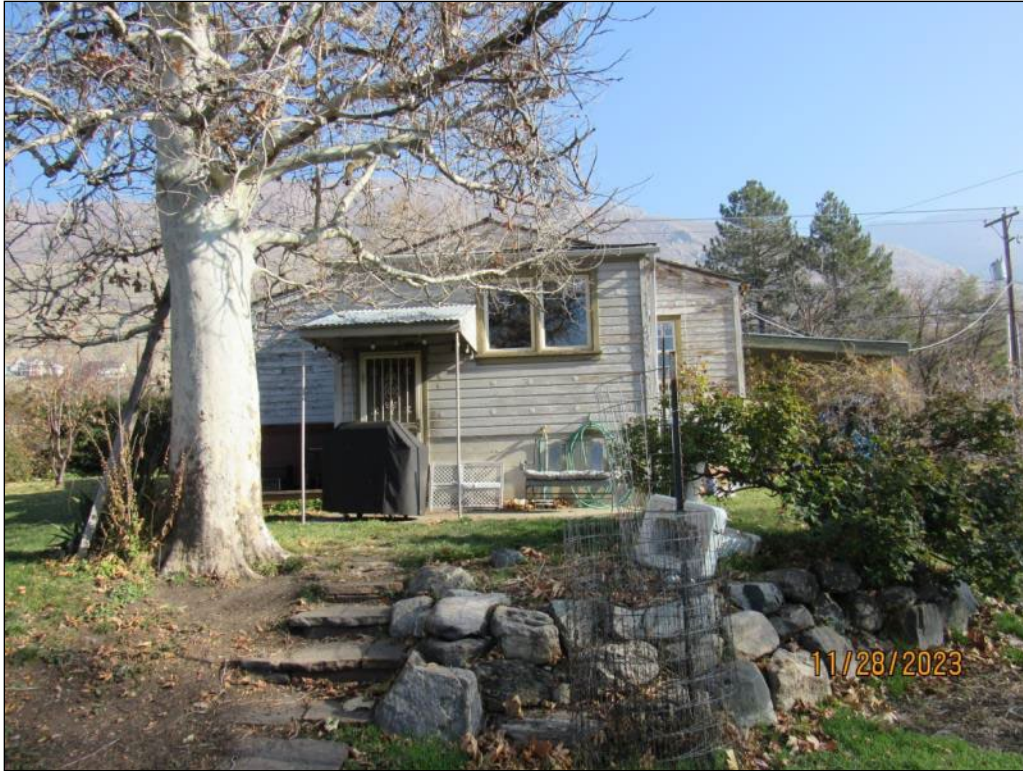
**Photograph 5. West elevation; camera facing east**

The west elevation of the original dwelling wing (Photograph 5) is completely obscured by Addition 1, which runs the length of the elevation. When viewing the west elevation at present, one sees the combined structure of Additions 1 and 2. Addition 2 is located at center in the west elevation of Addition 1; thus, roughly 6-8 feet of Addition 1's west elevation is visible beyond the edges of Addition 2. In these two areas (i.e., visible portions of the west elevation of Addition 1) the only notable architectural features are four window openings—two north and

two south of the edges of Addition 2 and. The openings are arranged with two in the main elevation and two in the raised, mortared stone foundation wall. The upper openings hold modern six-over-six single-hung window inserts identical to what are found in the east elevation of the dwelling. The lower openings hold three-pane, steel-framed, awning or hopper windows.

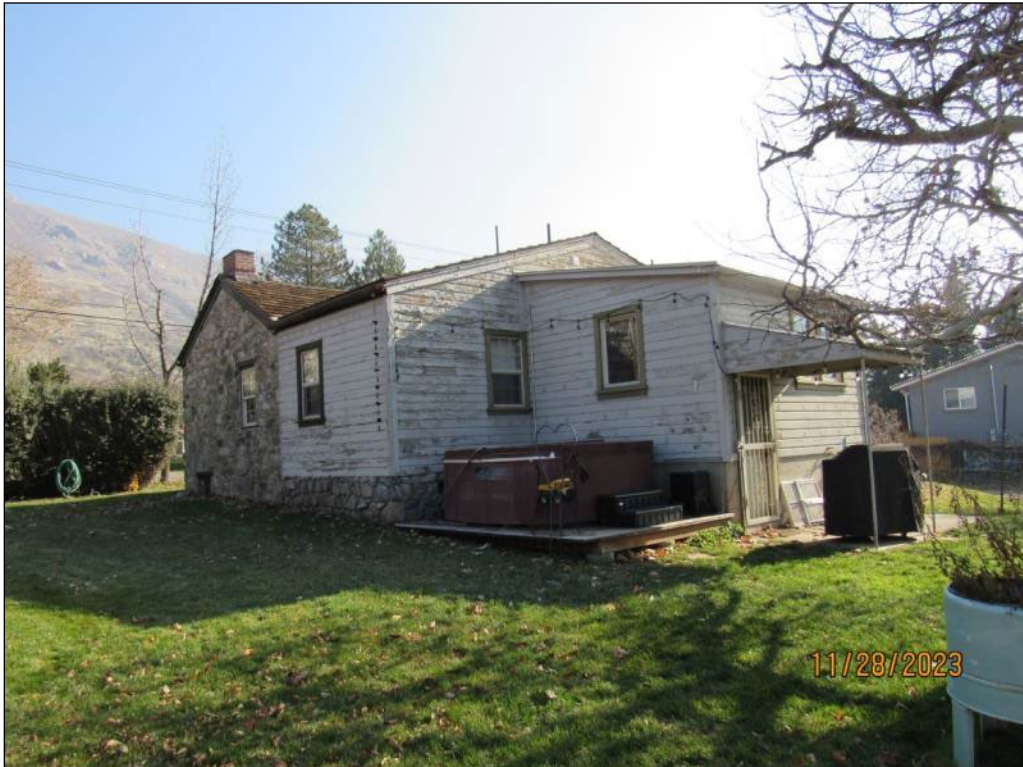
**Photograph 6. North (at left) and west (at center) elevations; camera facing southeast**

The north elevation of the dwelling (Photographs 6 & 7) is characterized by a combination of the elevations of the original dwelling and the two rear additions. The section of the original dwelling is characterized by two window openings—one in the western half of the elevation and one in the basement area in the east half of the elevation. The window opening and window in the west half of the elevation are identical to those previously described for the east of the dwelling. The opening in the basement portion of the elevation is somewhat different from other openings in that it has a slightly thicker wooden lintel and is semi-subterranean. This opening appears original to the structure but is very oddly placed. It holds a three-pane, wood-framed window of indeterminate type. The west elevations of Additions 1 and 2 are both characterized by single window openings located near center in each elevation. The openings are both rectangular in shape with the long axis oriented vertically. The opening in Addition 1 holds a modern 6-over-6, aluminum-framed, single-hung window while the opening in Addition 2 holds a modern aluminum-framed, single-pane, fixed-sash window.

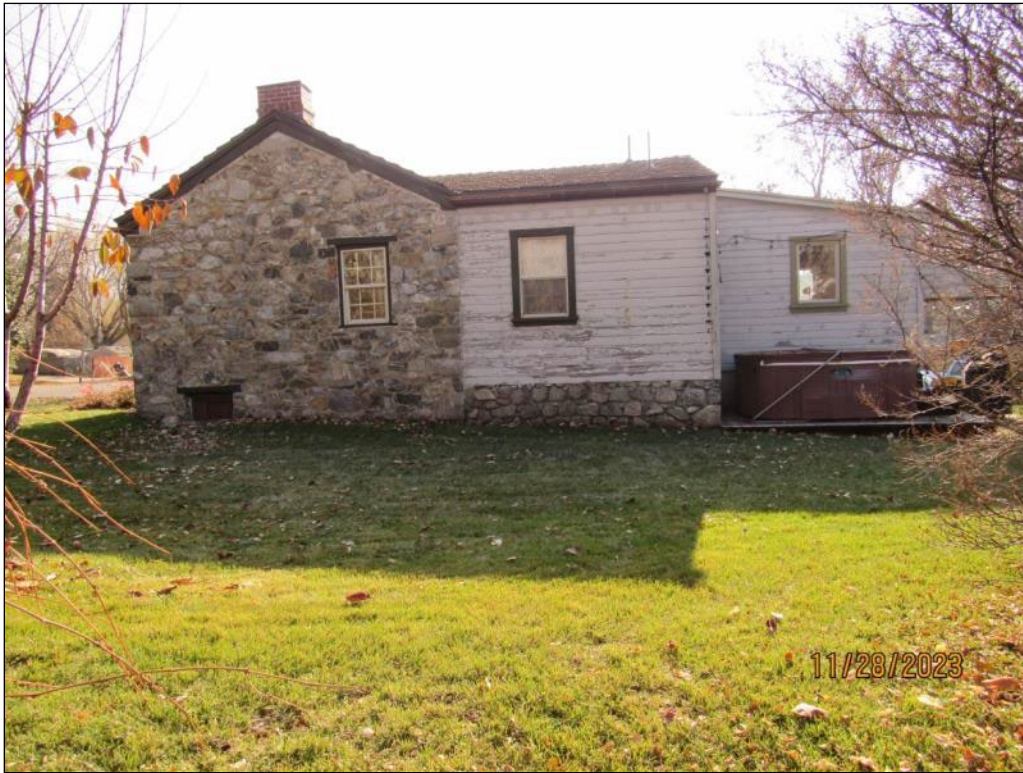
**Photograph 7. North elevation; camera facing south**

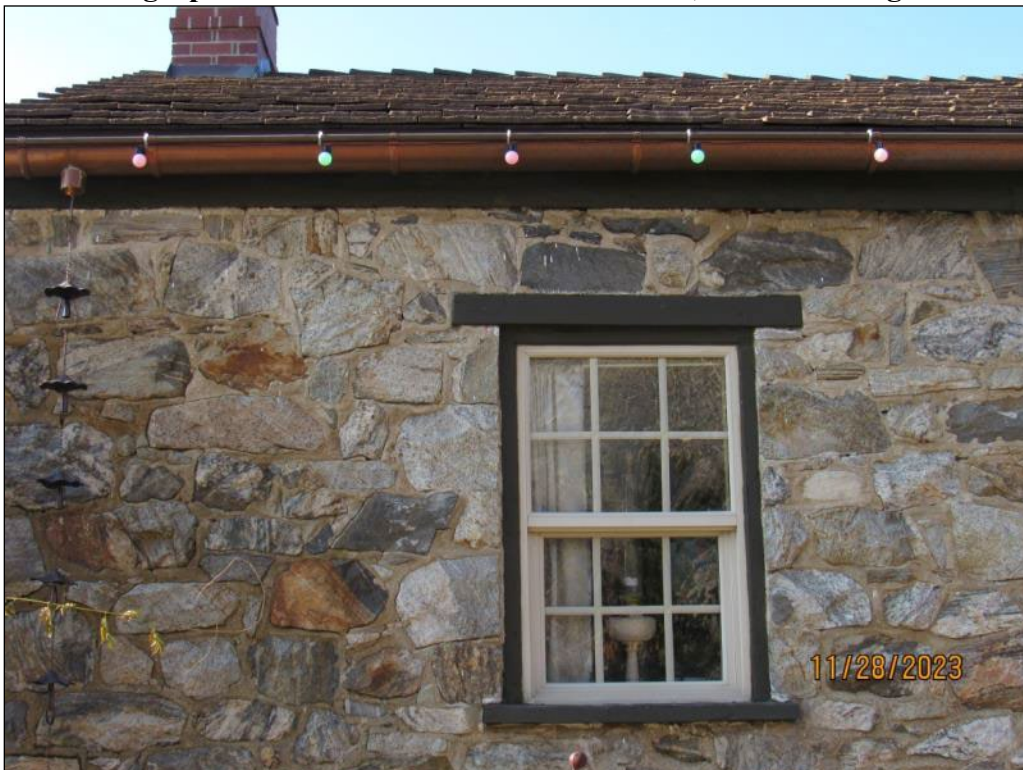
**Photograph 8. Window detail in east elevation; camera facing west**

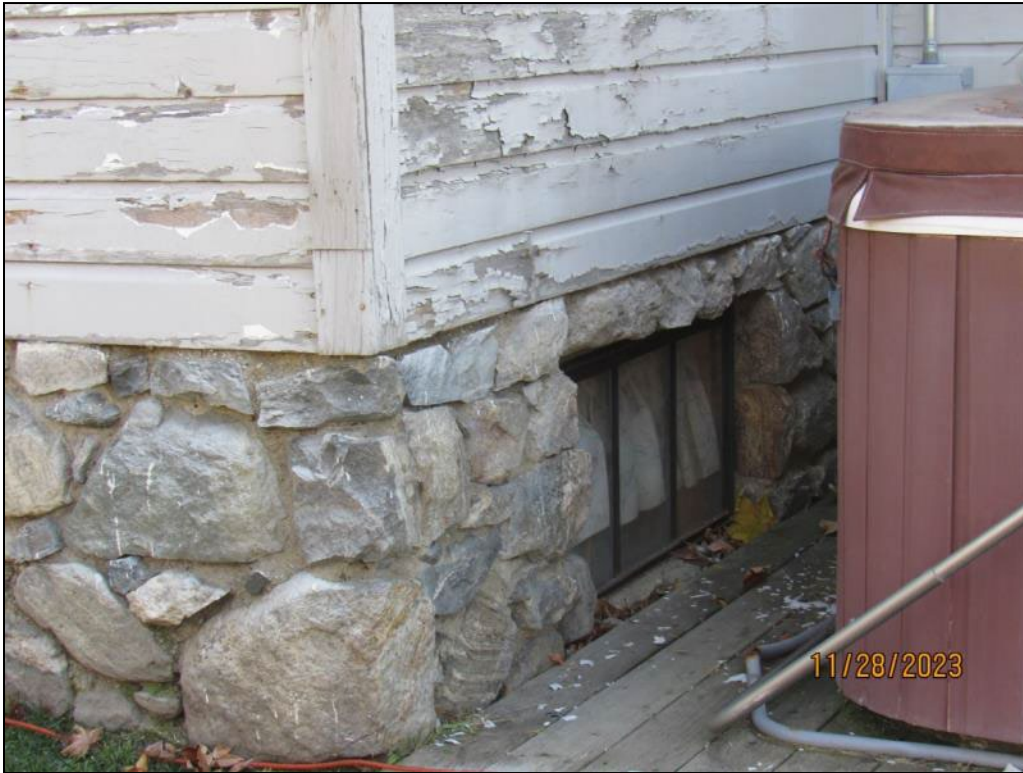
**Photograph 9. Foundation detail for rear addition; camera facing east-northeast**

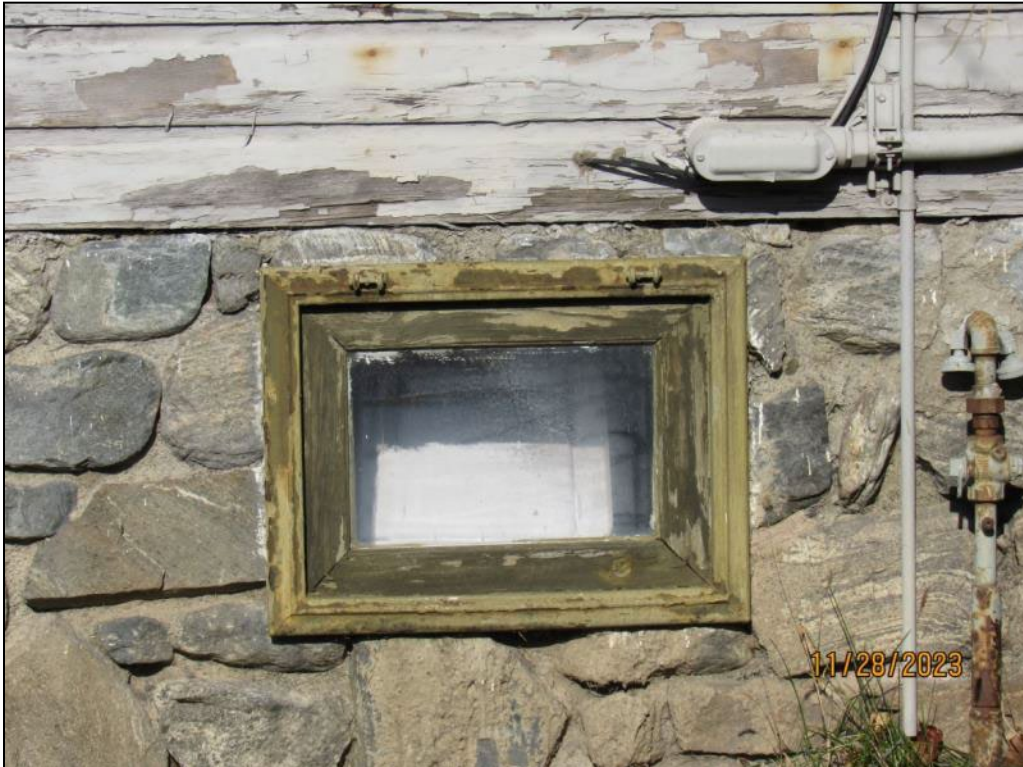
**Photograph 10. Basement window detail in rear addition; camera facing east**

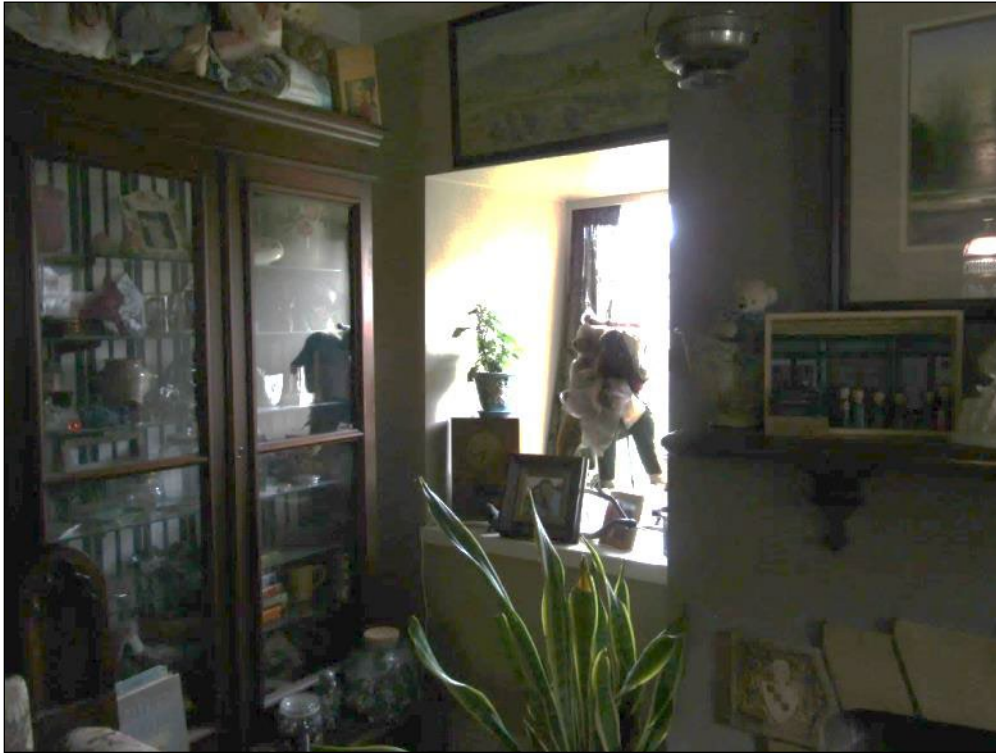
**Photograph 11. Interior – window opening in original section showing depth of walls;  
camera facing north-northwest**

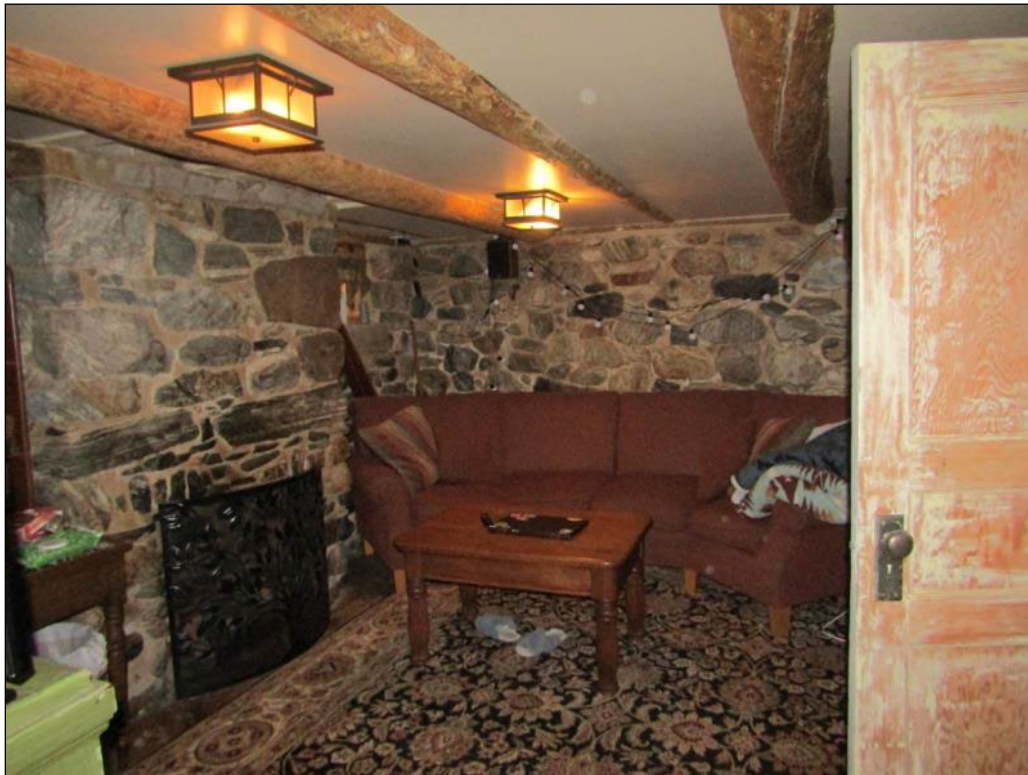
**Photograph 13. Interior – basement with original exposed stone foundation; camera facing east**

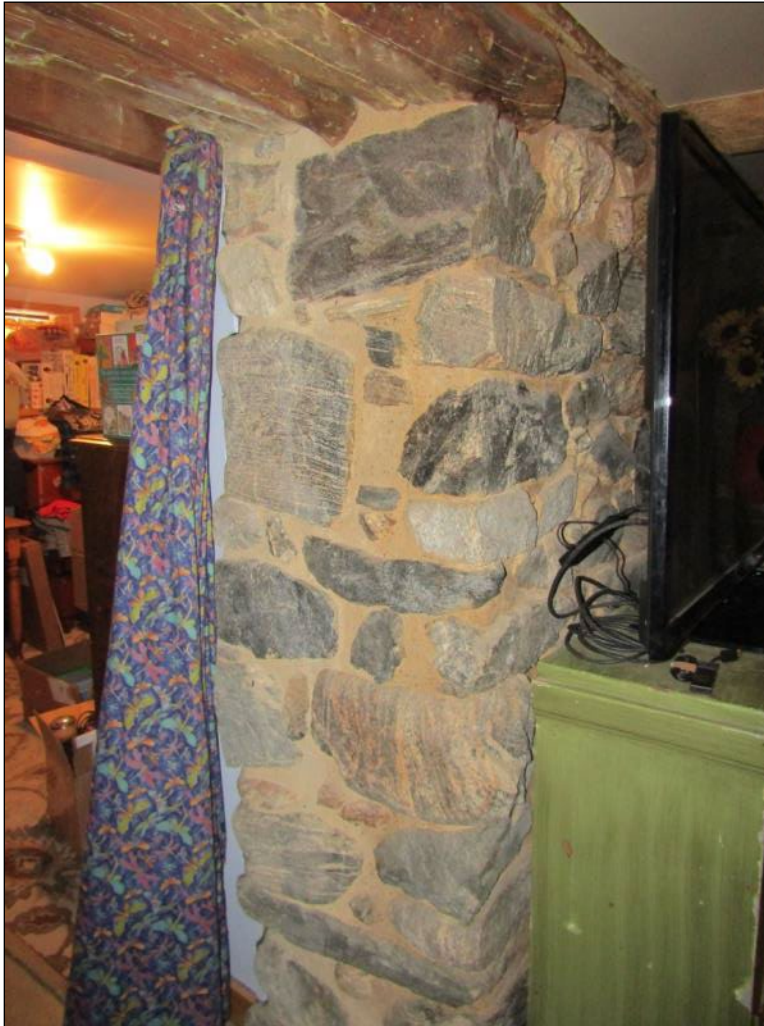
**Photograph 14. Interior – basement showing thickness of interior walls and raw timber floor joists; camera facing north-northwest**

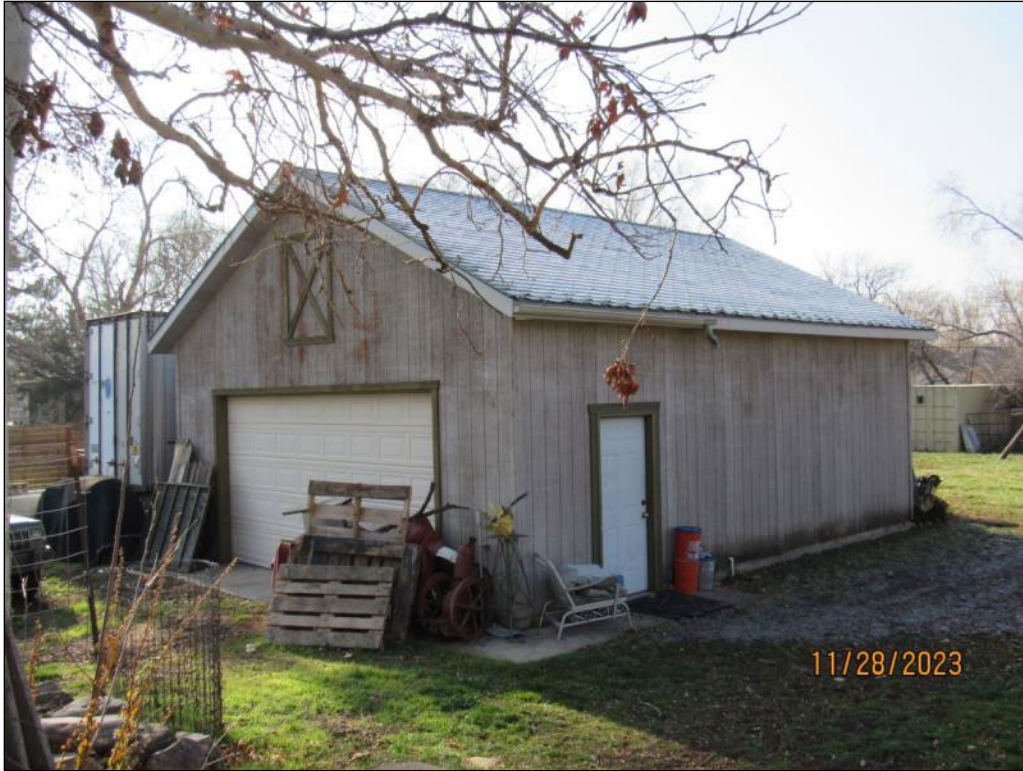
**Photograph 15. Detached non-contributing garage; camera facing southwest**

Three outbuildings and two ancillary structures are located on the parcel with the dwelling (Photographs 15–19). These include a detached garage that was constructed after 1953, a prefabricated shed likely constructed sometime around 2010–2015, a small animal/livestock shelter built during or after 2016, a small A-frame type chicken coop built after 2016, and a small semi-subterranean earth and stone root cellar that appears to be contemporary with the original dwelling. The root cellar is considered a contributing structure. All of the other resources are considered non-contributing to the property.

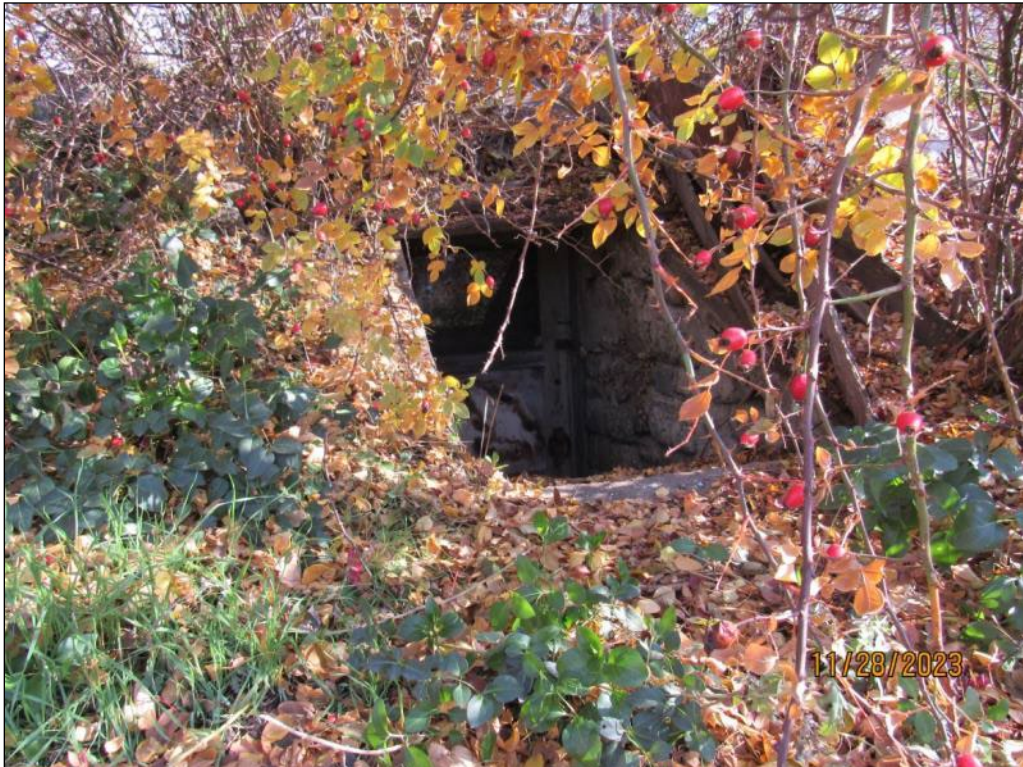
**Photograph 16. Root cellar; camera facing east**

The contributing root cellar is located a short distance north of the dwelling. The east edge of the cellar sits just west of the public sidewalk and essentially on the property line. It is estimated to measure roughly 16 feet long east-west by 8 feet wide north-south and stands as much as 5 feet above ground level at its peak. It has a rounded/barrel arch type "roof" that is covered with field stones, which were also used to construct the walls of the cellar. The stones appear to be mortared in place. The entire structure is heavily overgrown with vegetation and largely obscured from view. A partial view of the doorway, which is found in the west elevation, was available. This doorway is shorter than a standard house door and is accessed by a short concrete stairway leading down from the grade of the surrounding yard. A 4-inch diameter metal pipe extends nearly vertically from the roof of the cellar near its northeast corner. This pipe may serve as a vent for the cellar.

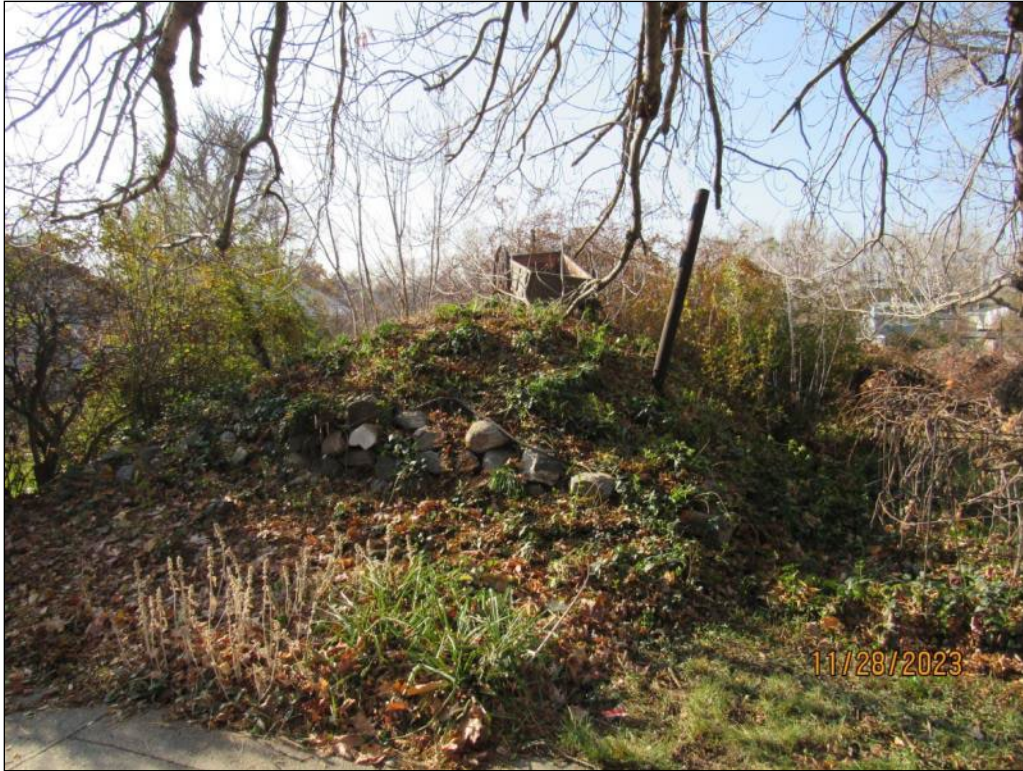
**Photograph 17. Root cellar; camera facing west-southwest**

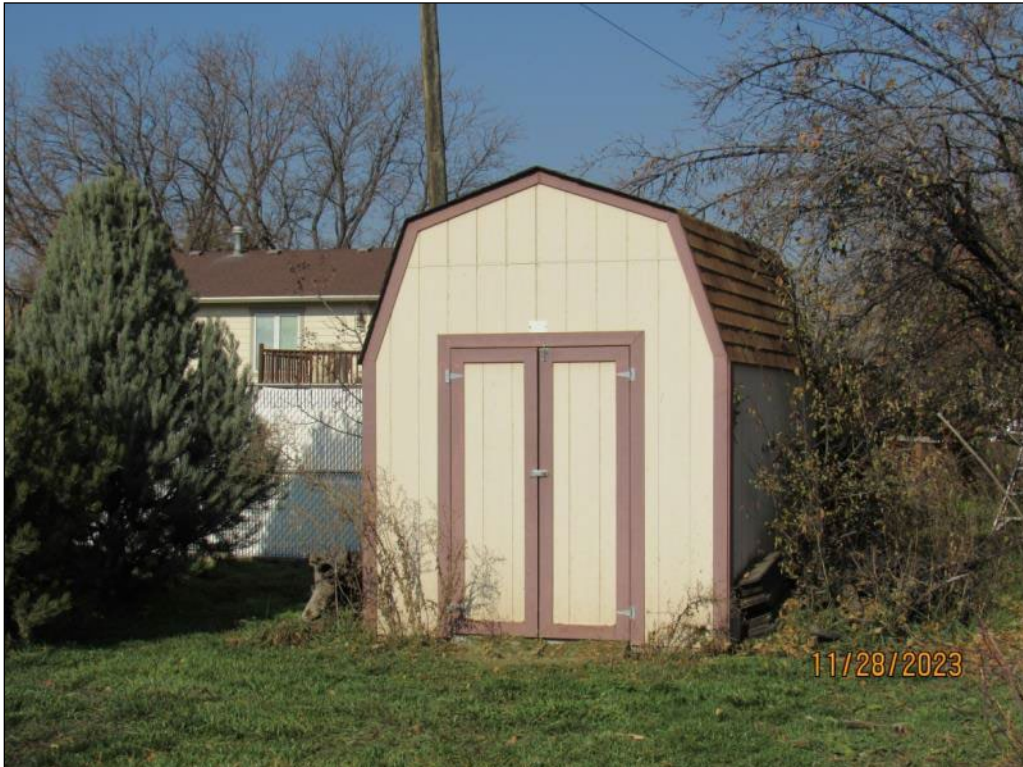
**Photograph 18. Non-contributing pre-fabricated shed; camera facing north-northwest**

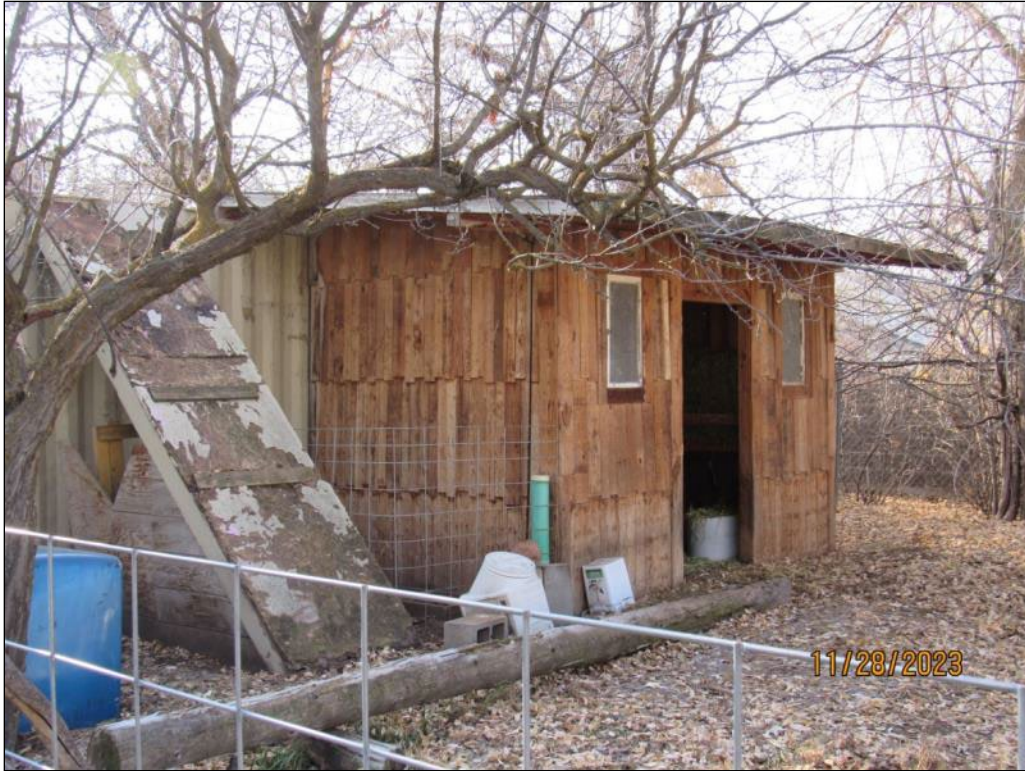
**Photograph 19. Non-contributing animal sheds/shelters; camera facing southwest**
