National Register of Historic Places Registration Form

Historic name: Silver King Coalition Mine Historic District

Name of related multiple property listing: Historic Mining Resources of Park City, Utah

Street & number: approximately 655 King Road

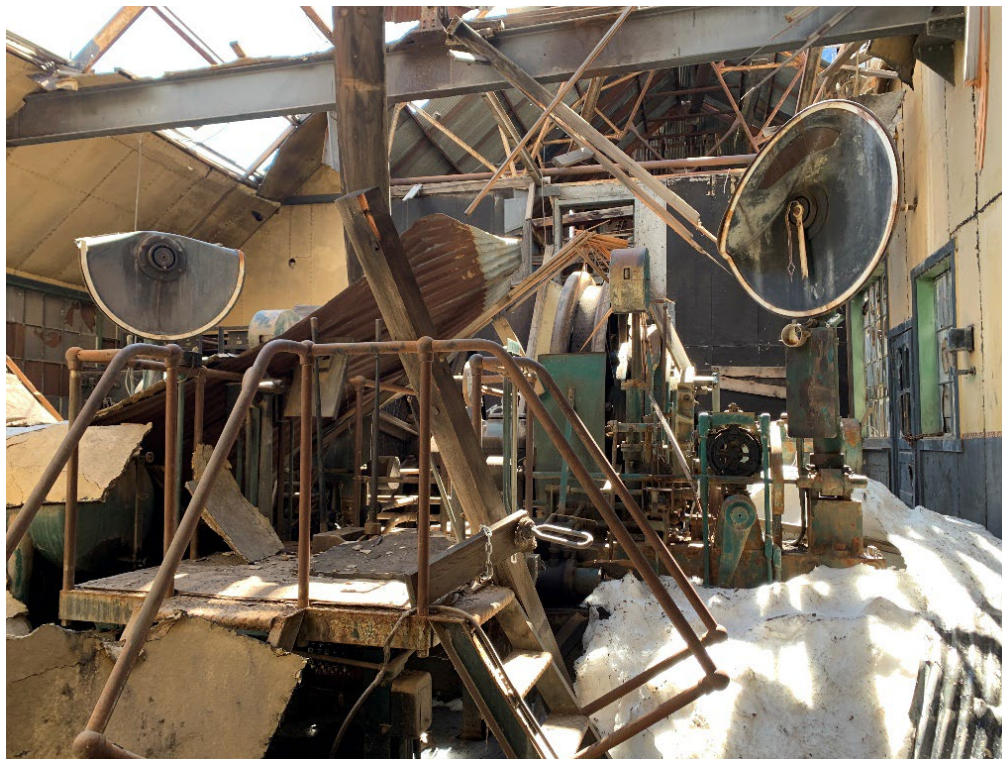
The original hoist was a Corliss Engine steam driven hoist made by Bullock Manufacturing Company and installed in 1893. ...Forty-four years later, in 1937, the steam engine was replaced by a 400 horsepower, 2,300 volt electric motor; and the old hoist was replaced by a new double reel plate type friction clutch machine built by Norberg Manufacturing Company.⁵

Figure 1. The 1937 Norberg electric hoisting equipment, including the reels and flat rope remain inside the Shaft House. The two (damaged) round gauges indicate on which level the cage is located.

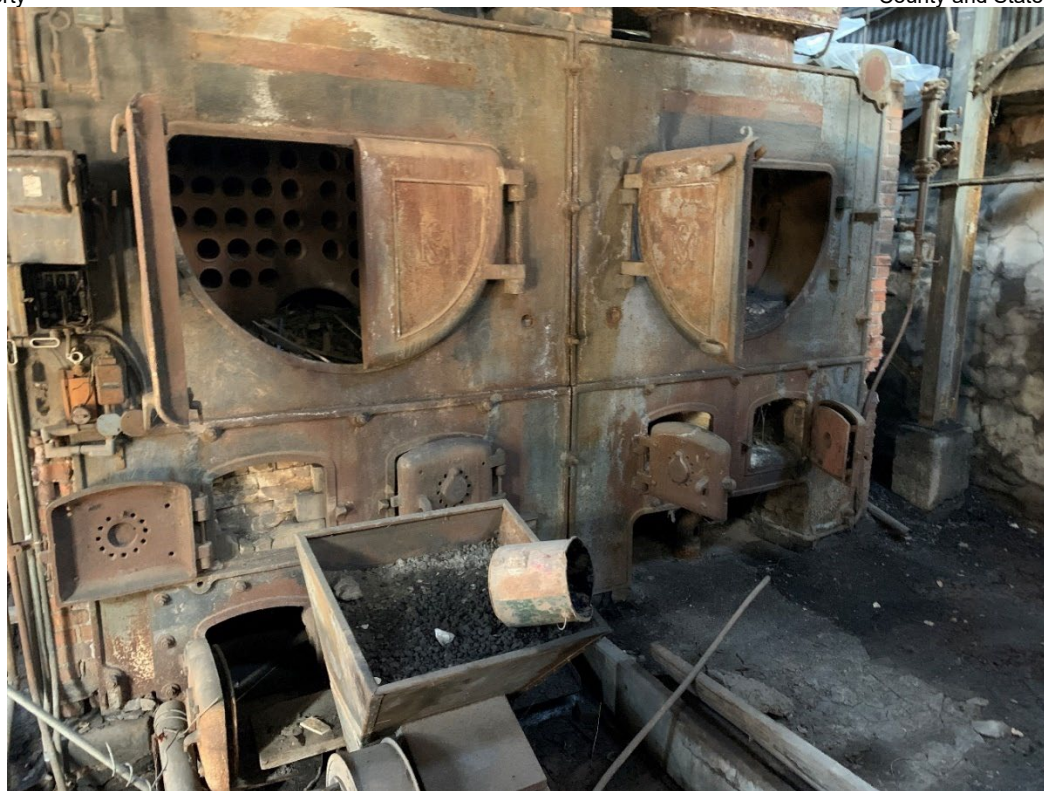
Figure 2. The two boilers located inside the Shaft House were abated for asbestos in 2023.
Source: Sandra Morrison 2024.

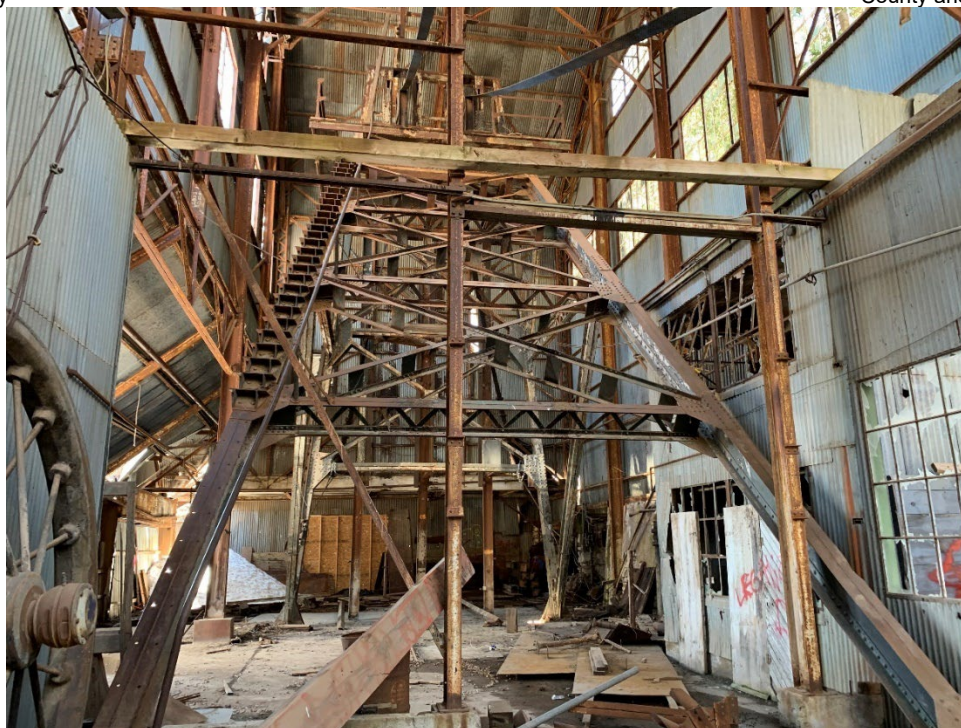
Originally sunk in 1891, when the Silver King shaft was enlarged to a three-compartment shaft in 1894, a wood headframe was erected over the collar.⁸ In July 1902, it was replaced with a new sixty-two-foot high steel production-class A-frame headframe. Installation required the shutdown of hoisting ore from the mine for several days, but the mill continued to operate by processing mined ore reserves.⁹ This steel headframe still stands inside the Shaft House.

Figure 3. The 62-foot tall headframe located in the middle section of the Shaft House.
Source: Sandra Morrison 2024.

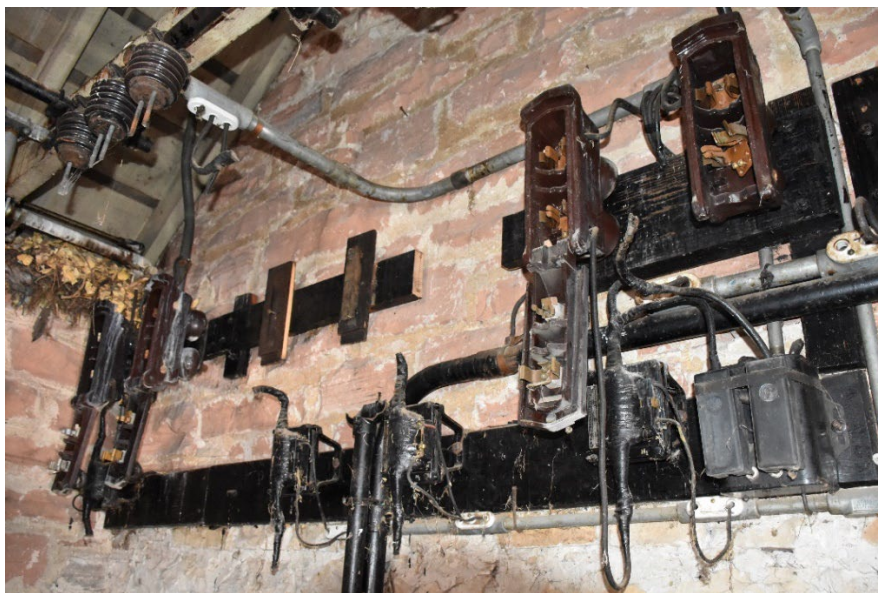
The Transformer House is not insulated and the interior is unfinished. The floors are bare concrete with the sandstone walls visible inside. Much of the electrical switches and equipment remain inside, although with decades of abandonment, the equipment suffers from deterioration and vandalism.

Figure 5. Switches and equipment located inside the Transformer House.
Source: Sandra Morrison. 2024.

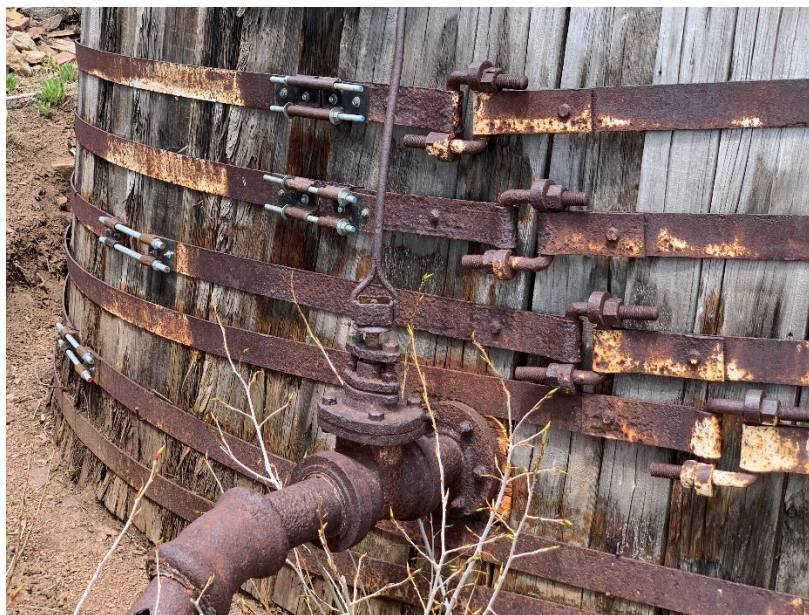
Water filled the tanks from underground pipes and emptied via a pipe and valve hardware still visible at ground level on the east side of each tank. The two tanks are also connected to each other by a pipe just below the roof line. This pipe allowed water to overflow from one tank into the other, preventing water loss or overflow waste.

Figure 6. Metal bands with new closure hardware and drainpipe/valve on Water Tank A.
Source: Sandra Morrison. 2024

Both water tanks were carefully repaired and stabilized in 1994. At this time, the tanks stood intact with most of the historic material surviving. Stabilization efforts focused on adding an engineered internal structure to each. Since the tanks no longer contained water, this work prevented any potential for inward collapse. The stabilization work was carried out in a manner that used appropriate materials and did not compromise appearance or the historic workmanship of either water tank. The tanks retain integrity of materials since sympathetic materials were used during the repair, although some new metal hardware was welded on to each end of the broken original metal bands to provide a means of adjusting and tightening (Figure 6). The tanks retain integrity of location and setting to the Silver King surface plant and the feeling and association of historic mining activity remains.

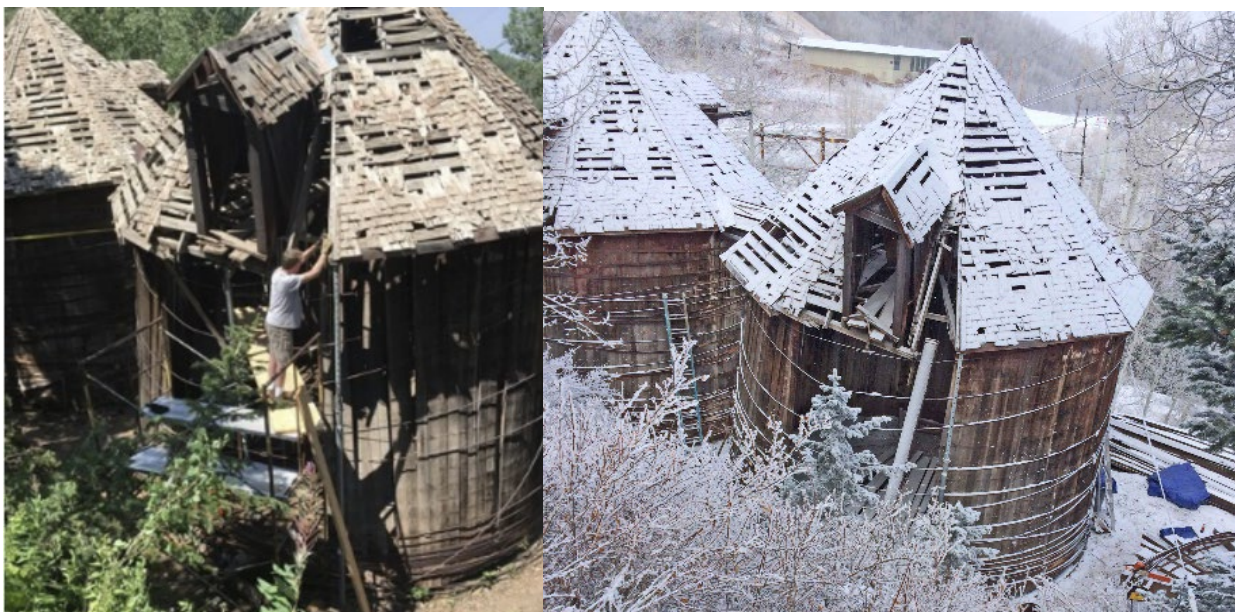
The structures have been exposed to the weather, lateral and vertical snow pressure for many years and many of the structural components were observed to be in various stages of deterioration. Shingles were damaged or missing, some of the roof framing had failed, and the walls were compromised and were listing due to the failure of some of the steel rods holding it together.

Figures 7 & 8. Two images of Water Tanks D & E before stabilization work.
Source: Friends of Ski Mountain Mining History and Lance Kincaid. 2019.

It was apparent that action needed to be taken to preserve these significant structures. Repairs made in 2017 & 2018 are as follows:

1. The roof structure was strengthened by placing a new steel center support in which bracing was secured to support the existing rafters.
2. An innovative approach of placing wood framed horizontal "cross bow" supports between center support and the exterior walls was incorporated to help stabilize the wood framed walls. The supports apply pressure to the walls like the water that once existed and applied this pressure.
3. Some deteriorated and failed timber members were removed and replaced with new of comparable sizes.

4. Existing tie rods encompassing the perimeter of the structure were re-aligned and tightened to help keep the structural walls plumb.
5. The main support timbers and existing posts were then anchored together using steel side plates and lag screws. This was done to help eliminate any future movement within the structure and for enhanced performance in resisting wind and seismic loading.
6. A new wood shingle roof was then installed.¹⁹

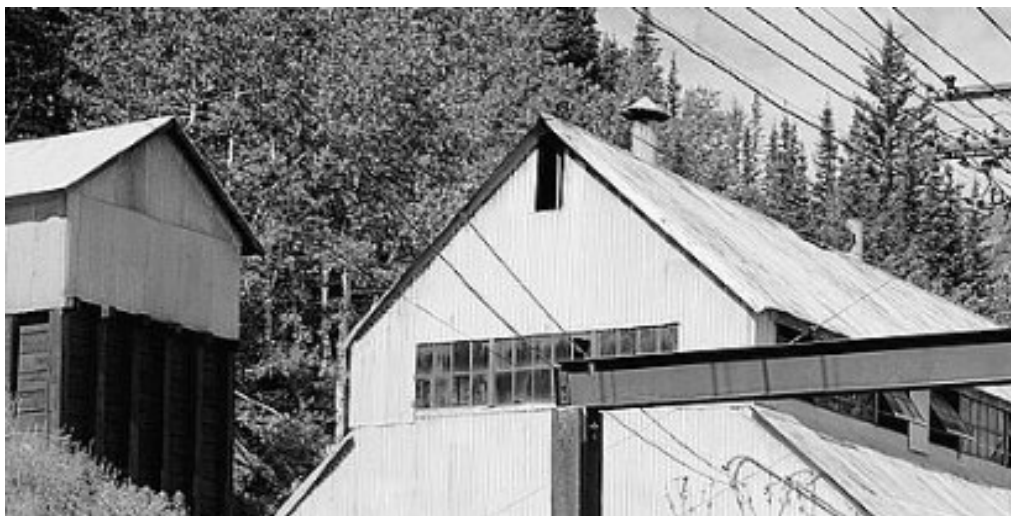
Historic images from HAER UT-22-A-A (Figure 9) show the bin crowned with wood-frame gable-roof structure and all clad in corrugated metal. The upper half of the coal bunker has since been lost.

Figure 9. Coal Bin on left, 1972. Source. HAER UT-22-A-A.

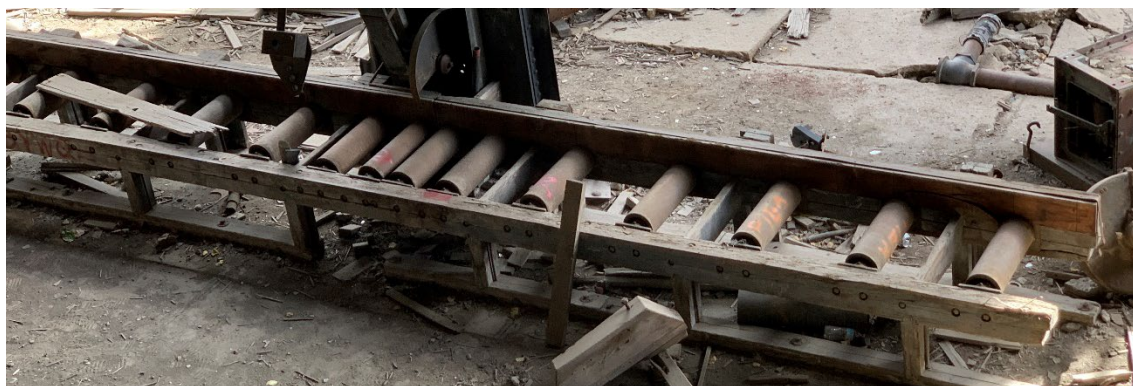
Many of the 18-inch-wide distributor conveyor belts remain throughout the building; these moved the various sized ore automatically to the next step in the crushing process.

Figure 13. A timber frame holds the rollers of this conveyor, while other conveyors remaining in the mill feature a steel frame. Source: Sandra Morrison, 2023.

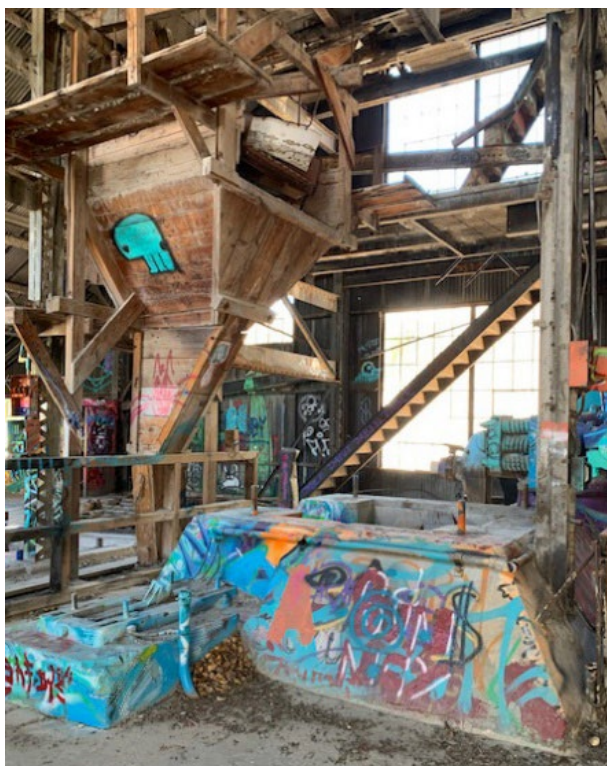
With the remodel of the grinding process in 1928, a four-foot Symons cone crusher was installed.²³ Introduced by the Symons brothers in the 1920s, this equipment is still preferred by mining operations throughout the world, offering many advantages over other crushers, such as low energy consumption and reliable and efficient operation. The crusher is gone from inside the mill, presumably sold given that these machines are still in use today. The two-story-tall wood feeder remains hovering over the concrete foundation. The Symons brothers' invention depended upon the ore falling vertically into the crushing chamber. Prefabricated metal stairs and mezzanine floor provide access to the mouth of the feeder.

Figure 15. Cone Crusher feeder and foundation. Source: Sandra Morrison, 2024.

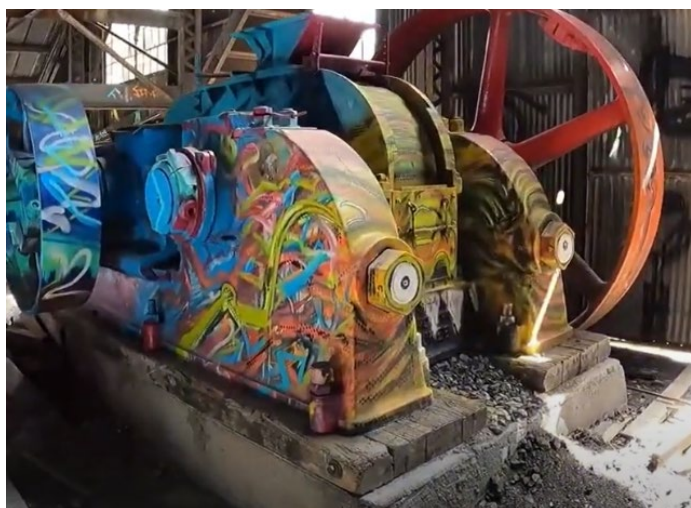
A roller crusher reduces ore by compressing it between two turning cylinders called rolls (Figure 17). Each roll is independently driven by the flywheel-type pulley on each side, with the shaft of the fixed or stationary roll attached to the large pulley and the moveable roll shaft to the small pulley. The crusher was powered using wide flat belts that transmit power across large distances with approximately 99% efficiency, although today these belts are missing. The moveable roll can be adjusted to change the distance between the rollers to accommodate the size of the incoming ore and control the output size. The speed can also be regulated according to the size of the incoming ore. Each roll is encased in a dust-tight steel housing, The movable roll is spring-loaded to provide safety relief of any excessive pressure.²⁴ Given all these adjustments, crushing rolls require a certain amount of skill and experience from the millman for best performance.

The 1921 concentration mill flow sheet indicates a 43” x 16” “A.C. [Allis-Chalmers] Roll installed after the gyratory crusher in the crushing plant. The 1928 flow sheet indicates this equipment was replaced by a Symons cone crusher. The Allis-Chalmers roll crusher (adjacent to the cone crusher) was possibly kept after the 1928 remodel to provide a back-up crushing method that could keep the mill operating if the Symons Cone crusher needed repair or maintenance.

Figure 16. Allis-Chalmers roll crusher.
Source: Sandra Morrison, 2023.

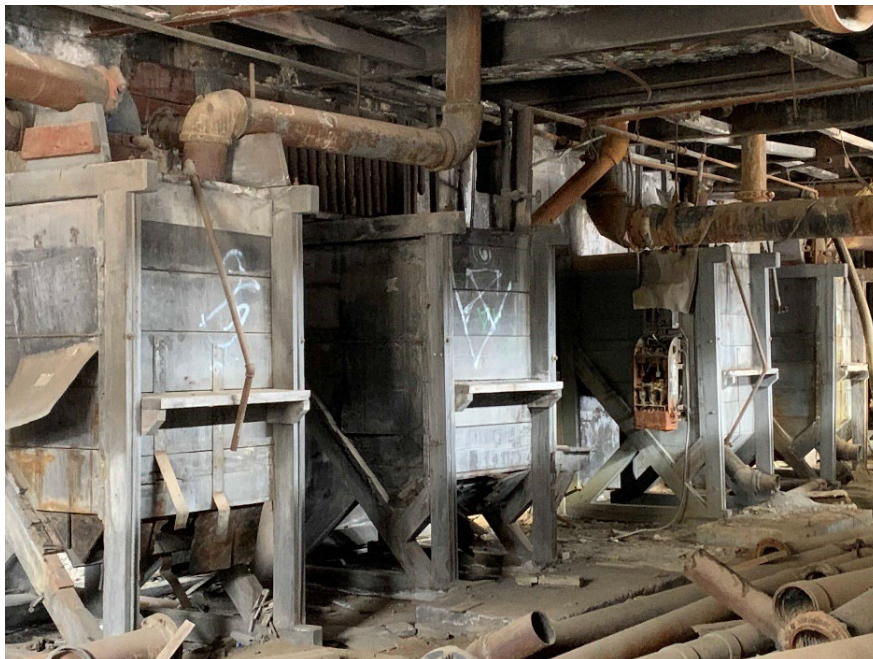
Figure 19. Four of the flotation tanks. 2023. Source: Sandra Morrison, 2023.

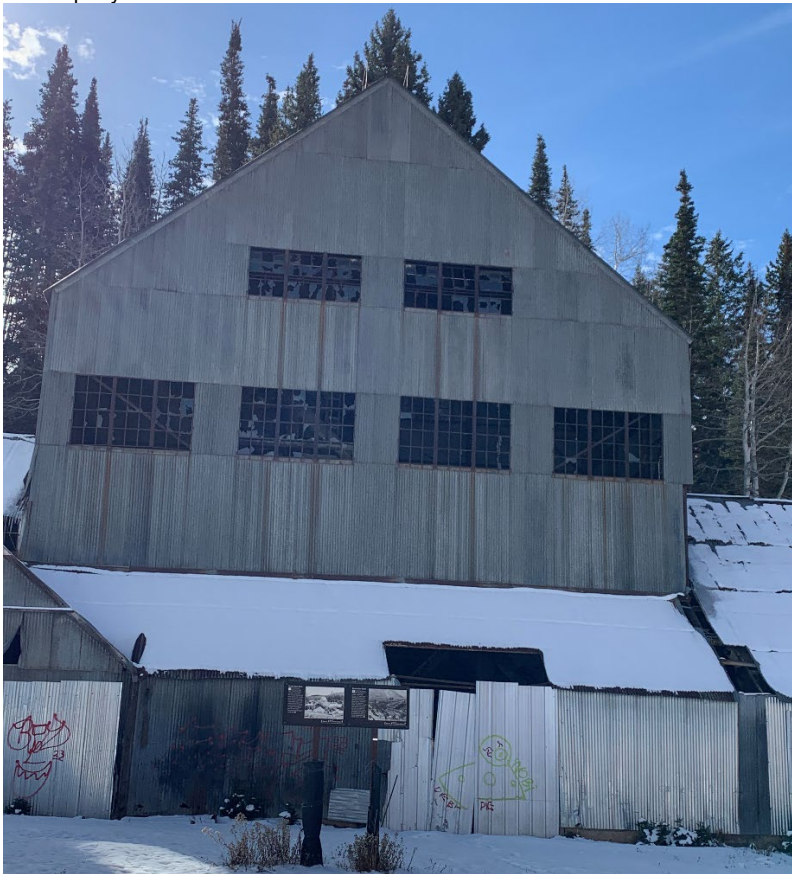
All windows retain the original metal sashes including mullions and muntins. Most of the clear glazing has been broken or is now missing and all the main floor windows are currently covered with corrugated metal panels.

Photo No. 7 Detail of Silver King Shaft House windows. Camera facing south

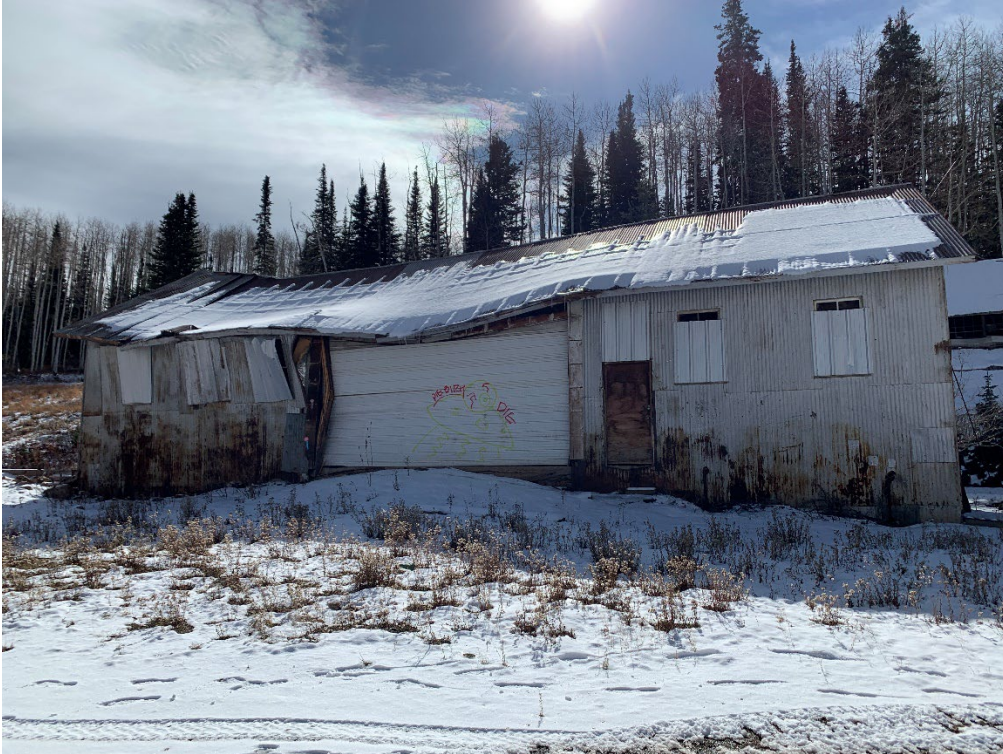
During the winter of 2018-2019, the east half of the building collapsed and was then demolished in the summer of 2020, leaving only the concrete slab foundation for that section. During the winter of 2022-2023, additional significant structural damage occurred to the remaining building (see Photo No. 14).

Photo No. 14 North (primary) elevation of the Warehouse. Camera facing south

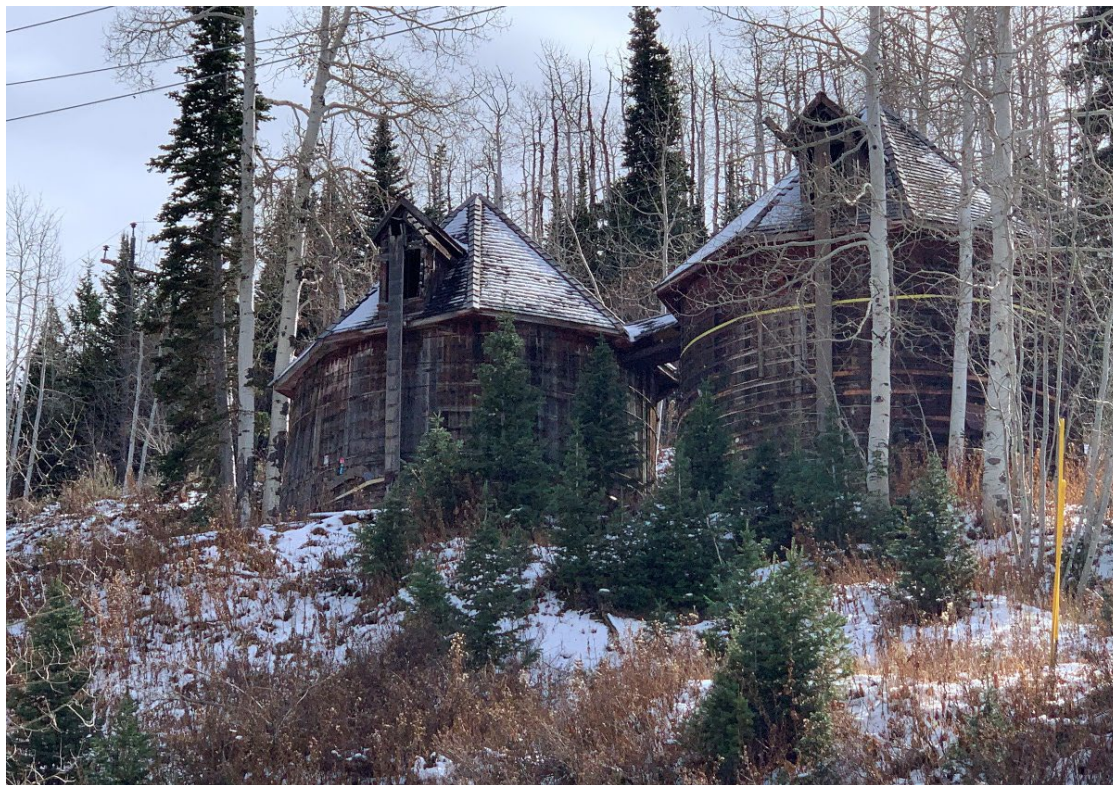
The eastern most tank C has completely collapsed with only the foundation and wood floor remaining and so is identified as a contributing historic feature. With this recent collapse, the design, materials and workmanship of Water Tank C has been greatly impacted, but as a ruin retains historic integrity in the areas of location, setting, feeling and association. Since this ruin remains in its original location, Water Tank C offers a strong sense of connectedness and association with Water Tanks D & E, and the feeling of historic mining activity remains.

Tanks D & E also retain integrity of location, setting, feeling and association. These two tanks were repaired and stabilized from 2018 through 2020 in a manner that did not change the appearance of either structure and used appropriate materials so did not compromise the integrity aspects of design, materials and workmanship. (Figure 7 & 8). The following Executive Summary was provided by the structural engineer engaged for the project:

Photo No. 32 North elevation of water Tanks C, D & E. Camera facing south

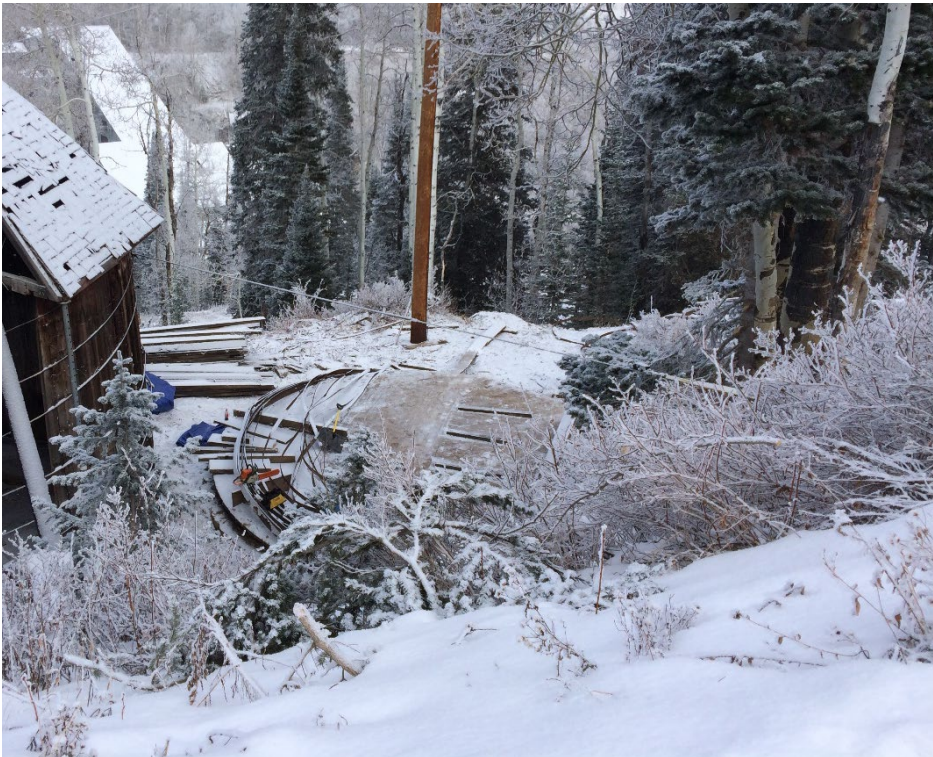
Photo No. 47 Remains of collapsed Water Tank C. Camera facing north.
