United States Department of the Interior National Park Service National Register of Historic Places Registration Form

Historic name: Clover Ward LDS Meetinghouse
Other names/site number: Rush Valley Fire Station #1
Name of related multiple property listing: <u>N/A</u>
(Enter "N/A" if property is not part of a multiple property listing

Street & number: 630 S. West Shambip Rd.			
City or town: Rush Valley	State: <u>Utah</u>	County: <u>Tooele</u>	
Not For Publication:	Vicinity:

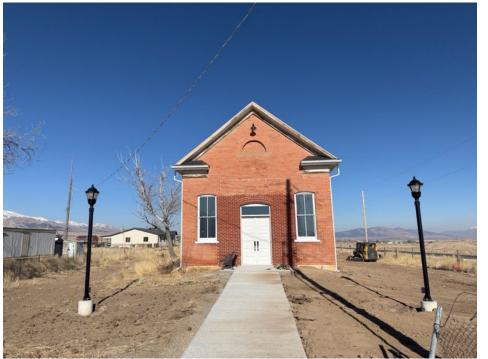
Photograph 1 of 19. Exterior, south (main) façade. Camera facing north.

The church's south elevation serves as its primary façade and retains many of its original materials. Historically, it housed a pair of centrally located double doors surmounted by a two-light transom and brick segmental arch. (Figure 1) These were removed, the opening enlarged, and a roll-up garage door inserted for the fire engine circa 1970. (Figure 4) The original entryway and brick surround were recently replicated with new materials, using a concrete block substrate and exterior brick selected to appear as much like the original as possible. The doorway has been replicated to match its historic opening size and original location within the south facade. Wood double doors, painted white, feature six panels divided by raised wood trim. The entry is surmounted by a single-light transom. (Photo 4)

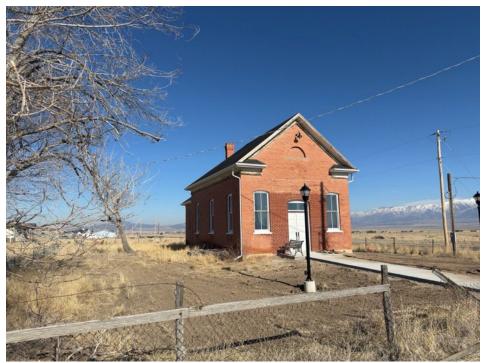
Photograph 2 of 19. Exterior, west and south (main) facades. Camera facing northeast.

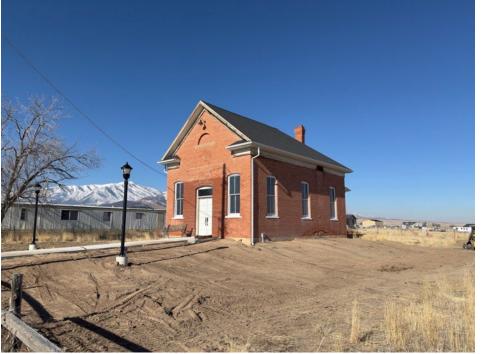
Photograph 3 of 19. Exterior, east and south (main) façades. Camera facing northwest.

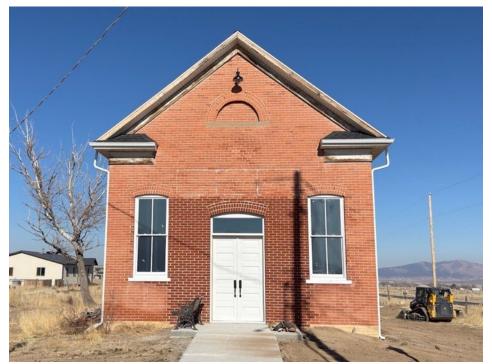
Photograph 4 of 19. Exterior, south (main) façade. Camera facing northwest.

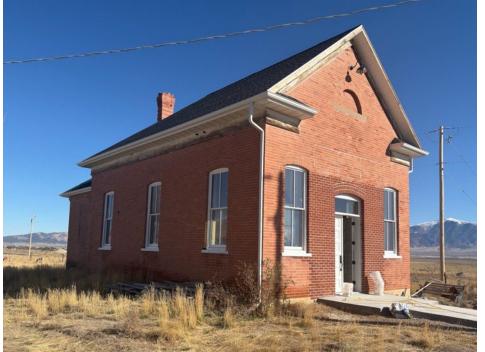
Photograph 5 of 19. Exterior, west and south (main) facades. Camera facing northeast.

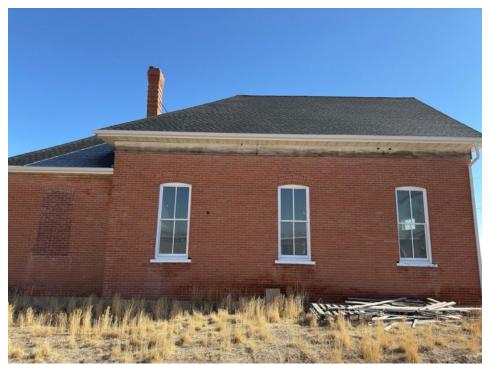
Photograph 6 of 19. Exterior, west facade. (Property boundary created a limitation to a clearer straighton view of this façade.) Camera facing east.

The west facade is composed of brick with three symmetrically placed 2-over-2 double-hung wood frame windows. The rear addition is recessed approximately one foot from the west facade and extends 16'7" to the north. The addition originally housed another window of similar size. The window was removed, and the opening was bricked in at an unspecified date, likely concurrent with the construction of the fire station in the early 1970s. Each window is framed by a rounded lintel topped by a segmental arch. The arches are composed of two rows of stacked header course bricks surmounted by a single row of horizontal headers. The windows are underscored by simple wood lug sills. (Photo 6) Discoloration is notable on the masonry near the west foundation. Some of the damaged bricks on the west addition facade near the northwest corner foundation were replaced at an unspecified time, likely during its period of use as a fire station, circa 1976-1993.

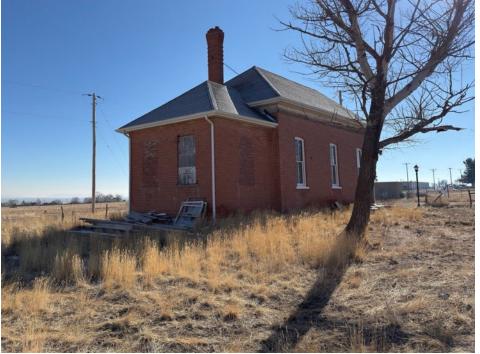
Photograph 7 of 19. Exterior, north and west facades. Camera facing southeast.

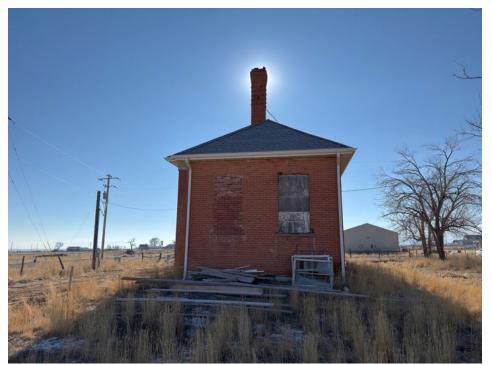
Photograph 8 of 19. Exterior, north facade. Camera facing south.

The north facade is dominated by the rear addition, which spans 12'5" of the 24-foot facade. Originally, the addition's north facade included two windows with openings similar to the others around the building. These were removed and bricked at an undetermined date. One of the openings is currently boarded. Several cracks in the masonry have formed around the westernmost opening. The north facade of the main structure originally contained a door that granted exterior access to the stage. The outline of the opening remains intact but was bricked in at some point, likely when the structure became a fire station, circa 1976-1993. The opening, like all features of the building, is surmounted by a segmental arch composed of brick headers. The building retains one of its original brick chimneys, which rises from the north slope of the hipped roof. (Photo 8) The chimney is most visible from the north (rear) facade. Five courses of brick corbelling add interest to the elongated feature and visually balance its verticality.

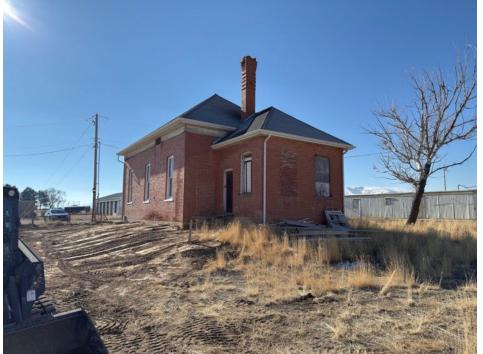
Photograph 9 of 19. Exterior, west and north (rear) facades. Camera facing southwest.

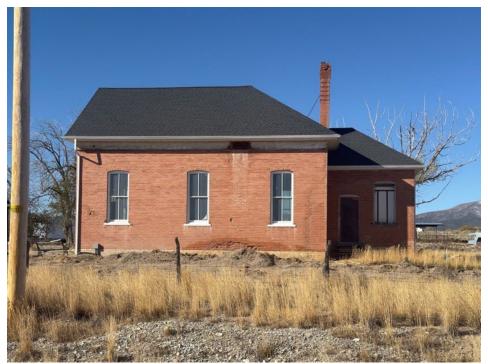
Photograph 10 of 19. Exterior, east facade. Camera facing west.

The east facade is like the west, with three double-hung two-over-two wood frame windows spaced symmetrically along the facade. A brick stove chimney originally rose from the east facade and connected to an interior pot-belly stove between the two northernmost windows. The chimney rose approximately six feet above the roofline. (Figure 2) It was removed during the 1970s remodeling for the fire engine. At that time, central heating was installed in the building.³ The east facade of the rear addition includes an extant entrance to the former vestry, which is currently accessed by a makeshift metal door. However, the frame is original and is composed of wood. The door is elevated approximately two feet from the ground and is reached by a weathered wood staircase. (Photo 10) A single window formerly flanked the door to the north. The window has been removed, and the opening is bricked in, but the wood encasement and sill are original. Two areas of the east facade masonry have been damaged by drainage from the roof. Near the foundation, areas of the original brick are discolored and crumbling.

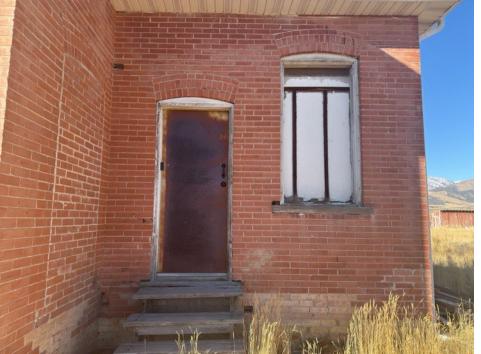
Photograph 11 of 19. Exterior, east facade, details of vestry addition. Camera facing west.

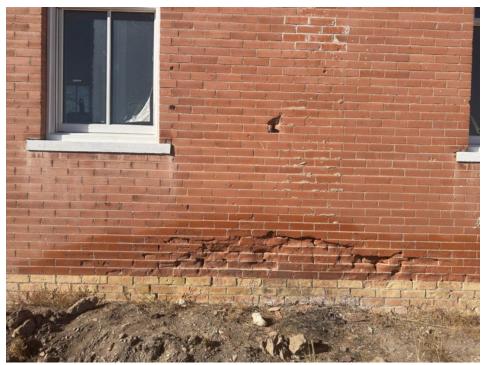
Photograph 12 of 19. Exterior, detail of brick deterioration, east facade. Camera facing west.

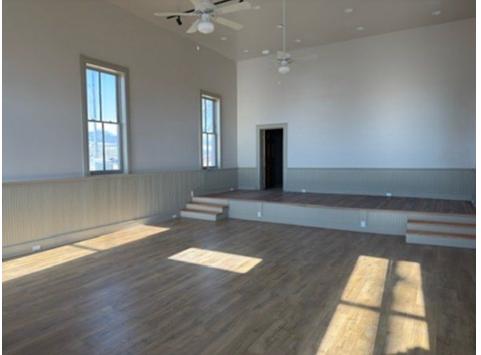
Photograph 13 of 19. Interior, refinished floor and stage. Camera facing northwest.

has been renovated and no known historical photos of the interior exist (Photo 13-15). Inside the chapel, pews or chairs would have faced the north end of the room where there was a stage for presentations. The furnishings and stage were likely removed between 1970 and 1976 when the building was remodeled to house a fire engine. The stage has been recreated, and the size and height were determined by "ghost lines" (figure 12) left when the original stage was removed.⁴ The stage is 19 inches in height off the main chapel floor. Behind the stage are two entryways: one on the east and another on the west. The western entryway was probably used as a separate entrance to the chapel. It was filled with brick at some unknown time and covered with plaster and wood panel siding. The eastern entryway behind the stage measures 2'11" wide and 7' tall and retains original trim (photo 13).

On the main floor of the chapel, a concrete floor, installed for the fire truck in the 1970s, is covered with vinyl planks with a wood finish. The stage, measuring 21'9" long, 8'7" wide, and 1'7" tall, was replicated with wood and has small wood stairways from the main floor to the raised stage on both the east and west ends. The ceiling is covered with drywall and contains 24 recessed can lights, three hanging ceiling fans, and three stage lights above the stage area. Wainscoting paneling follows every wall of the main chapel area and rises from the main floor to the base of the eight windows of the main chapel and stage areas. According to exterior historical images, a brick chimney adorned the east facade, which probably heated the chapel. No evidence of the stove and chimney remains on the interior. Along the east interior wall and bordering the main entrance façade is a small electrical control box (photo 16). On both the west and east facades are six double-hung wood frame windows that were custom-built to replicate the original windows.

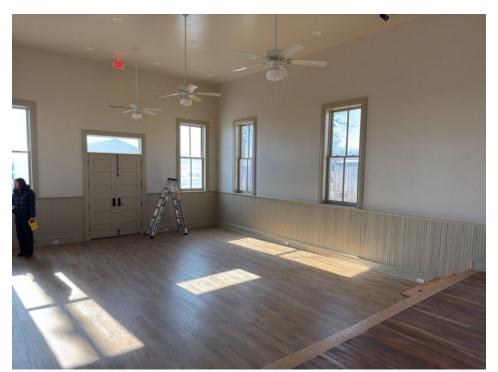
Photograph 14 of 19. Interior, showing wainscoting, windows, plaster, and replicated main entryway. Camera facing southwest.

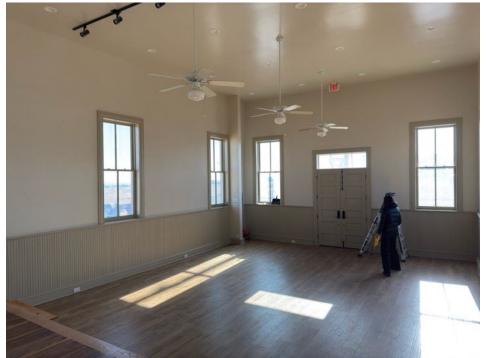
Photograph 15 of 19. Interior, showing lighting and replaced windows. Camera facing southeast.

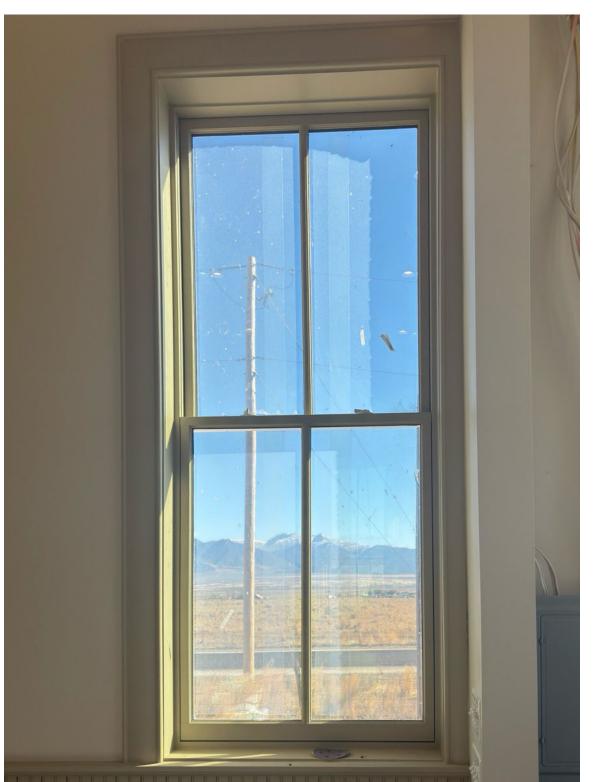
Photograph 16 of 19. Interior, detail of restored windows and power box can be seen to the right. Camera facing east.

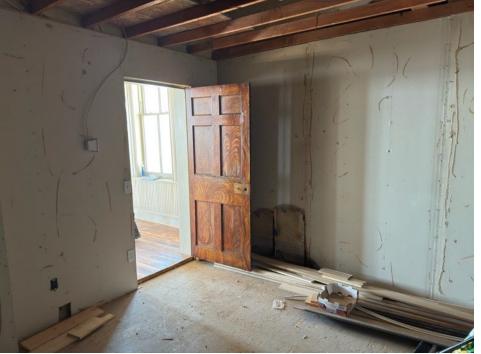
Photograph 17 of 19. Interior, vestry addition, detail of removed panels, and exposed rafters. Camera facing southwest.

Behind the stage rear wall, in the north addition, is the vestry. The vestry currently houses construction equipment and is used as a general storage area for the rehabilitation project. All of the interior walls are exposed drywall in various states of repair (photos 17-19). In the 1980s, wood paneling was installed by the Beehive Telephone Company (figure 14) when the building housed telephone equipment during the construction of the telephone building to the south. This paneling has since been removed.⁵ The wood paneled, faux-grained door that leads to the vestry is not original and was salvaged from another historic building. The ceiling is presently exposed rafters with exposed electrical work. The original brick of the remaining chimney can be seen along the south wall of the vestry and above the exposed rafters.

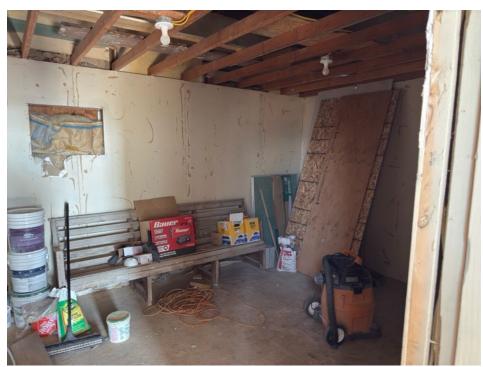
Photograph 18 of 19. Interior, vestry addition, detailing more rafters. Camera facing northeast.

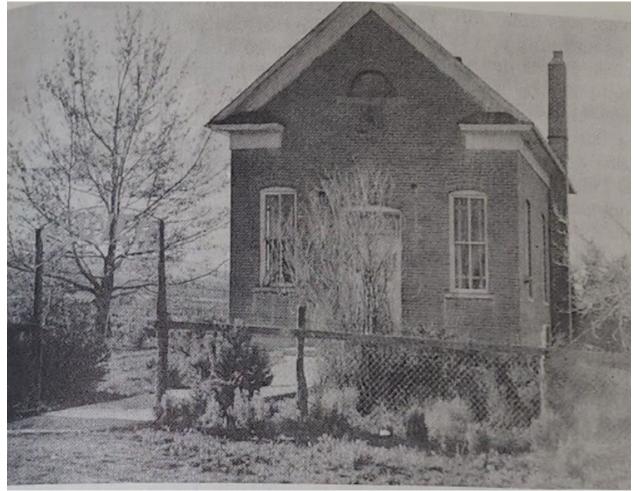
Figure 2 of 14. Clover Meetinghouse, ca. 1922. Note the fencing and trees that were planted before this time. Camera facing north. Source: Familysearch.org; John William Green (1883-1963). Accessed: February 2, 2025.

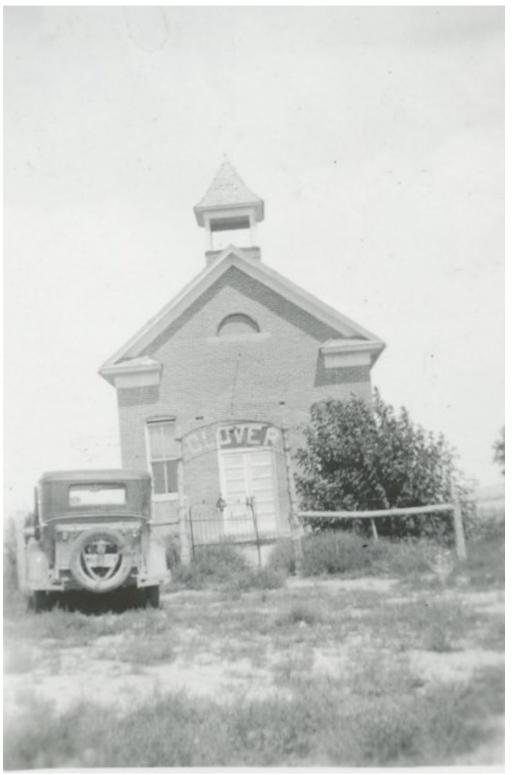
Figure 3 of 14. Clover Meetinghouse showing the main (south) façade, taken in 1944. Camera facing north. Source: Church History Library, The Church of Jesus Christ of Latter-day Saints

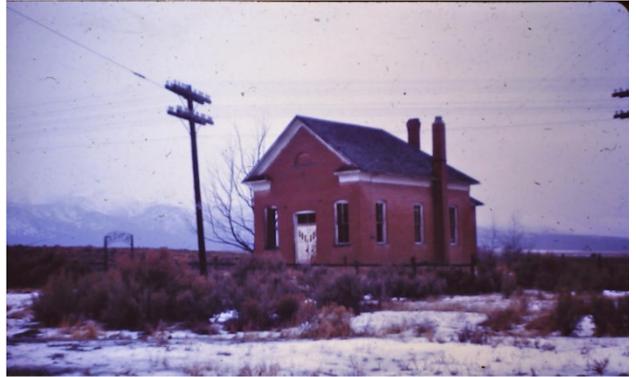
Figure 4 of 14. Clover Meetinghouse, ca. 1960. Note the power lines, replaced entryway doors, and removal of the bell tower. Camera facing northwest. Source: John Cluff.

² Historic photos show the extant cupola as late as 1944. The tower is absent in a photograph from 1960.

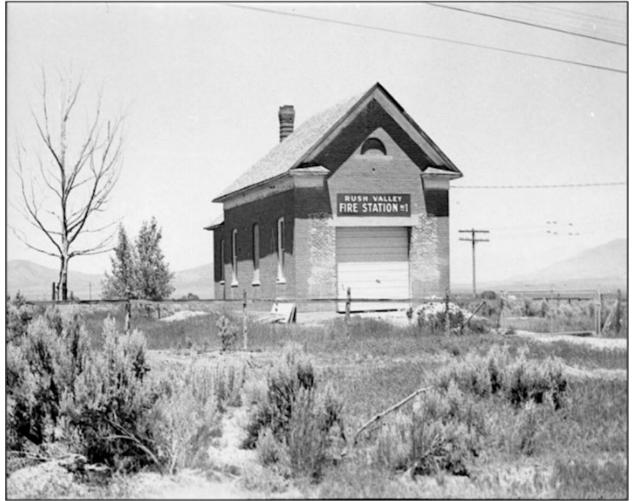
Figure 5 of 14. Rush Valley Fire Station No. 1, ca. 1971. Camera facing northeast. Source: Utah State Historical Society, Site No. TL 01 02.

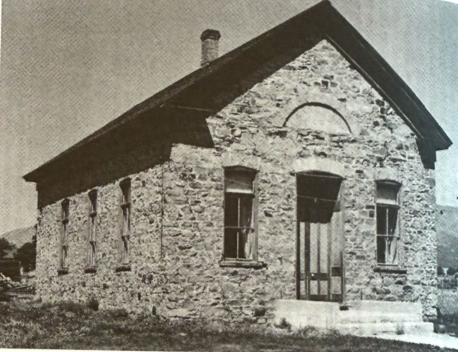
Figure 6 of 14. St. John meetinghouse, ca. 1900. The St. John meetinghouse shares similar features to the Clover Meetinghouse and was demolished in 1961. Source: Lacey Burrows, *The History of Rush Valley*, 35.

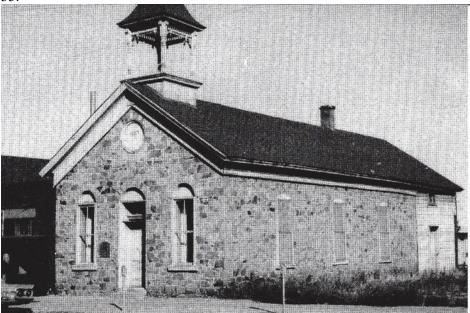
Figure 7 of 14. The Tooele County Courthouse, ca. 1950. The Tooele County Courthouse shares features similar to those of the Clover Meetinghouse. The Tooele County Court House currently serves as the Tooele County Pioneer Museum. Source: tooelepioneermuseum.org.

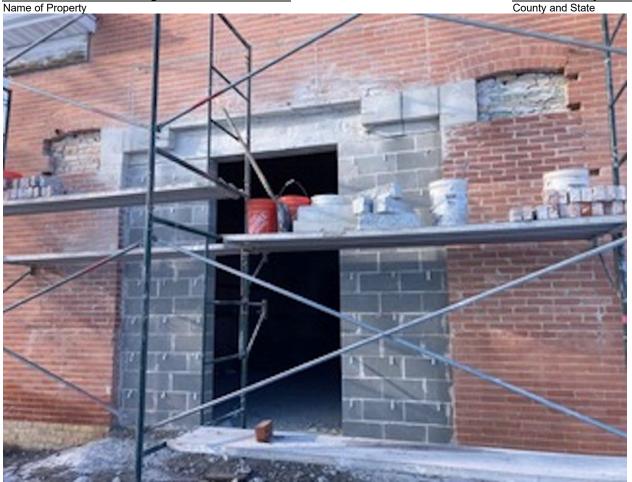
Figure 8 of 14. Restoration of the main (south) façade entryway, ca. 2022. Camera facing north. Source: Clover Church Restoration Committee.

The scope of work for the rehabilitation included replicating the original appearance on the south elevation including bricking in the larger opening and replicating the original fenestration, including the double doors, transom window, and segmental arch. Deteriorated mortar joints have been repointed on all facades in critical areas.⁶ The project also entailed installation of custom-made wood-sash and frame windows to match the originals based on photographs. Other exterior

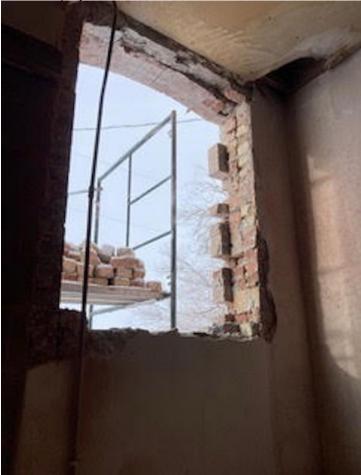
Figure 9 of 14. Interior photo of the south façade window restoration, ca. 2022. Camera facing south. Source: Clover Church Restoration Committee.

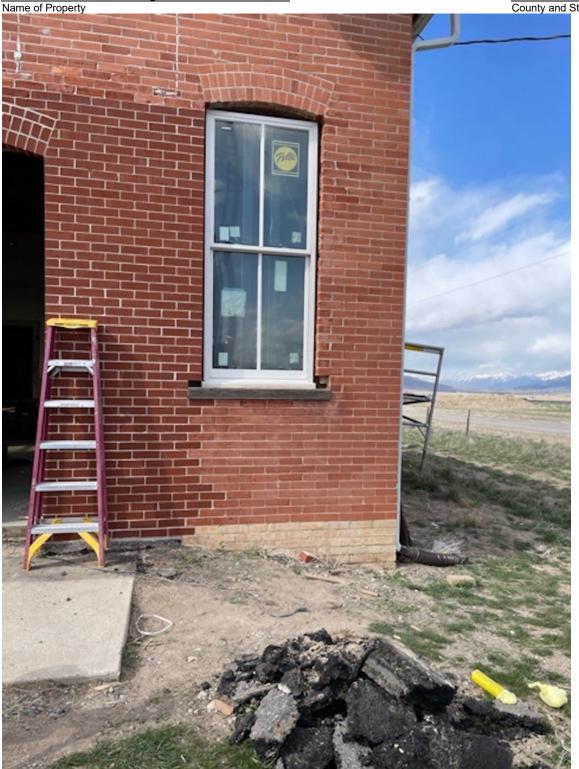
Figure 10 of 14. Restored brick and masonry on the Clover Meetinghouse main (south) façade, ca. 2022. Camera facing north. Source: Clover Church Restoration Committee.

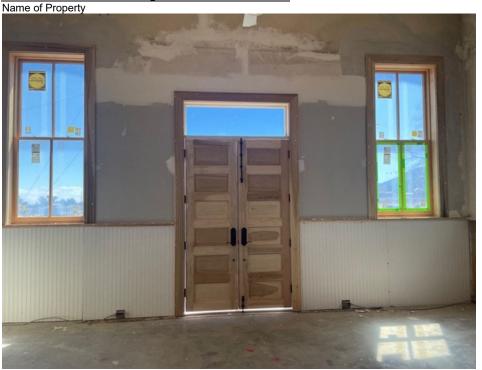
Figure 11 of 14. Interior renovations of the south façade, showing window and entryway replacements, ca. 2022. Camera facing south. Source: Clover Church Restoration Committee.

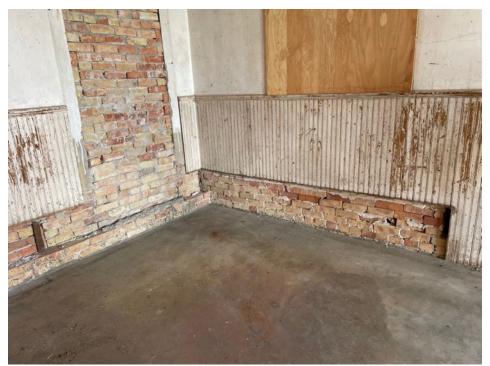
Figure 12 of 14. Photograph of the stage area prior to reconstruction, ca. 2022. Note the extant "ghost lines" of the original stage and the bricked doorway. Camera facing northeast. Source: Clover Church Restoration Committee.

⁴ Images provided by local historian, and site coordinator, John Cluff, show the exposed brick from the original stage removal, and the height of the stage can be identified.

The firehouse concrete slab was leveled and covered by vinyl flooring that approximates the building's original wood. The stage was reconstructed of reclaimed tongue-in-groove wood from buildings at the Dugway Proving Ground, a nearby U.S. Army facility. The committee led a grassroots effort to power wash the wood and reassemble the stage in its original height and location. The acoustic tile ceiling installed during the fire station era was removed and the original height from the period of significance restored. Above the ceiling, the rafters and beams of the roof are original to the building. The interior walls are largely original. The beadboard wainscoting has been repaired/replaced in kind to its appearance during the period of significance.⁷ The plastered walls are original. Cracks have been repaired, the walls skim coated, and restored to their original color, which was matched to an early layer of paint discovered during the process.

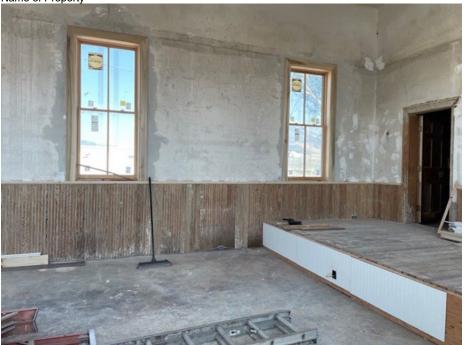
Figure 13 of 14. Interior renovations to the west façade and stage reconstruction, ca. 2022. Note the replacement windows and new stage. Camera facing west. Source: Clover Church Restoration Committee.

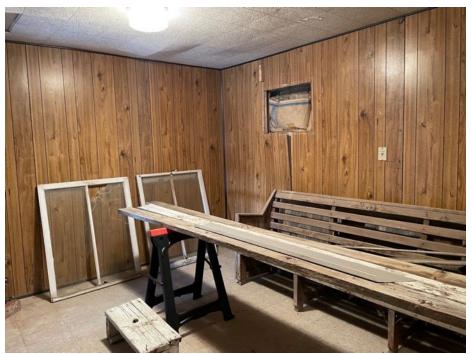
Figure 14 of 14. Interior of vestry prior to renovations, ca. 2022. Note the wood paneling installed by Beehive Telephone Company in the 1980s. Camera facing northwest. Source: Clover Church Restoration Committee.
