United States Department of the Interior
National Park Service**National Register of Historic Places Registration Form**

1. Name of PropertyHistoric name: Scenic Drive and Capitol Gorge Historic DistrictOther names/site number: Capitol Gorge Road, Capitol Gorge Trail, Capitol Gorge Highway, Reef Road, Monument Road, Route 10, Utah State Route 24, and Blue Dugway

2. LocationStreet & number: N/A; Capitol Reef National ParkCity or town: Torrey State: Utah County: WayneNot For Publication: ☐ Vicinity: ☒**3. State/Federal Agency Certification**

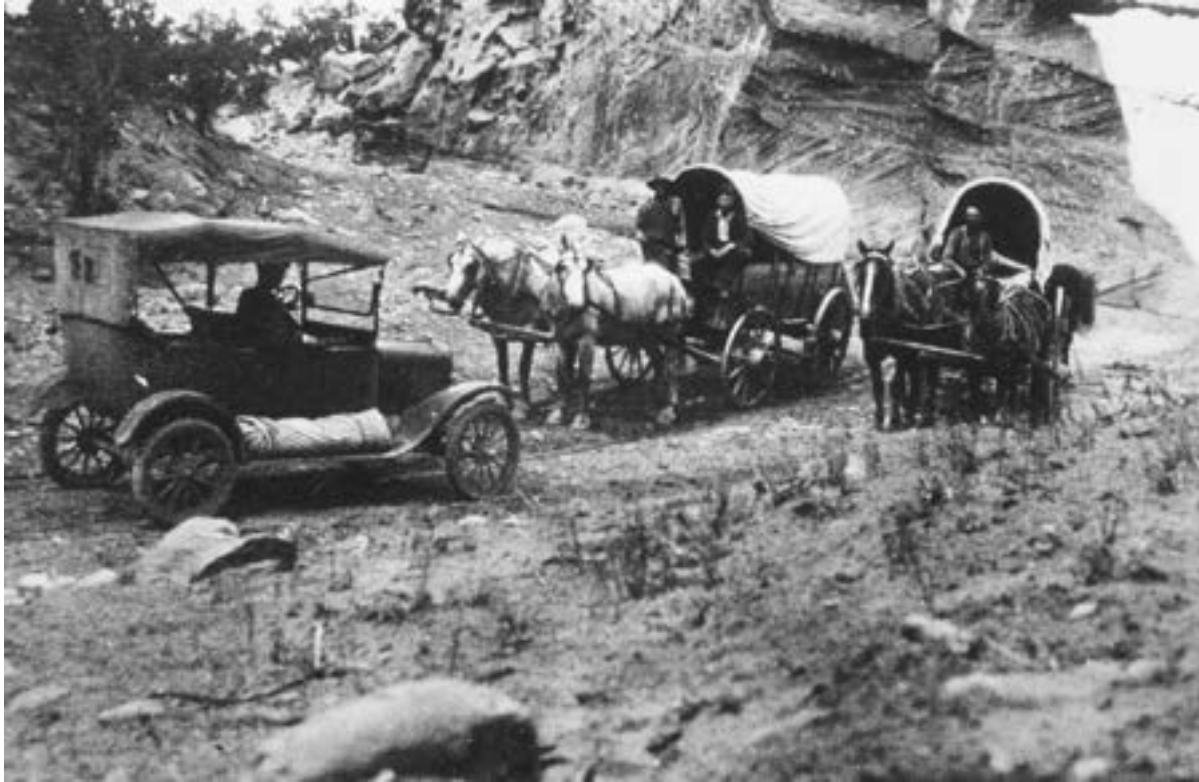
Figure 1. Photograph of Capitol Gorge Road ca. 1920, on file at the Capitol Reef National Park archives collection.

remained unpaved in many areas.¹³ Although King's perspective only discusses conditions on the east side of the Waterpocket Fold, characteristics on the west side can be hypothesized. The road followed the same alignment as it does in the present, indicated by the lack of traces of other road alignments; it passed in and out of the washes and over small hills where it was likely damaged frequently during floods, and it likely was no wider than one wagon, except for in small areas where the terrain became flatter. Based on early photographs of the Blue Dugway, it appeared little changed by the time motor-powered vehicles started to travel the route around the 1920s (Figure 1).

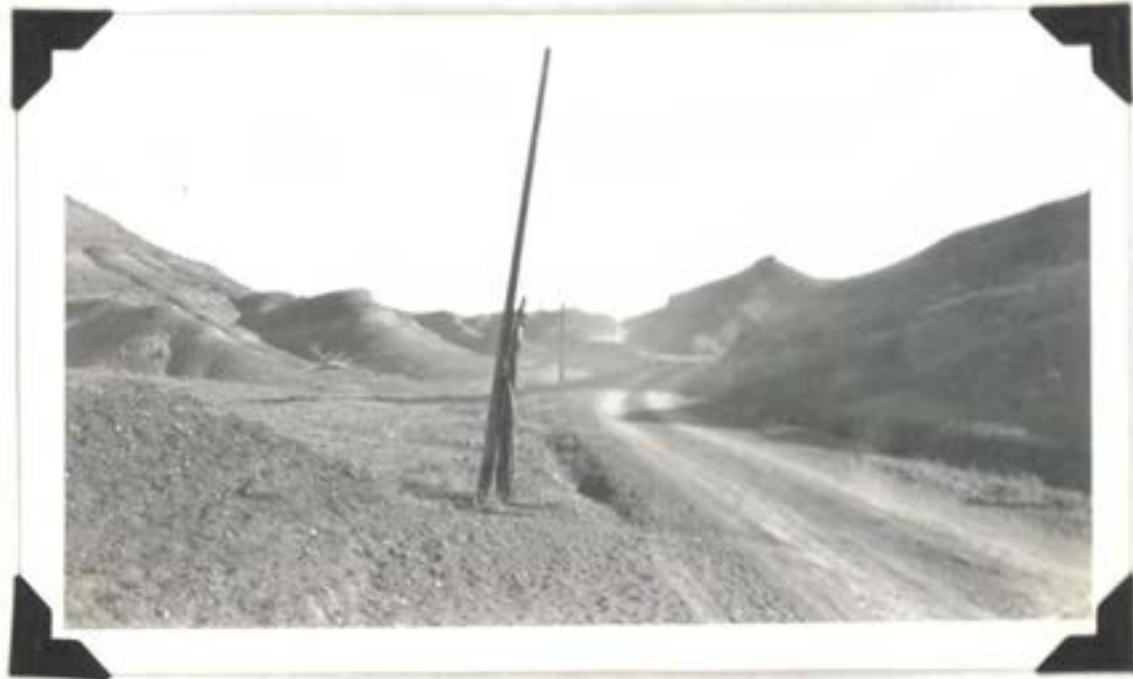
No.13 Looking South Capitol Wash Road to Notom Near Fruita

Figure 2. Photograph of Scenic Drive looking south from Fruita in 1938, from Huston, Report on Roads.

photographs depicting the conditions of Scenic Drive and Capitol Gorge Road, including a bridge over the Fremont River and the Slick Rock Divide bridge (Figure 2). The bridges were built from several materials and techniques: the Fremont River bridge was constructed of wooden cribbing filled with rocks, whereas the Slick Rock Divide bridge features a large wall composed of squared, coursed sandstone blocks. The Slick Rock Divide bridge's materials and techniques appear very similar to those used in the following years by the CCC; this may indicate that some culverts presumed to have been built by the WPA or CCC predate the Public Works Era.

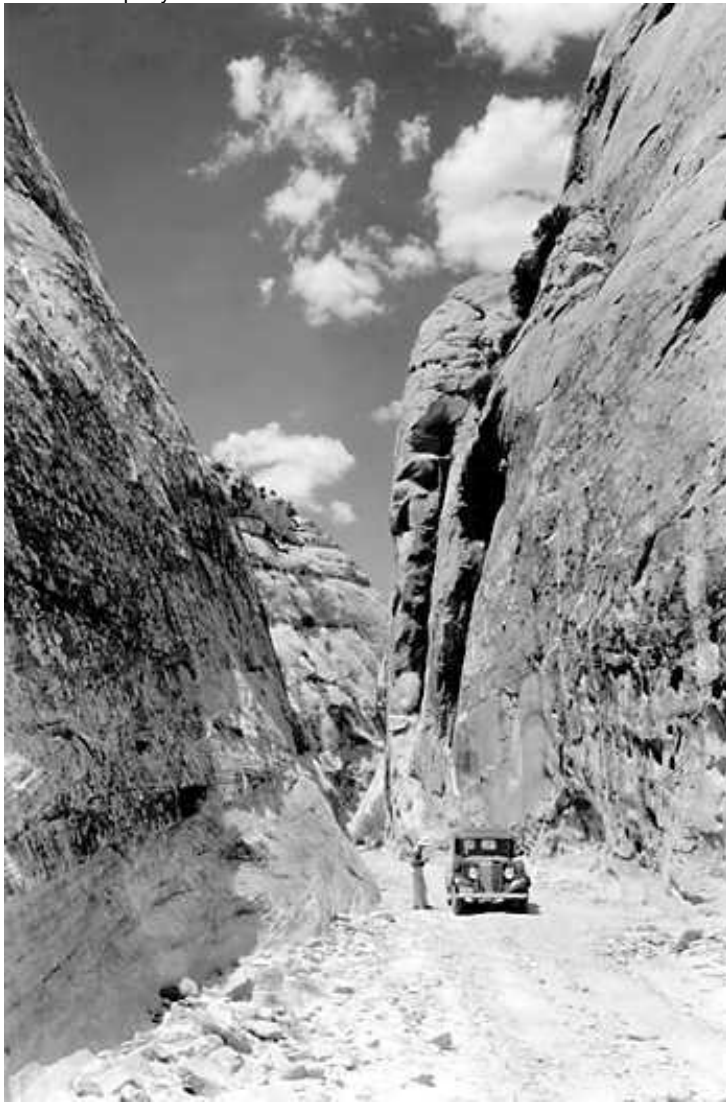
Figure 3. Photograph of Capitol Gorge Road in 1938, from Huston, Report on Roads.

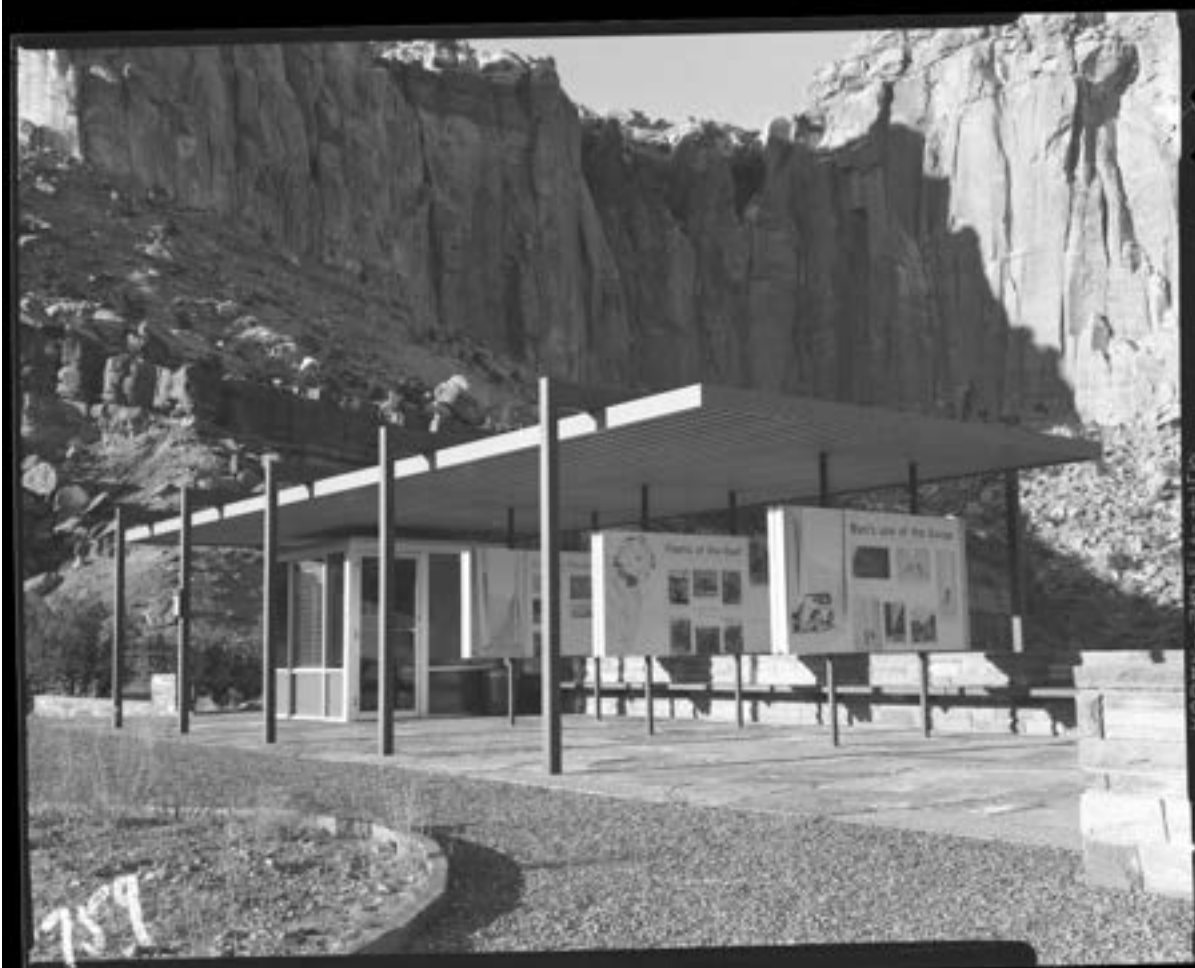
Figure 8. The Upper Interpretive Shelter as it appeared shortly after completion in 1962. Note the interpretive panels and enclosed kiosk: both features are not extant.

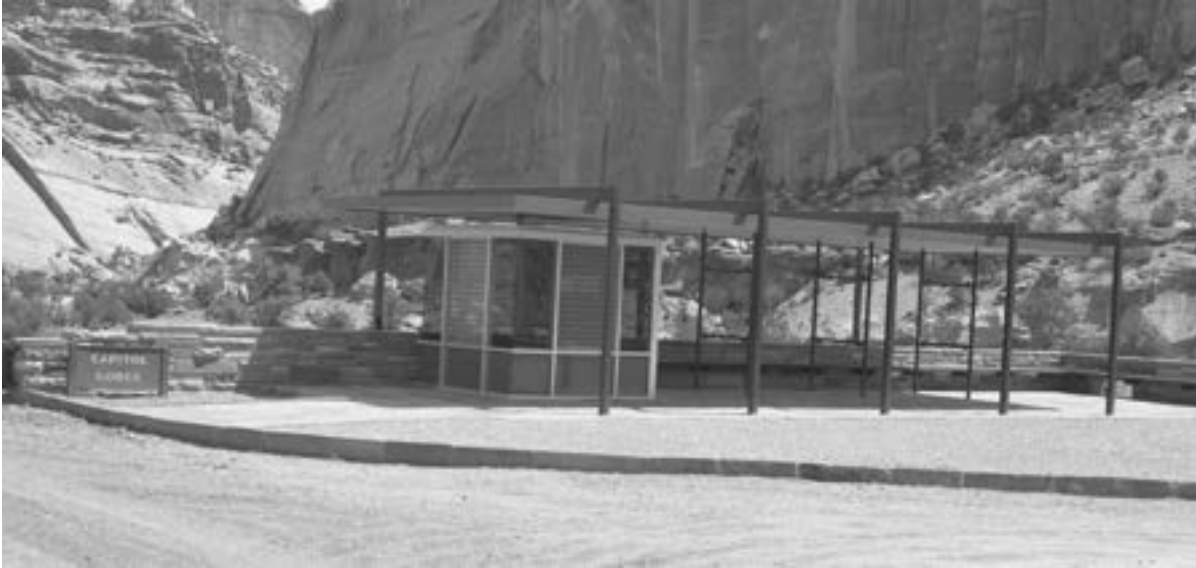
Figure 9. Original booth/kiosk at the Upper Interpretive Shelter at Capitol Gorge (Drawing 3028A; Image CARE 0475).

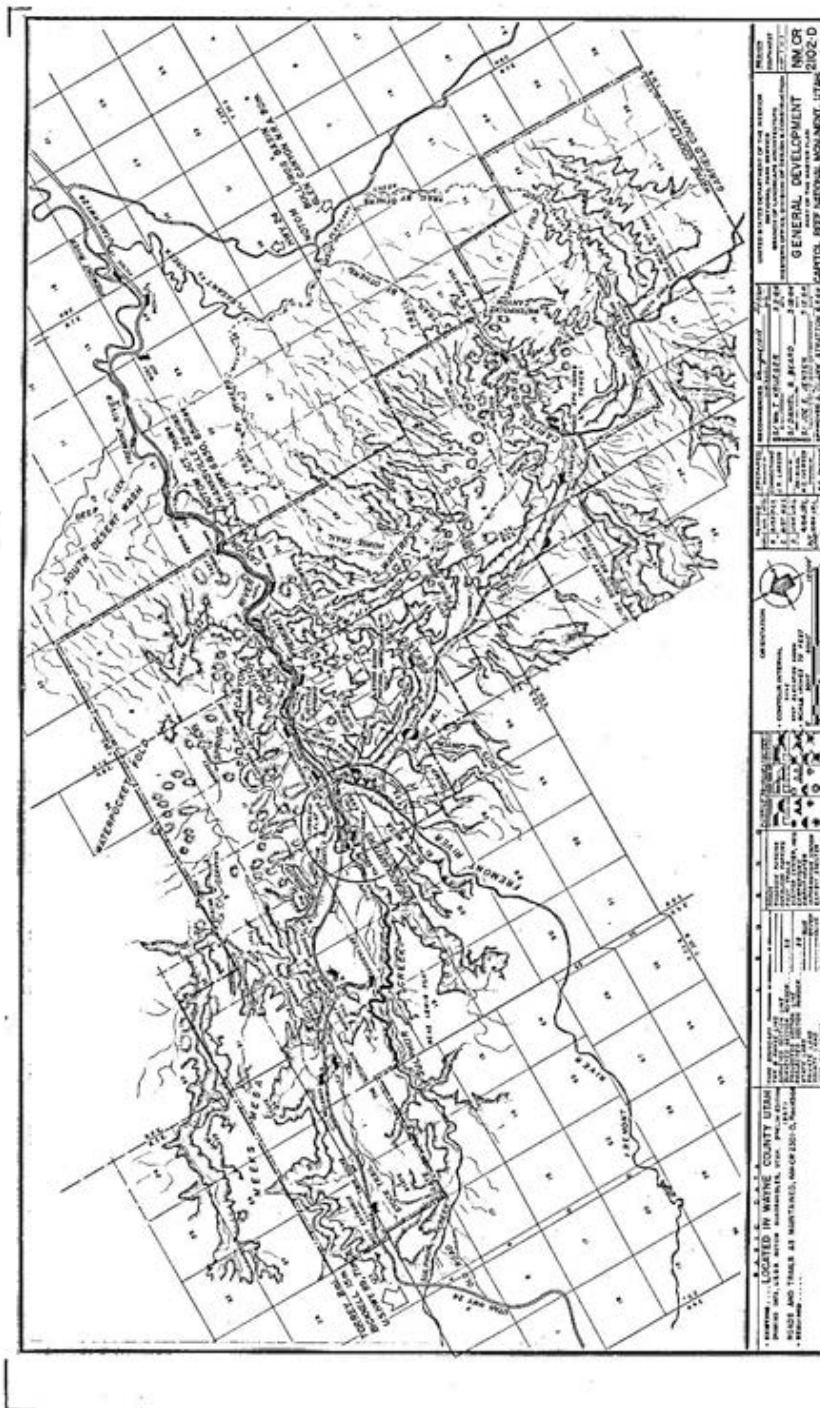
Figure 11. Map of roads and parking areas in 1964, Drawing NM-CR 2102D, June 1964, on file at the Technical Information Center, Denver.

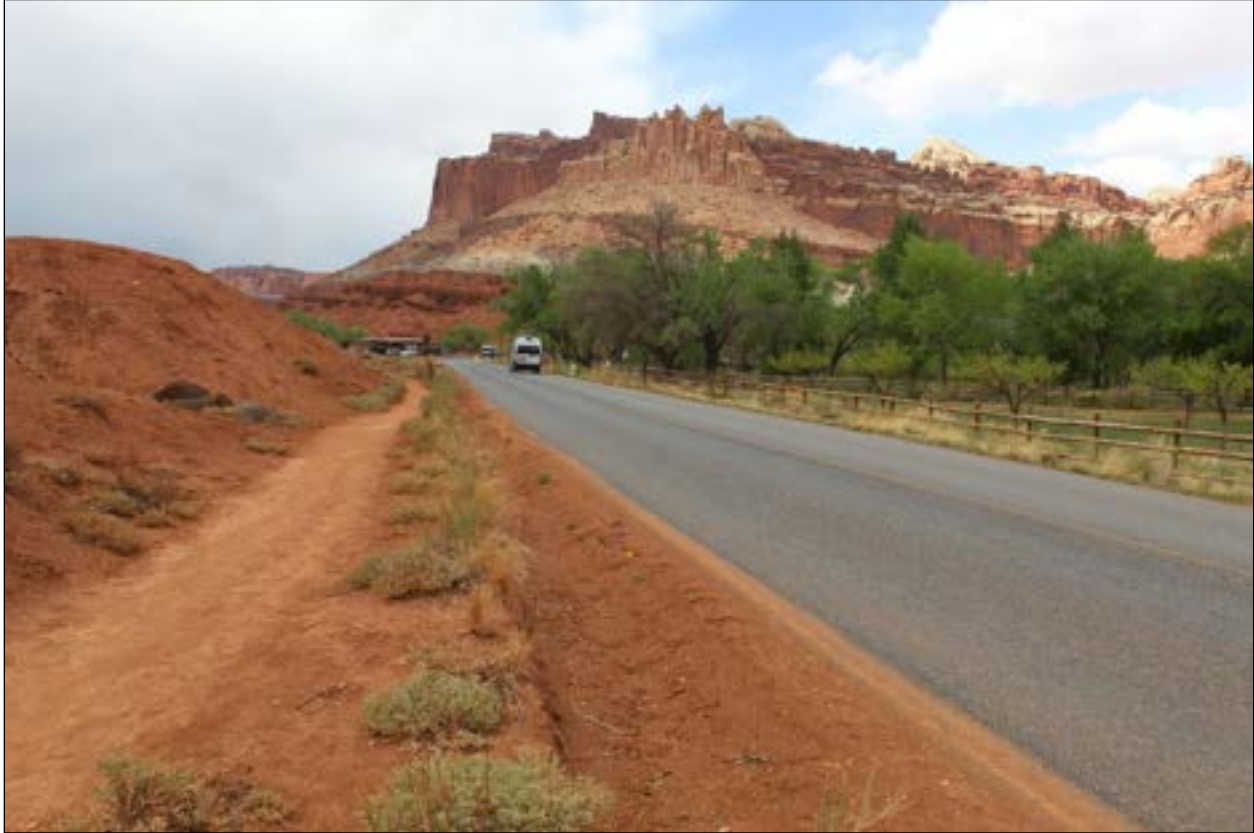
Photo 001. At its northern end, Scenic Drive passes through the Fruita Rural Historic District, where it is a two-lane, asphalt-paved road with a painted centerline. View to the north-northwest.

First established in 1883 as a wagon road (Blue Dugway), Scenic Drive is a 7.9-mi, two-lane, chip-seal-paved road that extends south from Utah SR-24 to a parking area at the beginning of Capitol Gorge Road. For its first 2 mi, Scenic Drive passes through the former community of Fruita, where the Visitor Center, Park headquarters, and staff residences stand. Through Fruita, Scenic Drive has been widened to 22 ft wide with two traffic lanes, divided by a painted double-yellow centerline (Photo 1). In this northern section, many asphalt-paved and unpaved roads branch off Scenic Drive and continue outside the district boundary; these provide visitor and staff access to Park buildings and other points of interest. Scenic Drive widens near the Visitor Center to provide parallel parking on both sides of the road. The road also widens near the Ripple Rock Nature Center and Picnic Area to provide three parallel parking spaces and six parking spaces on the north side of Scenic Drive.

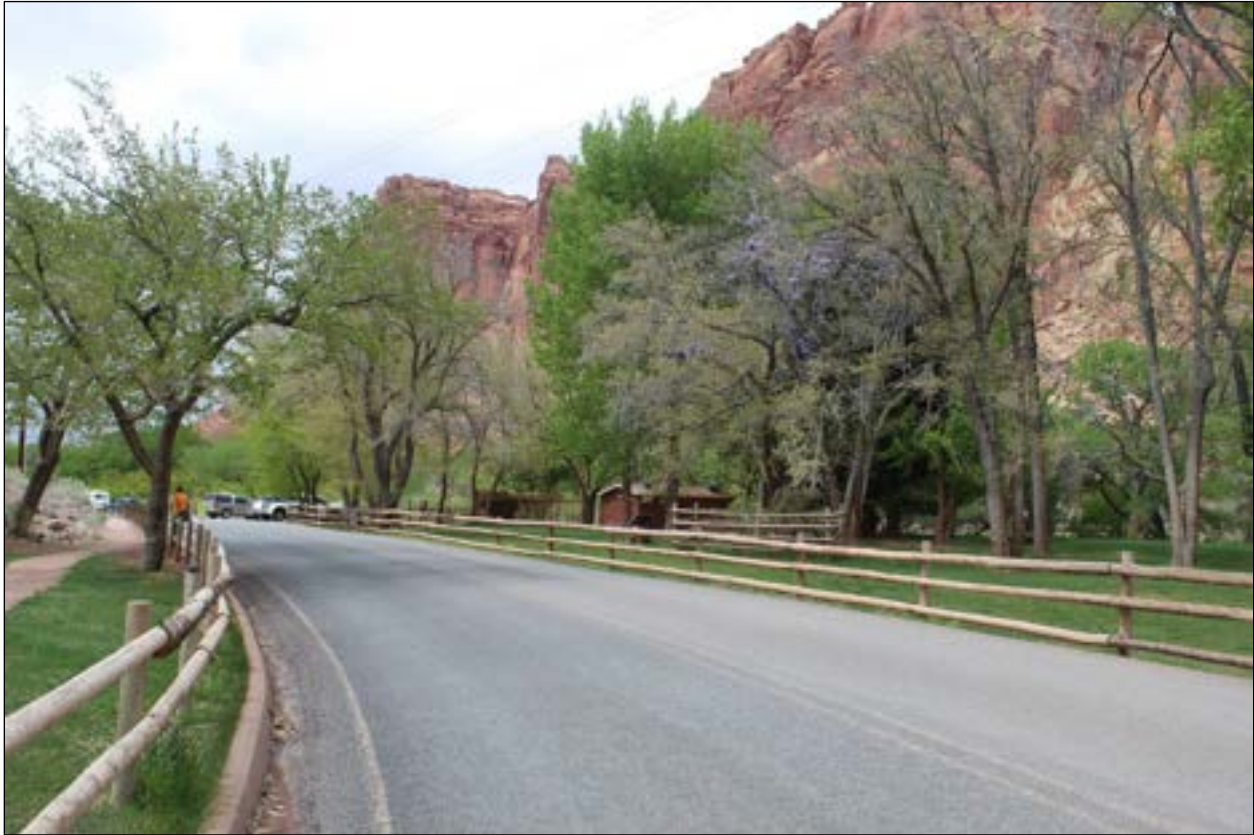
Photo 002. South of the Merin Smith Implement Shed, the road widens slightly and includes an asphalt-paved shoulder and a concrete curb. View to the northwest.

South of the Merin Smith Implement Shed, the road widens slightly to 25 ft to provide a narrow, asphalt-paved shoulder on the southern side, providing additional space between the traffic lane and a footpath. This section of Scenic Drive is also lined with a concrete curb on its southern side, and both the shoulder and curb continue to the water treatment plant (Photo 2). Immediately south of the water treatment plant, Scenic Drive crosses the Fremont River via the Fremont River Bridge. The road winds south and east towards the Gifford Barn, where the southern shoulder widens to provide a few parallel parking spaces.

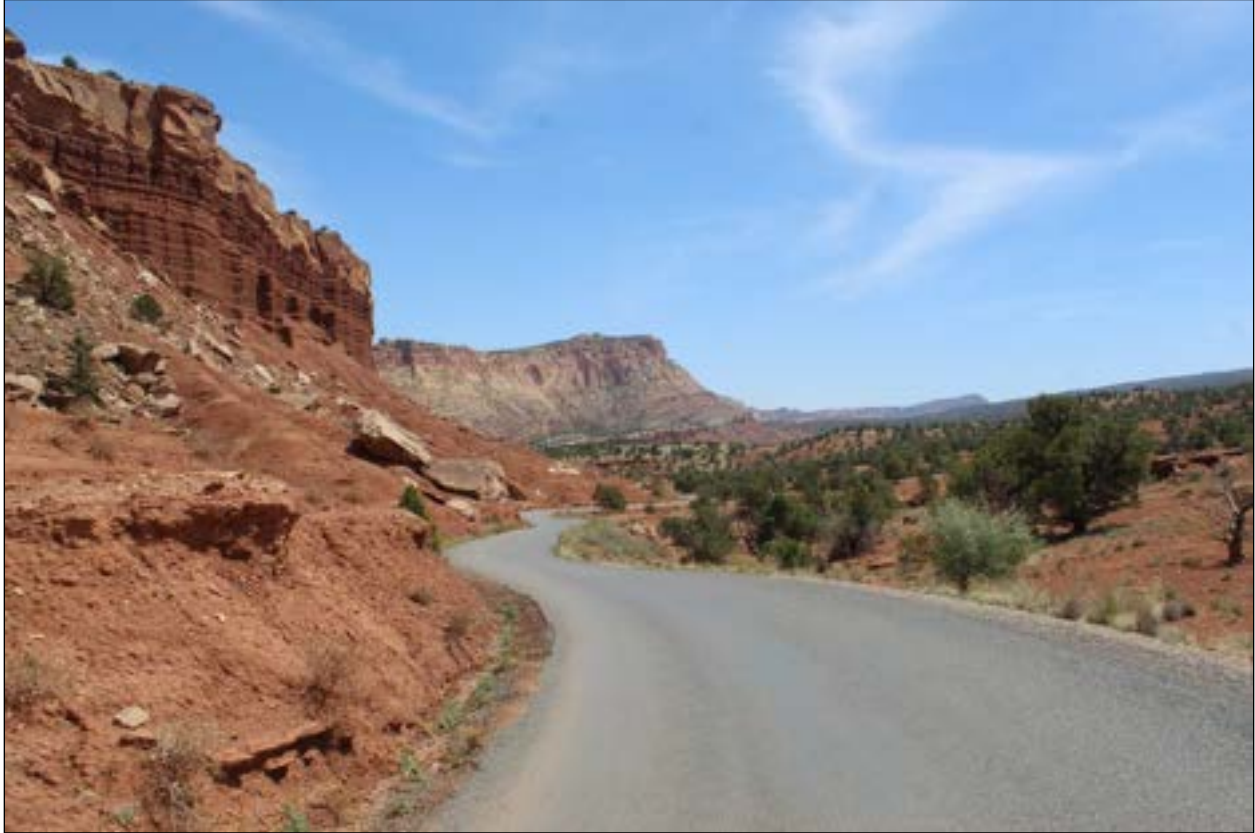
Photo 003. Past Fruita and a roadside fee station, Scenic Drive narrows and has no painted centerline. It continues to wind south along the western side of the Waterpocket Fold. View to the south.

Approximately 1.6 mi south of Utah SR-24 and just south of the Fruita Campground, Scenic Drive widens to form a one-way pullout on the west side of the road. A fee station and a wayside exhibit stand are at the southern end of the pullout. As Scenic Drive continues south of the kiosk and Boneyard Road, the road narrows to 20 ft with no painted centerline (Photo 3). The road is crowned in the center, and ditches line the sides of the road in many areas, directing water towards the washes. Eight asphalt-paved pullouts stand along Scenic Drive and numerous unpaved, visitor-created parking pullouts. Scenic Drive winds to the south and east for 6.3 mi past the kiosk before reaching an asphalt-paved parking area with a vault toilet and an interpretive shelter. Past the shelter, the road is named Capitol Gorge Road.

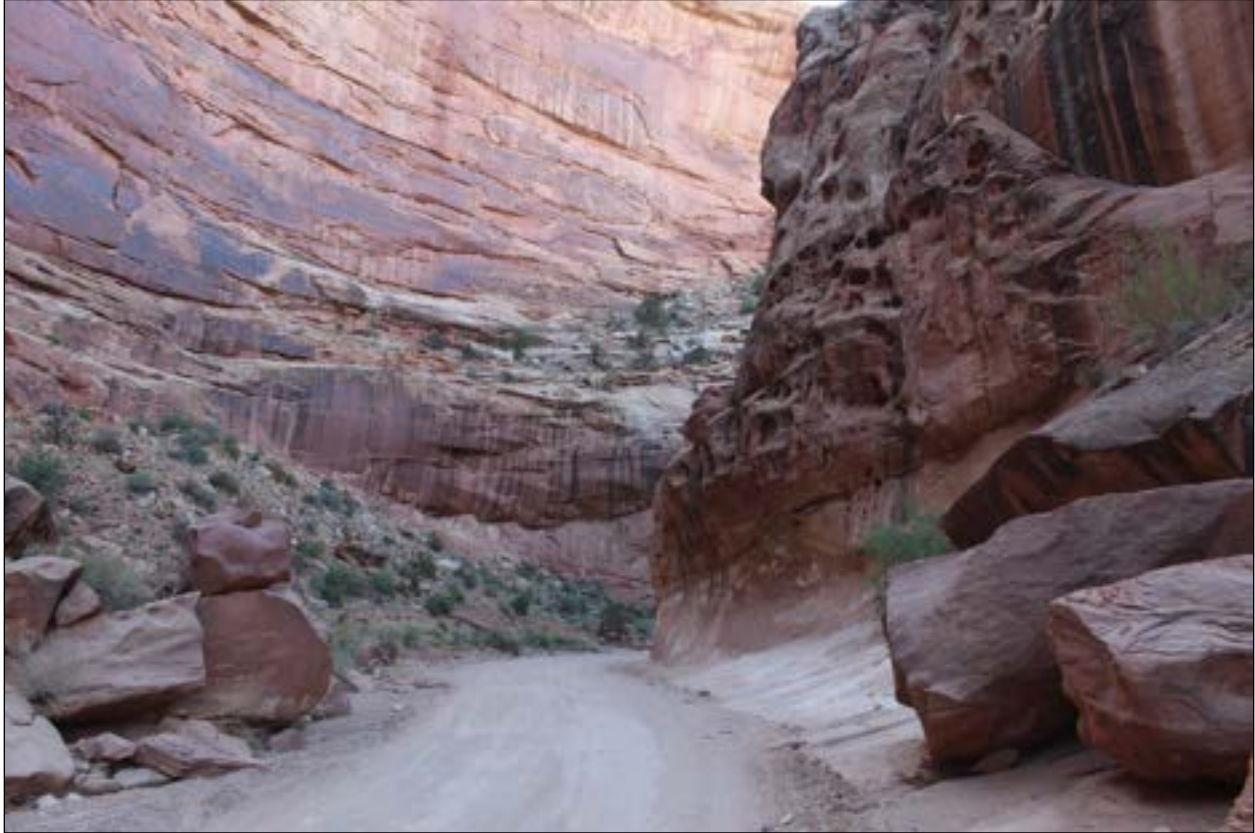
Photo 004. Capitol Gorge Road is a narrow, unpaved, graded road that travels through the narrow Capitol Gorge, with cliffs rising hundreds of feet above the road. View to the southeast.

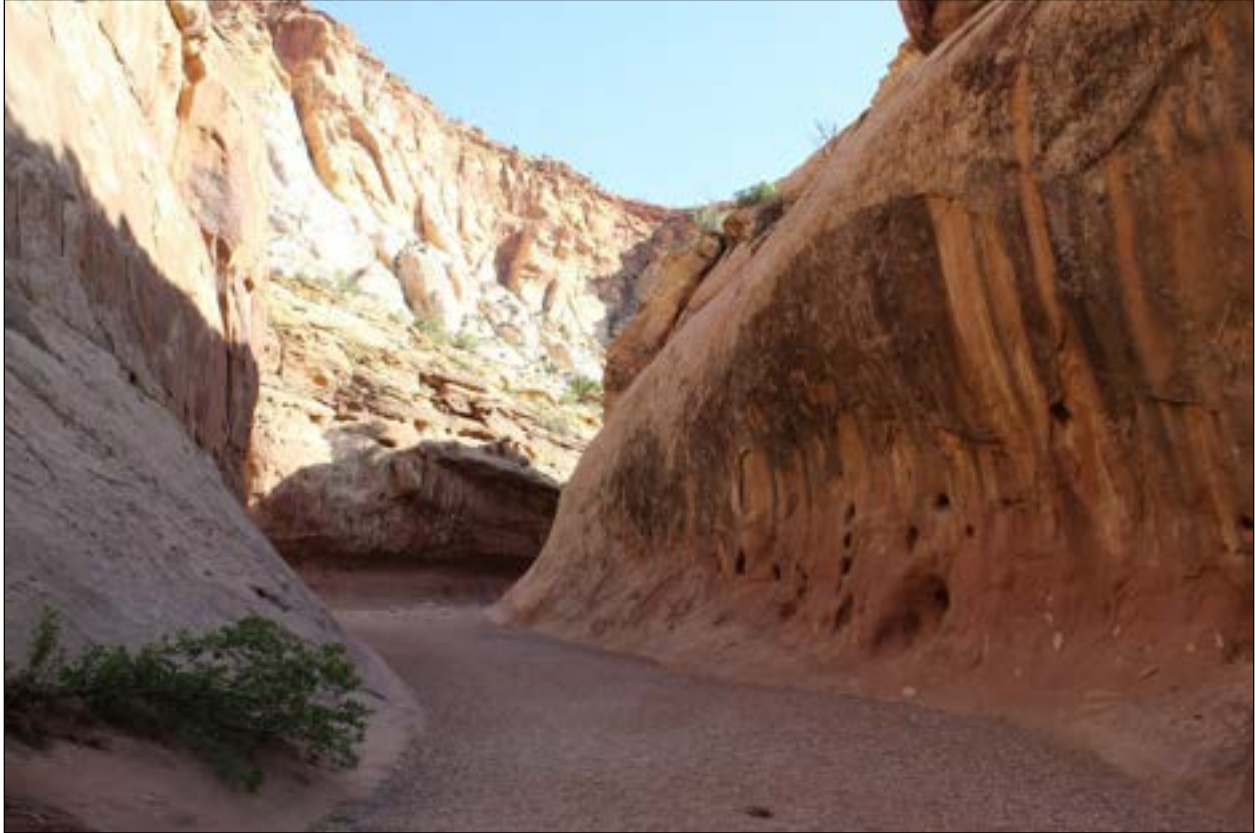
Photo 005. Capitol Gorge Trail follows the alignment of the former Blue Dugway and Utah SR-24 to the Park's eastern boundary. View to the east.

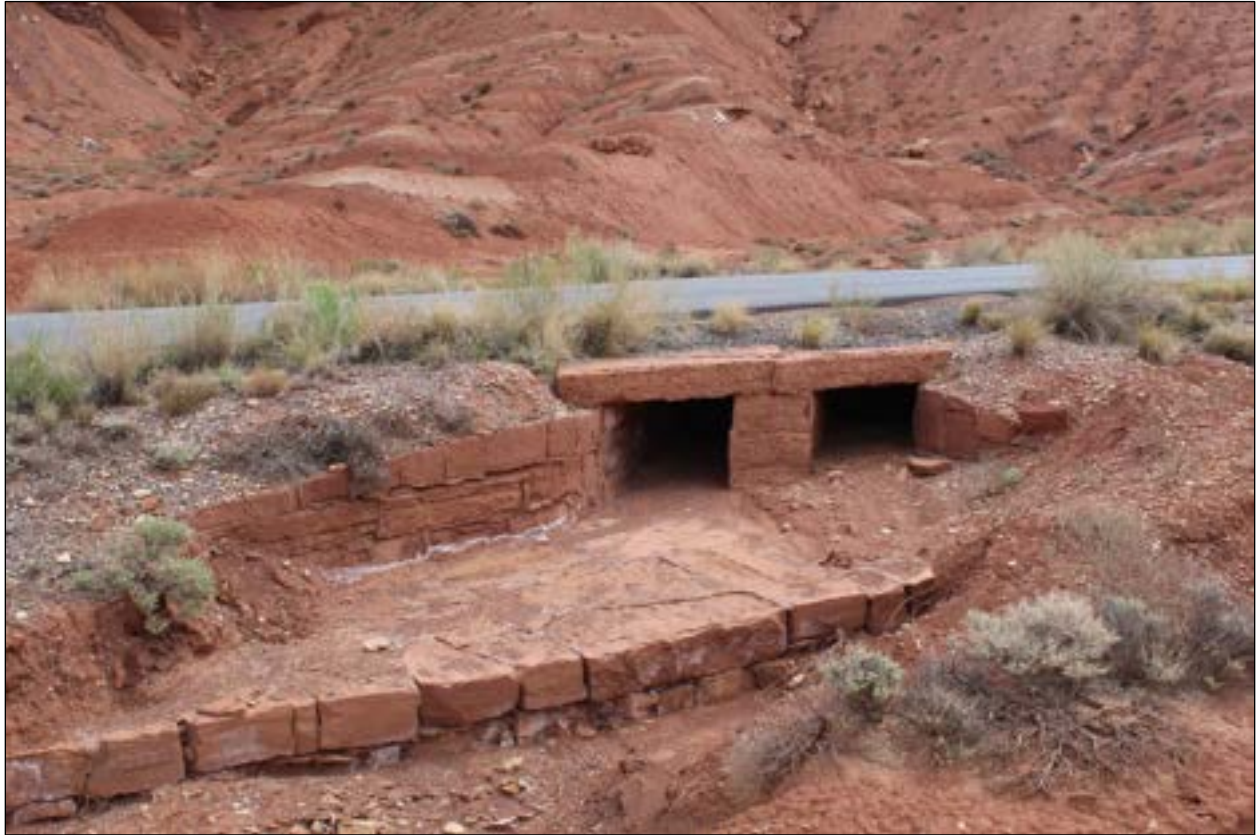
Photo 007. The CCC-constructed culvert at milepost 2.26 has a double box culvert with sandstone inlet and outlet basins. The culverts feature large, coursed, squared sandstone blocks. View to the east-southeast.

The nine CCC/WPA culverts retain integrity of location, design, setting, materials, workmanship, feeling, and association. Any repairs have used in-kind or compatible materials. These nine culverts, particularly the box culverts, represent a distinctive design and illustrate the workmanship of the CCC/WPA by using large, squared, coursed sandstone blocks likely found on site and shaped with hand tools. All nine are considered contributing to the district.

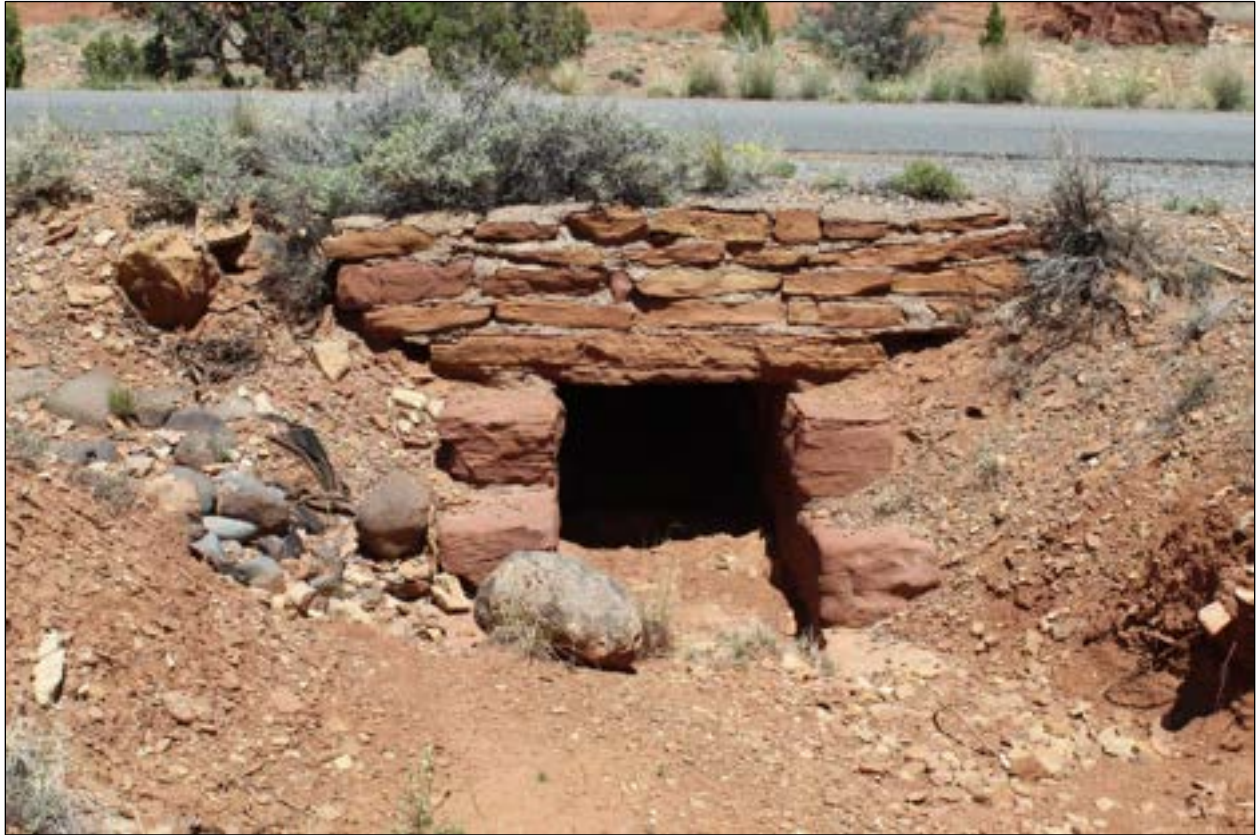
Photo 008. Some culverts appear to have been originally built during the WPA era but rebuilt during the Mission 66 era, such as this one at milepost 3.30. Its headwall's lower courses are large, squared sandstone blocks characteristic of the CCC and WPA work, whereas the upper courses are smaller and more roughly squared, indicative of Mission 66 construction. View to the east.

headwalls; the large sandstone blocks appear very similar to the blocks used to construct the box culverts known to have been built by the CCC/WPA. Stonework built during the Mission 66 era also used sandstone blocks, but these blocks were not as carefully squared and coursed, and the blocks were generally smaller than those used during the WPA era. The culverts at mileposts 3.30 and 6.63 have boxed inlets that also use the same materials and construction methods as those found at mileposts 2.26 and 3.38. However, the upper courses of stonework are Mission 66 in design and materials (Photo 8).

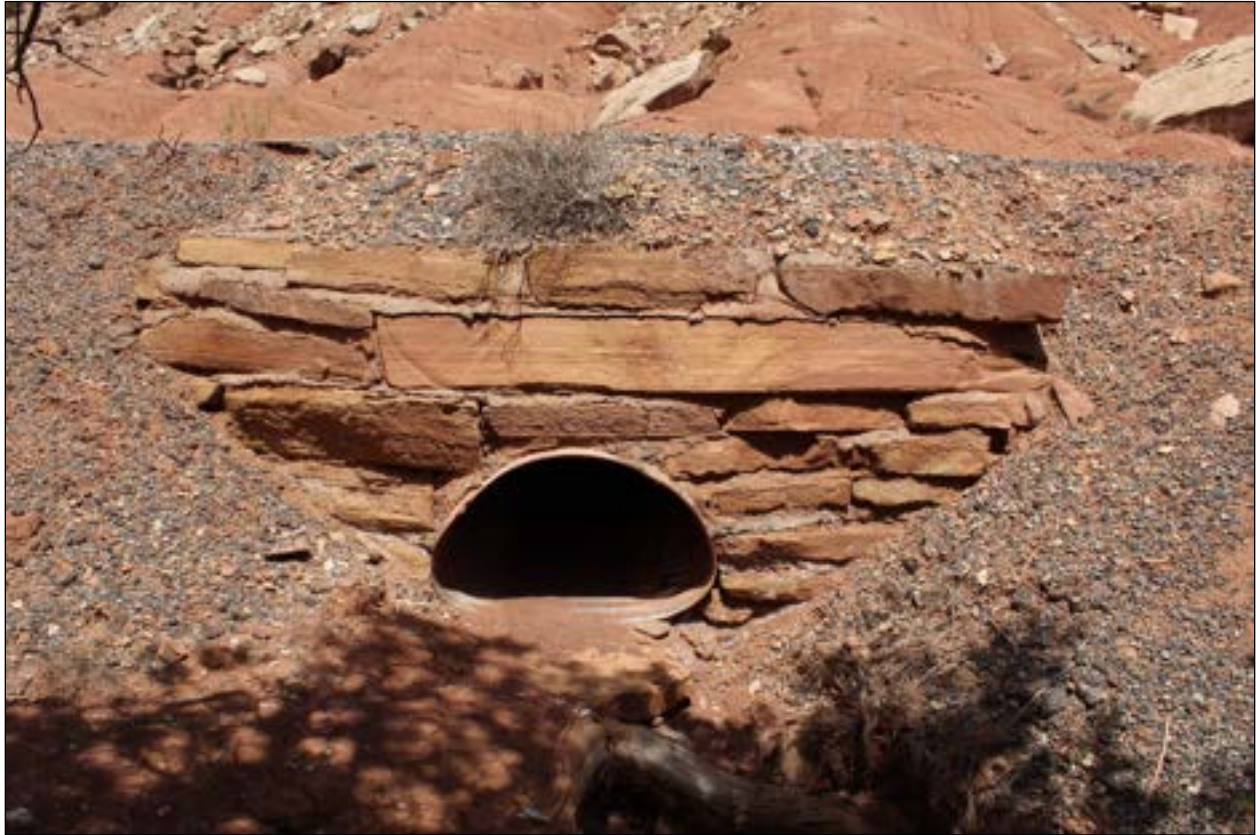
Photo 009. Culverts built during the Mission 66 era feature headwalls with roughly squared and coursed sandstone blocks, all of which are smaller than the blocks used by the CCC/WPA. View to the east of the culvert at milepost 6.75.

The 21 Mission 66 era culverts are considered contributing to the district. Three culverts, at mileposts 5.56, 6.53, and 7.64, have lost integrity due to the replacement of their concrete headwalls in 1999. No alterations have been made to the remaining culverts since the end of the period of significance, and any repairs have used in-kind or compatible materials. Therefore, these culverts retain integrity of location, design, setting, materials, workmanship, feeling, and association.

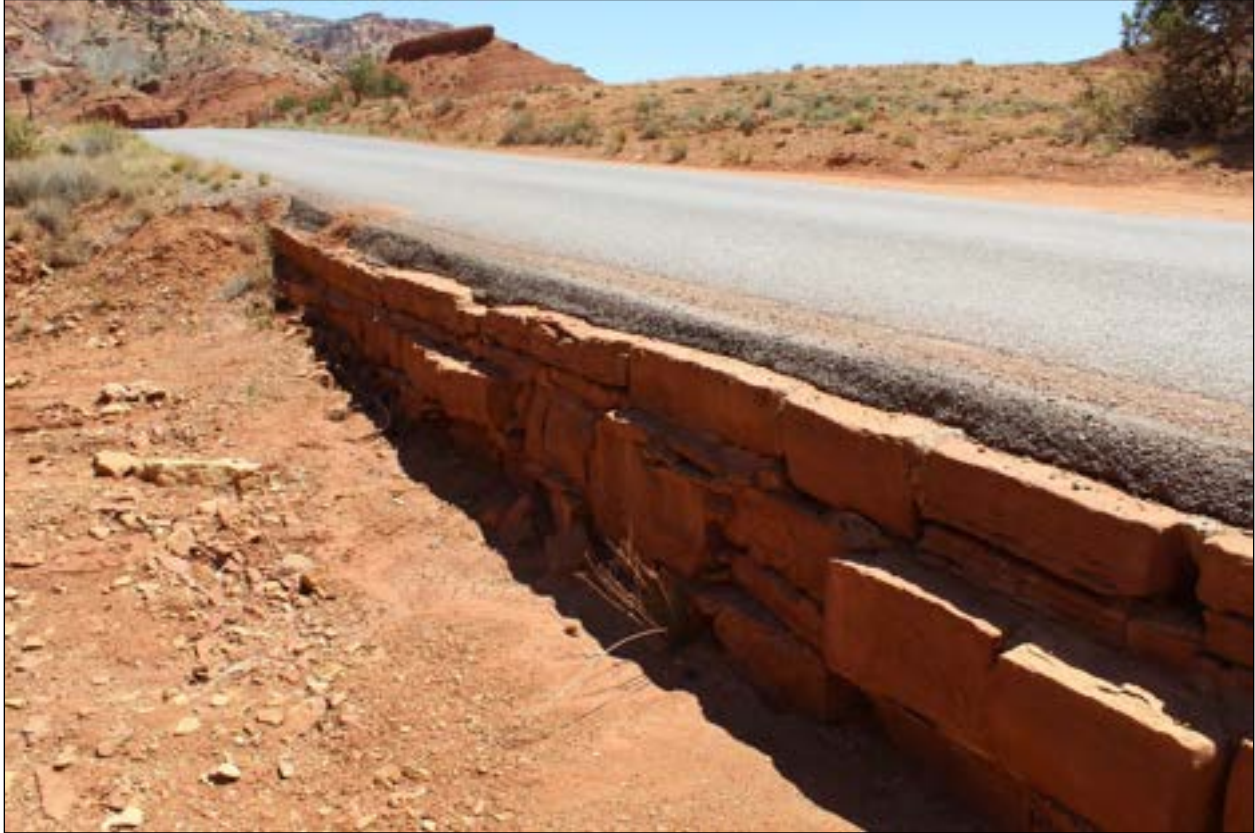
Photo 010. Three low-water crossings along Scenic Drive were likely built by the CCC or WPA. These crossings are constructed of large, squared sandstone blocks similar to those used for the box culverts and culvert headwalls. View to the southwest of the low-water crossing at milepost 3.33.

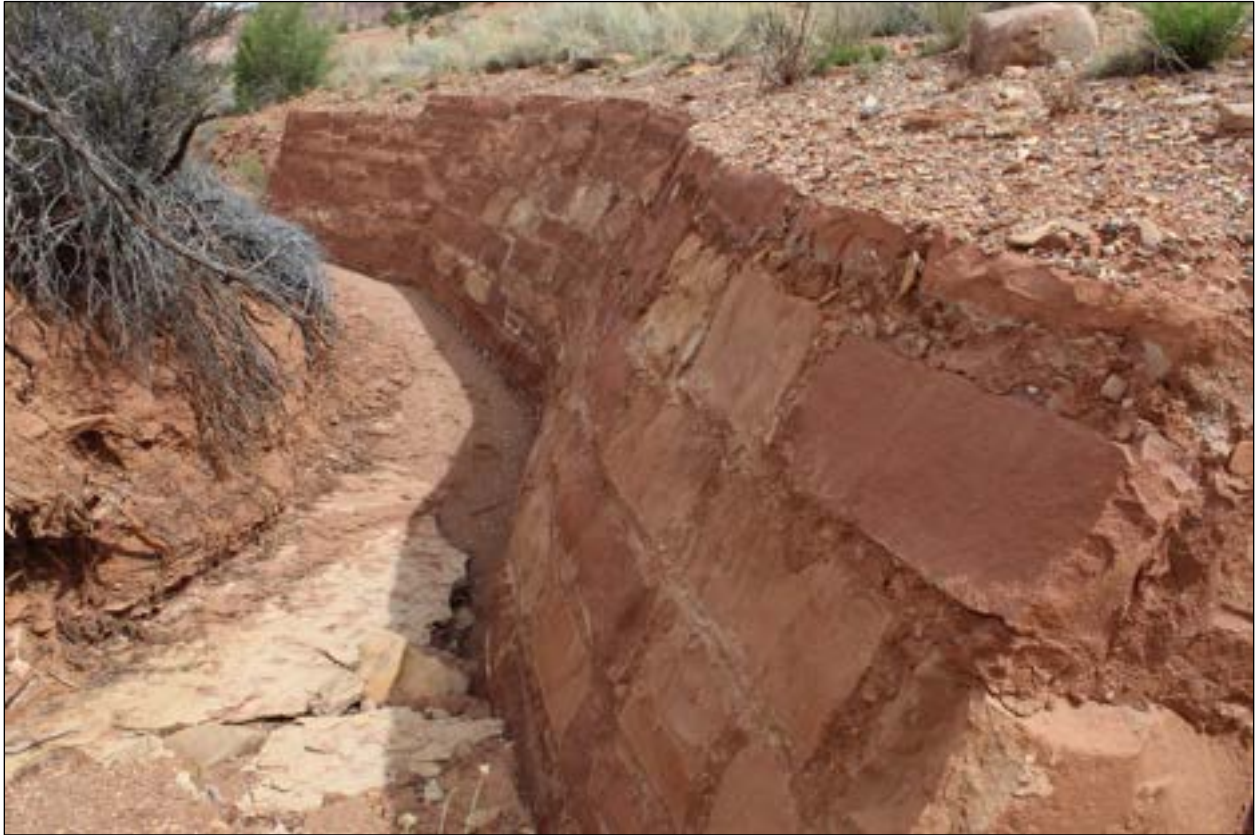
Photo 011. Four sandstone retaining walls that line Scenic Drive were built in 2010-2011 as part of the rock embankment project. View to the northeast of the retaining wall at milepost 5.69.

There are five sandstone block retaining wall segments that line Scenic Drive. Four sandstone retaining walls were constructed as part of the 2010-2011 improvement project and were designed to assist with embankment protection and erosion control. These walls are found at mileposts 2.19, 4.10, 5.62, and 5.69. These walls are typically six courses with raked joints and concrete foundations set below grade and reinforced with rebar. The walls are angled towards the roadway and backfilled with dirt. They vary greatly in length, from 40 to 260 ft long, but each is about 2 ft thick. The stone used was locally sourced and is visually compatible with other rock wall features throughout Scenic Drive. The fifth retaining wall, at milepost 5.71, uses the same materials and construction materials used for the culvert headwalls during the Mission 66 era. This wall was likely built in 1966 when Park maintenance crews also built culverts in the same area using the same materials. The northern portion of the wall appears to have been constructed or rebuilt during the 2010-2011 project.

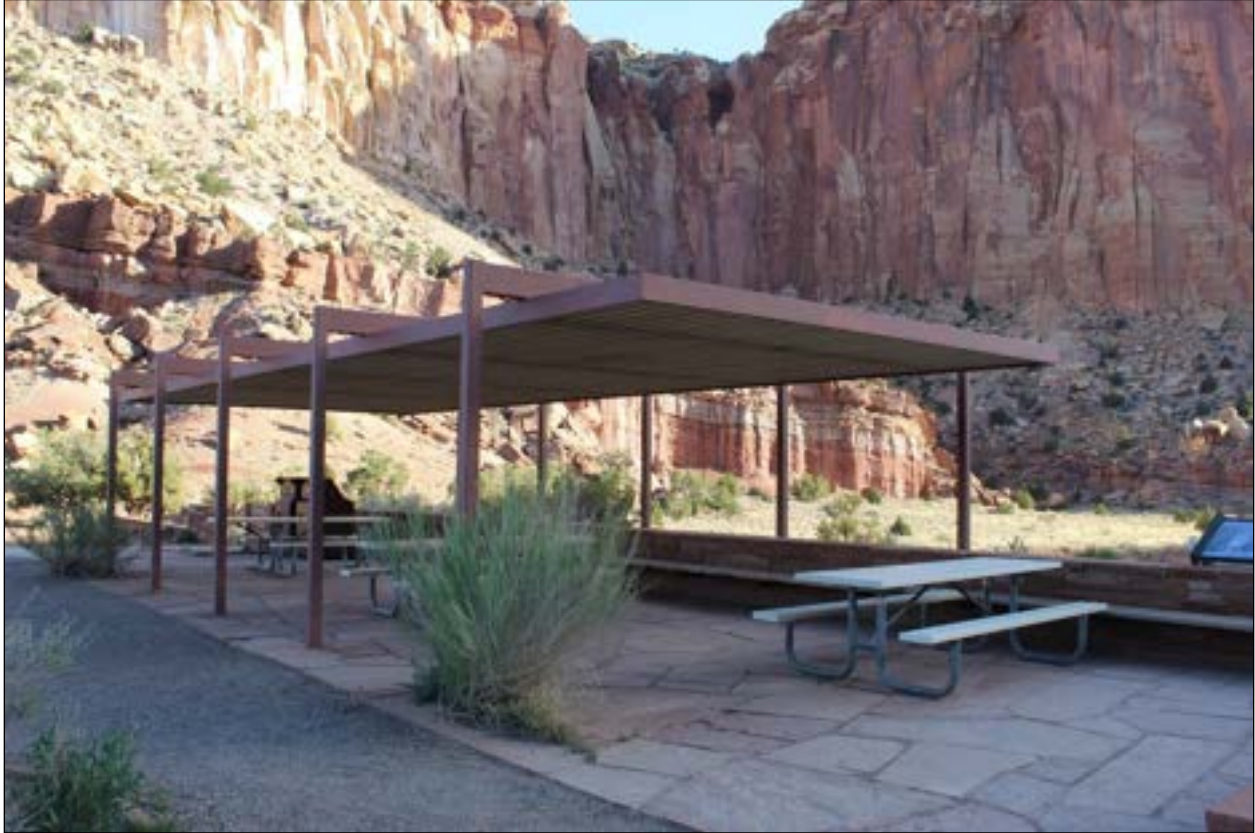
Photo 012. The Park Service Modern-style Upper Interpretive Shelter stands near the entrance to Capitol Gorge and was built in 1963. View to the northeast.

Both interpretive shelters have an associated parking area and vault toilet, which are discussed in further detail below, as well as associated landscaping. The Upper Interpretive Shelter comprises of five evenly spaced sets of posts and beams composed of square steel tubes (Photo 12). A flat, steel roof is attached to the underside of the beams and has a corrugated metal ceiling. Open on all four sides, the interpretive shelter stands on a concrete foundation capped with a sandstone slab patio. The shelter has a low, uncoursed sandstone block wall that extends across the eastern and southern sides of the shelter. The wall continues from the north end of the shelter to Capitol Gorge Road, where a shorter section also stands on the north side of the road; the set of metal

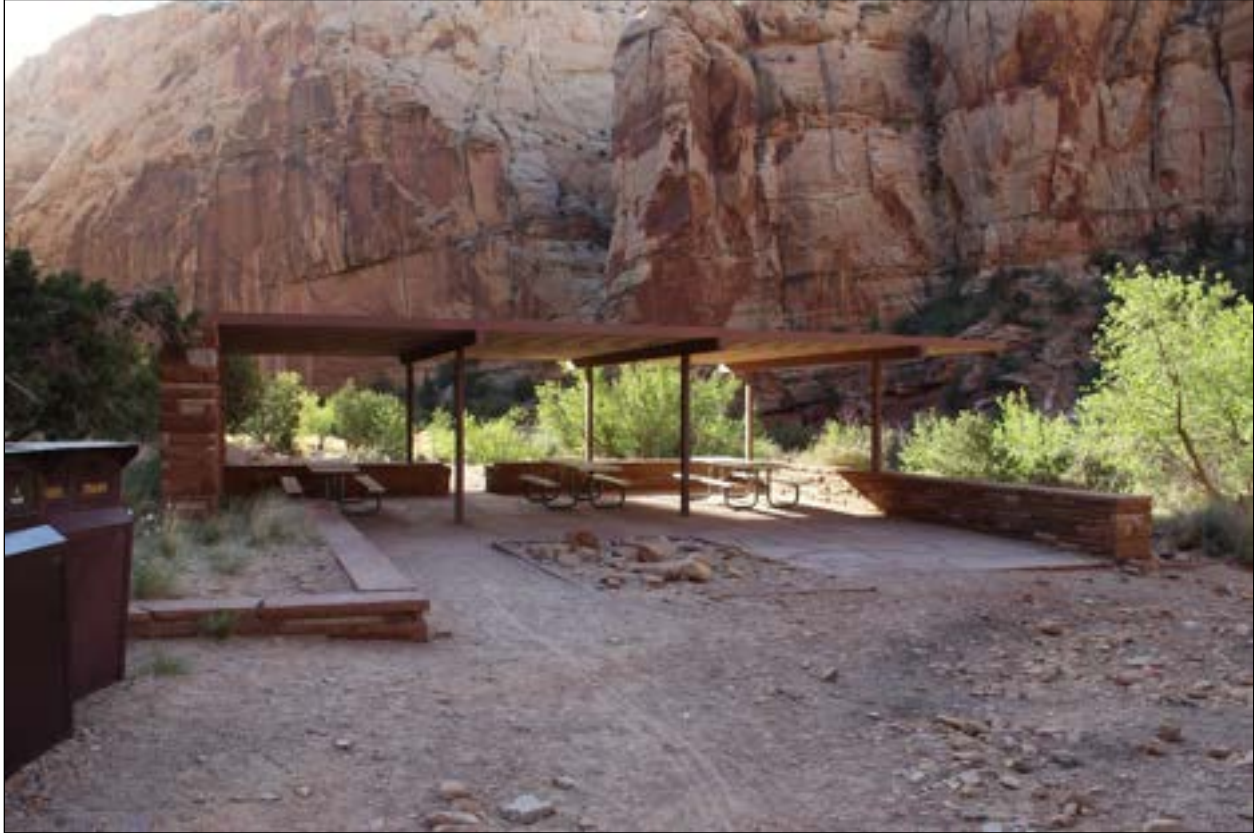
Photo 013. Two mi into Capitol Gorge, the Park Service Modern-style Lower Interpretive Shelter provides access to the Capitol Gorge Trail. View to the east-southeast.

The Lower Interpretive Shelter has three post and lintel support beams, and an uncoursed sandstone block wall at the northern end that supports a flat steel roof with a corrugated metal ceiling (Photo 13). A low, uncoursed sandstone block wall extends across the shelter's south and east sides. The shelter's southernmost posts are anchored in this wall, whereas the middle support structures have one post anchored in the wall and one in the patio. Like the Upper Interpretive Shelter, the patio has a concrete foundation with sandstone slabs. A small opening was cut into the eastern wall sometime after the original construction to provide access to the Capitol Gorge Trail. Both interpretive shelters also have small, low landscaping beds encircled by sandstone blocks filled with native vegetation and rock.

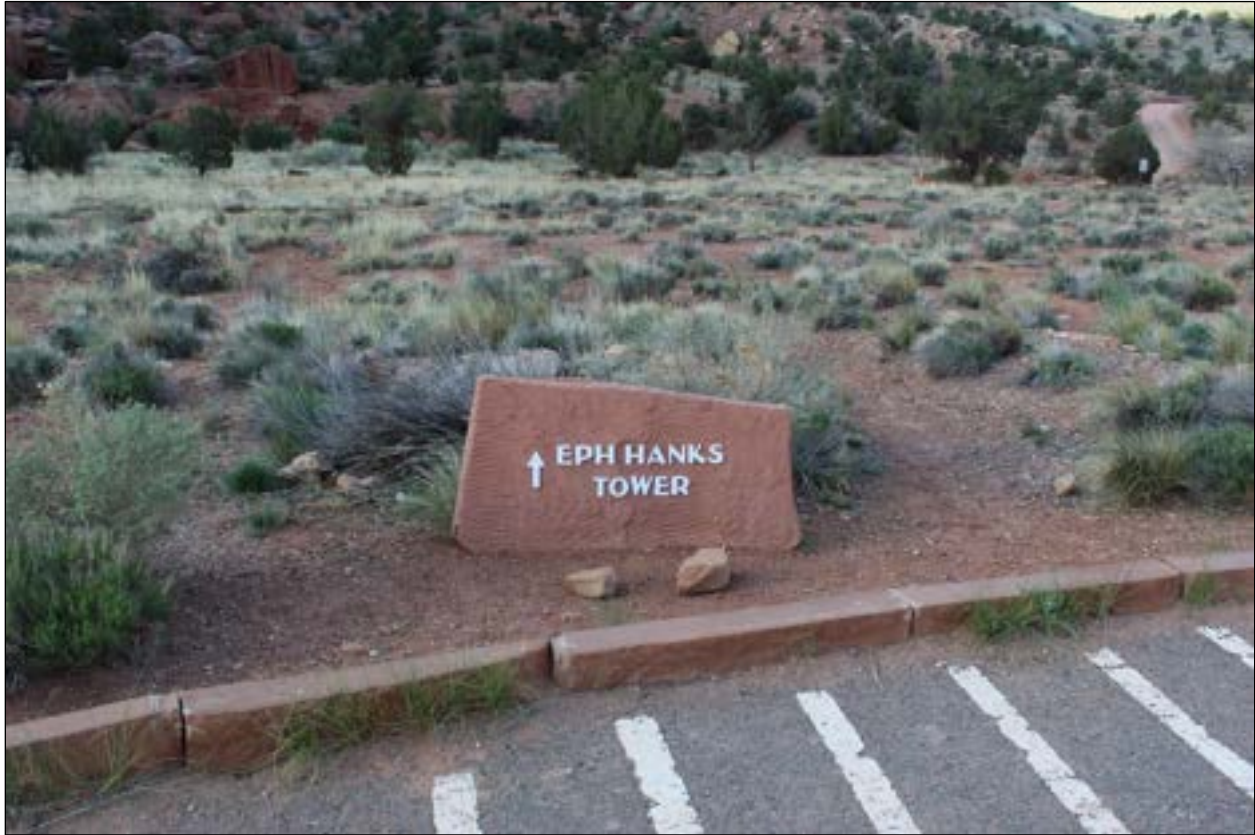
Photo 014. Nine sandstone signs stand alongside Scenic Drive and were installed during the Mission 66 era, such as this one indicating the Ephraim Hanks Tower geological feature near the Upper Interpretive Shelter in Capitol Gorge. View to the south.

Nine sandstone signs stand alongside Scenic Drive and indicate points of interest and warnings regarding potential flooding in the washes (Photo 14). Each consists of a large sandstone slab with lettering affixed to one side of the slab that has been tool finished; the other side is roughly finished. Two signs near Grand Wash also have ashlar foundations. The signs were planned and developed between 1957 and 1964 as part of the Park's Mission 66 improvements. All nine signs are considered contributing to the district and retain integrity of location, design, setting, materials, workmanship, feeling, and association.
