United States Department of the Interior
National Park Service**National Register of Historic Places Registration Form**

1. Name of PropertyHistoric name: Scenic Drive and Capitol Gorge Historic DistrictOther names/site number: Capitol Gorge Road, Capitol Gorge Trail, Capitol Gorge Highway, Reef Road, Monument Road, Route 10, Utah State Route 24, and Blue Dugway

2. LocationStreet & number: N/A; Capitol Reef National ParkCity or town: Torrey State: Utah County: WayneNot For Publication: ☐ Vicinity: ☒**3. State/Federal Agency Certification**

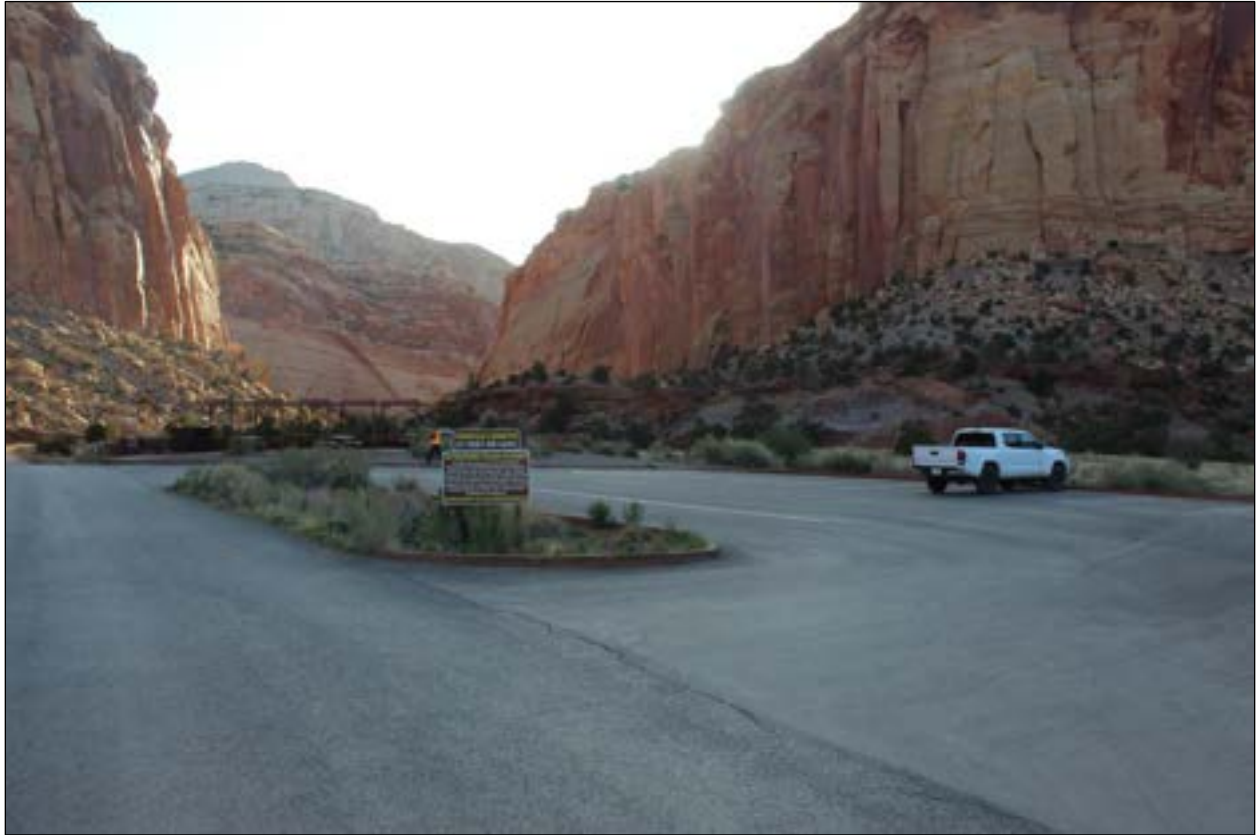
Photo 015. The Mission 66 era parking area associated with the Upper Interpretive Shelter has lost integrity of materials and workmanship as a result of paving in 2010 but retains integrity of location, setting, design, feeling, and association. View to the northeast.

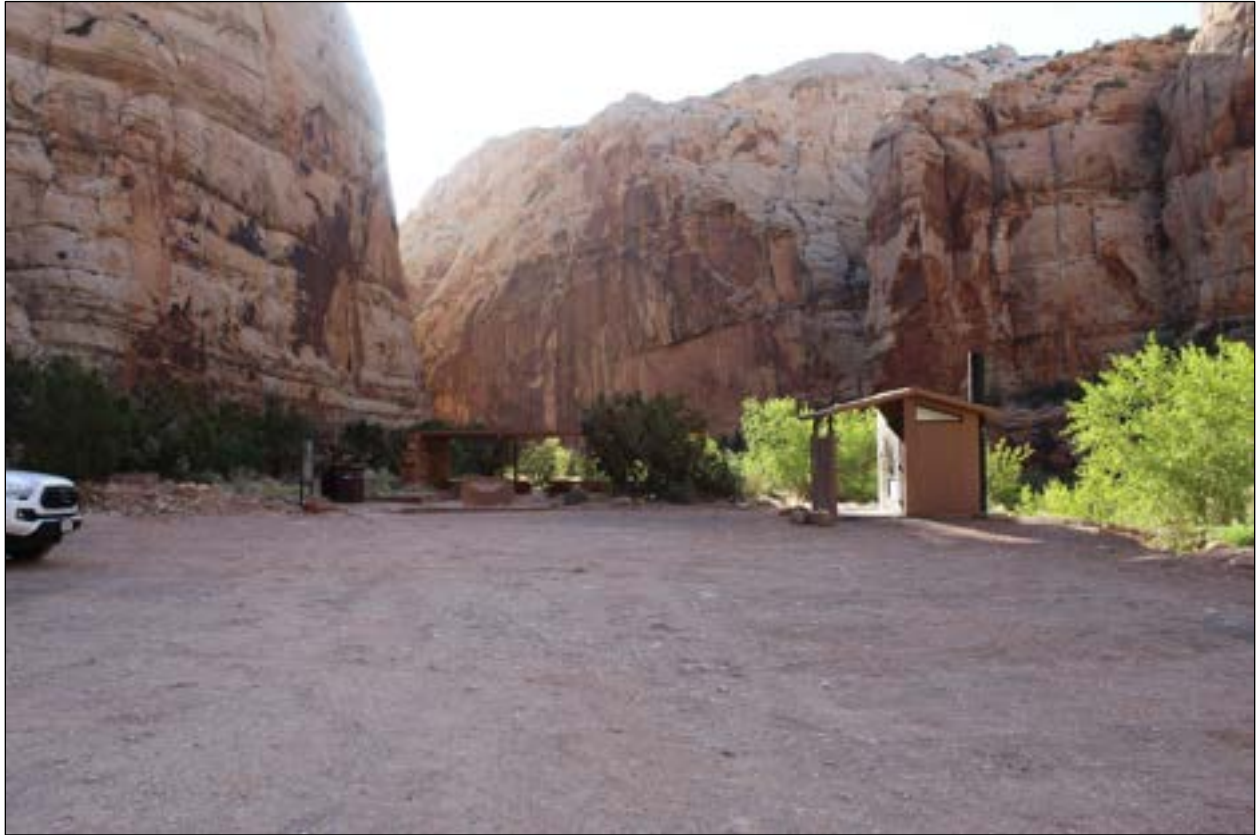
Photo 016. The Mission 66 era parking area associated with the Lower Interpretive Shelter retains integrity of location, setting, materials, feeling, and association. View to the east.

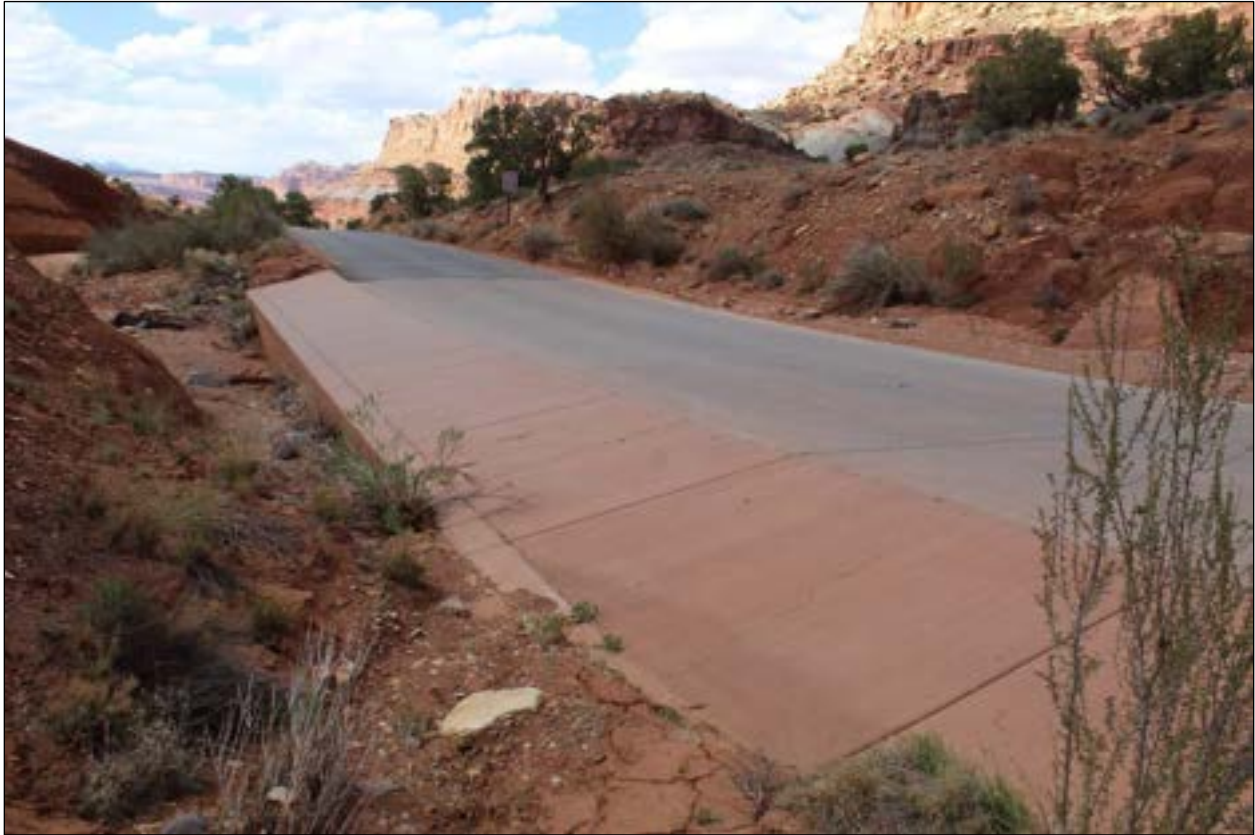
Photo 017. Thirteen low-water crossings were constructed on Scenic Drive after the period of significance and are non-contributing to the district, such as this one near milepost 4.26. View to the northeast.

Thirteen low-water crossings were constructed on Scenic Drive after the period of significance. All 13 are poured concrete slabs with sloping sides to direct water across the road and through the washes (Photo 17). Seven were installed in 1983, three in 1997, and three in 2010. Because they were built after the period of significance, they are considered non-contributing. However, they are considered compatible with the district. Although concrete was not used during the period of significance except for foundations, the long-lasting material is necessary to prevent additional roadbed erosion in the washes. Further, the low-water crossings' lengths represent a very small percentage of the road's total length.

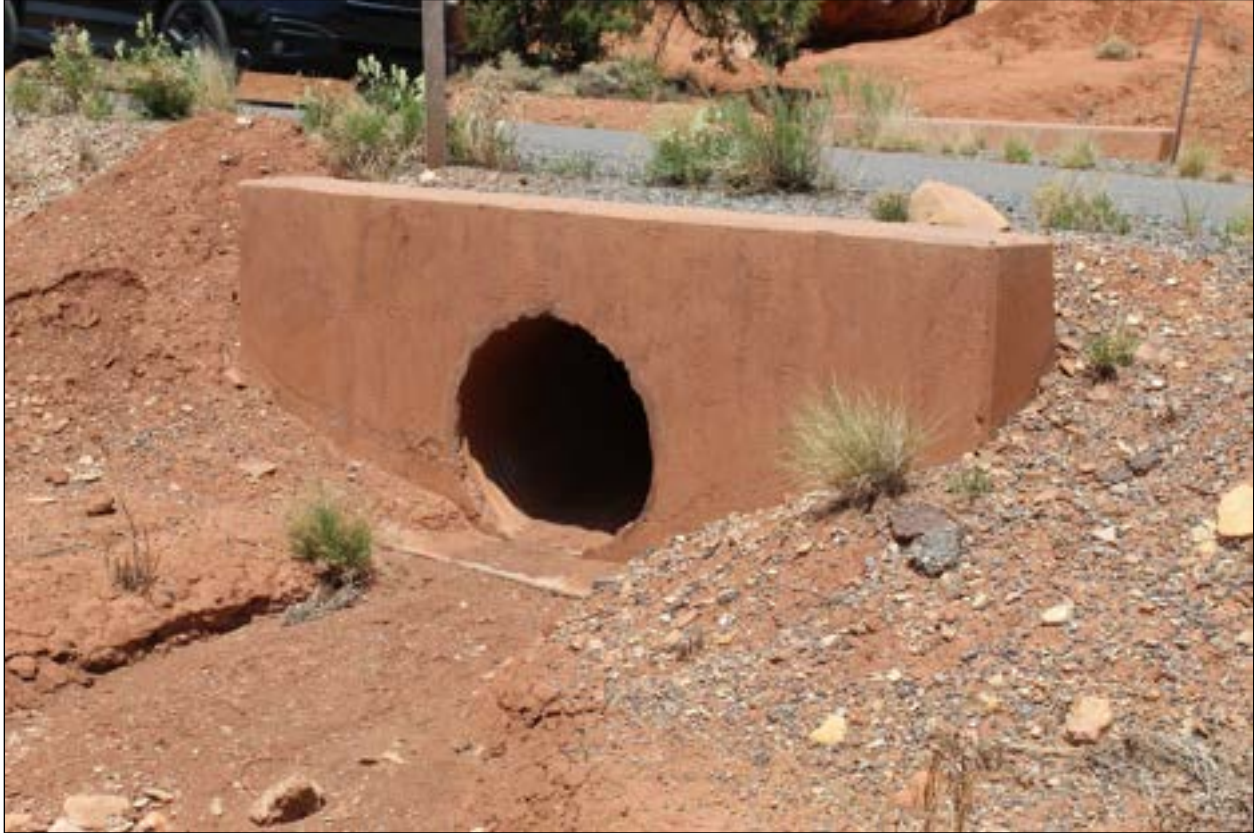
Photo 018. After the period of significance, culverts with poured concrete headwalls were constructed along Scenic Drive. View to the northeast of the culvert near milepost 6.90.

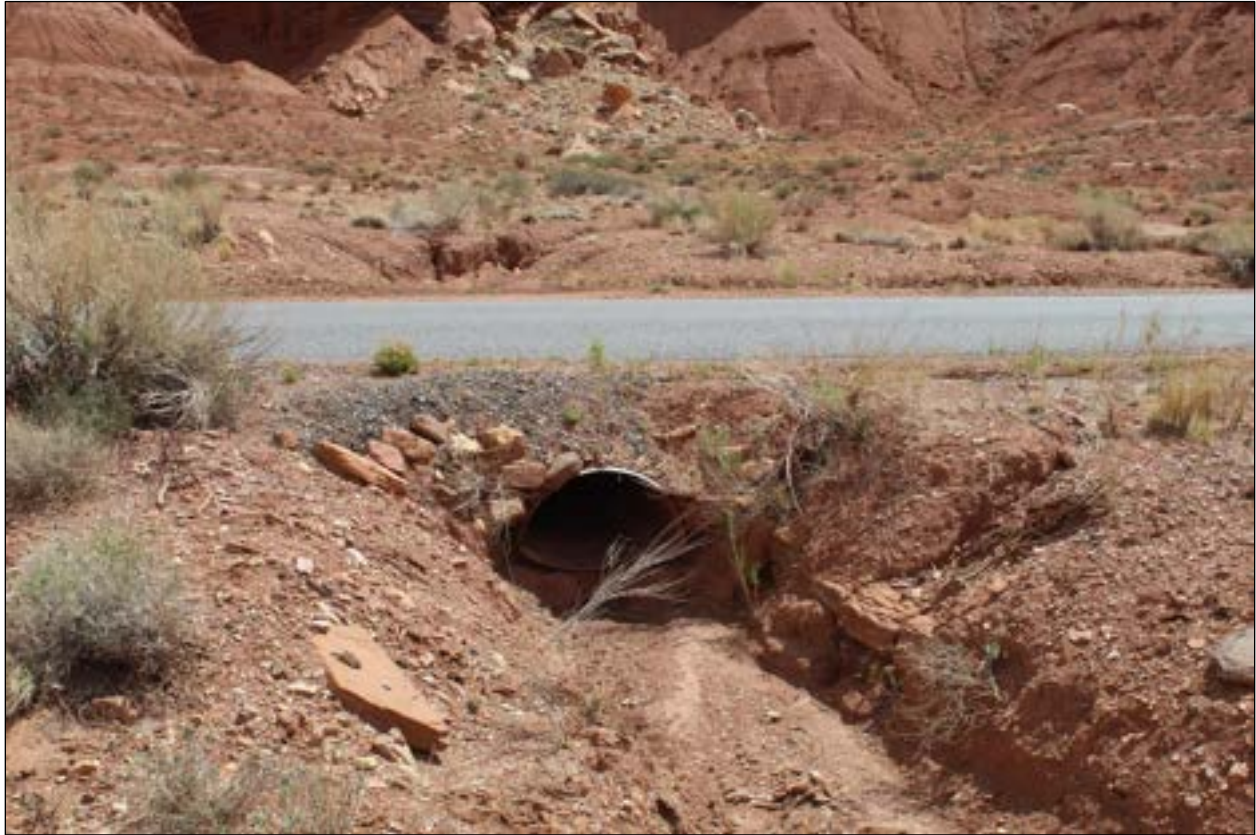
Photo 019. This culvert near milepost 1.90 was likely built by the CCC, indicated by the large sandstone blocks used for the headwall, but its condition has deteriorated to the point that it no longer retains historic integrity. View to the east.

Two culverts likely constructed by the CCC/WPA are considered non-contributing to the district because they have lost their historic integrity and are in very poor condition (Photo 19). These culverts are at mileposts 1.90 and 1.95. All three of these culverts are in the section of Scenic Drive between the Fruita Campground and Danish Hill that was rehabilitated by the CCC and WPA, and the extant materials are large sandstone blocks indicative of their work. However, the headwall at mileposts 1.90 and 1.95 have collapsed. Both headwalls at culvert 1.90 appear to have been disassembled to replace the corrugated steel pipe but not accurately or carefully reassembled. This is also evident at the inlet for culvert 1.95, which also has its outlet headwall replaced with a concrete headwall. Because of the alterations and poor conditions, these three culverts have lost integrity of design, materials, workmanship, feeling, and association.

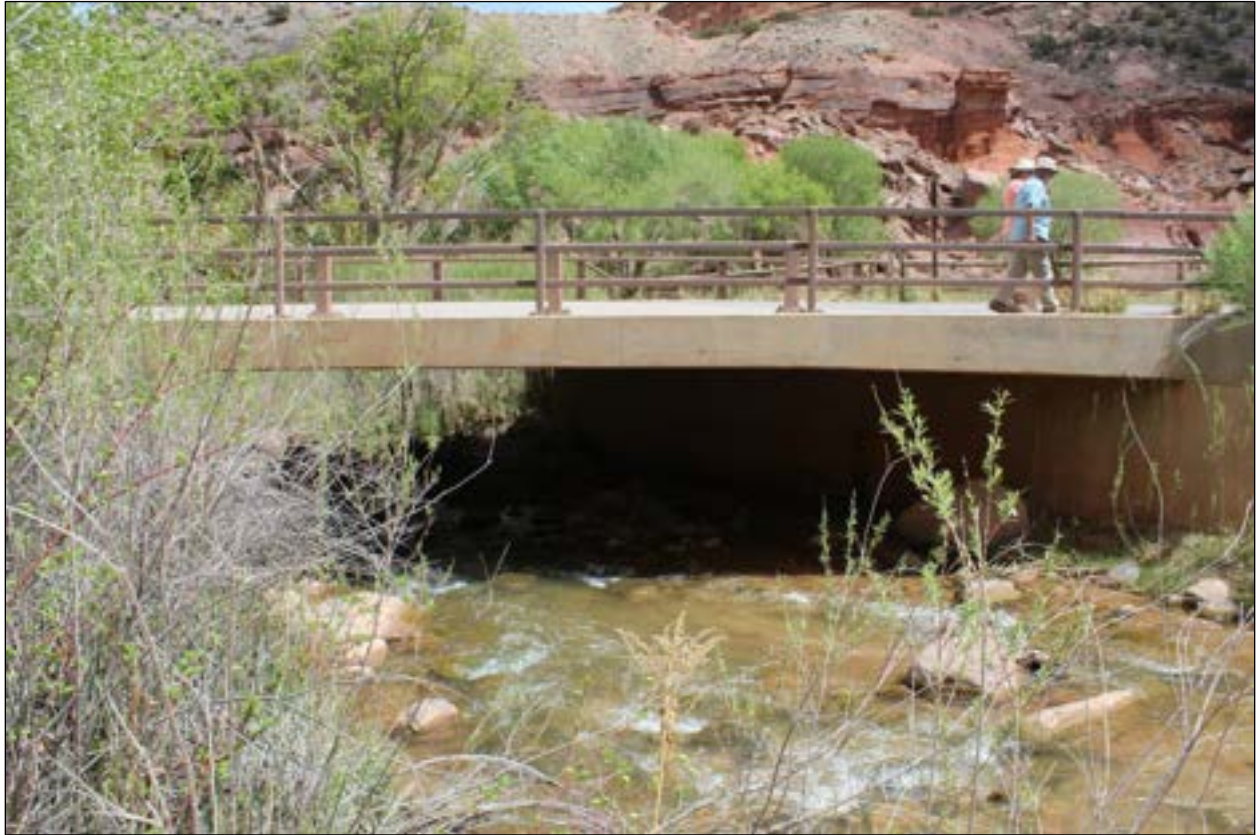
Photo 020. The Fremont River Bridge carries Scenic Drive over the Fremont River in the former community of Fruita. It was built in 1986 and is non-contributing to the district. View to the southeast.

The extant Fremont River Bridge was built in 1986 to replace a former bridge extensively damaged by flooding. The bridge is 47 ft long and carries two lanes of traffic. A pedestrian pathway extends across the bridge's western side and is separated from the traffic lanes by a steel guardrail; steel guardrails also line the outside edges of the bridge. The bridge has a concrete decking, wingwalls, and abutments (Photo 20). No historic materials from earlier bridges remain; therefore, the Fremont River Bridge is considered non-contributing to the district. The bridge has no outstanding stylistic elements but is rather plain in appearance; therefore, it is compatible with the district.

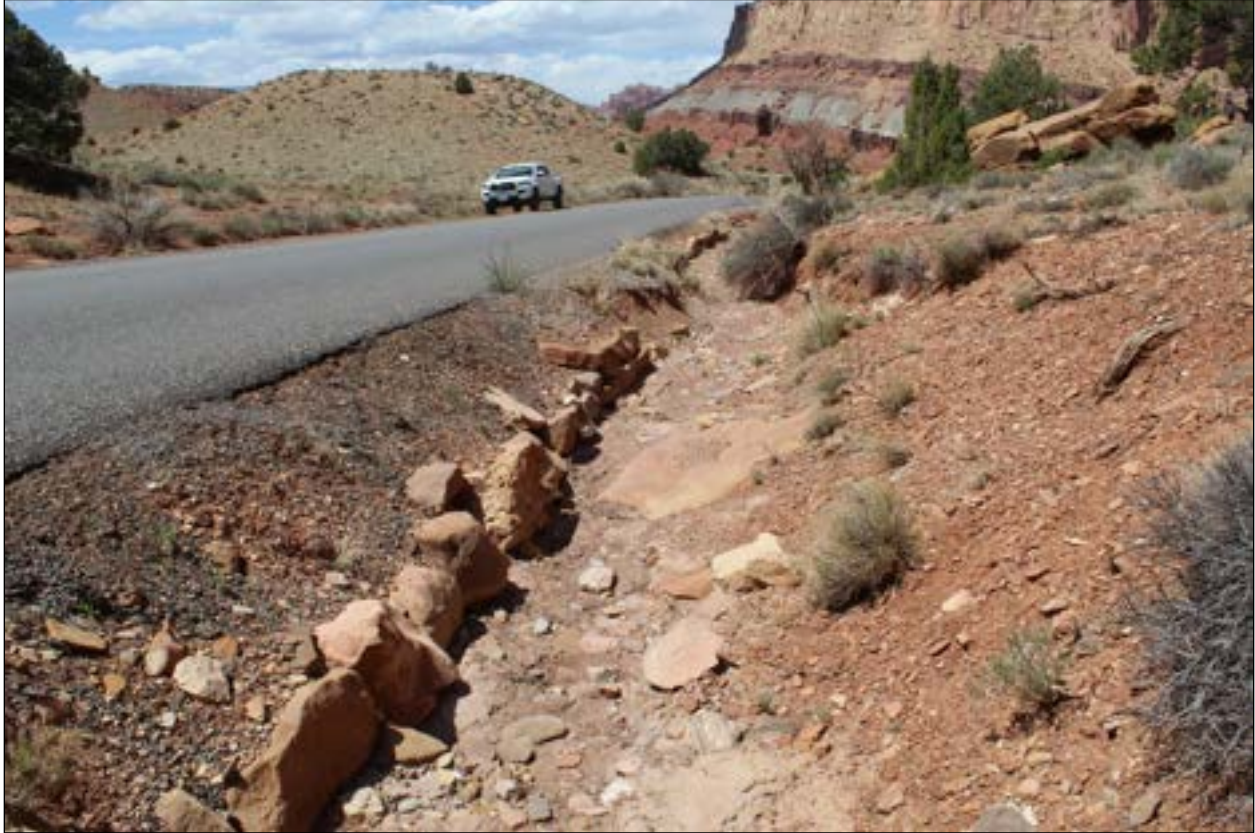
Photo 021. Ditches line many sections of Scenic Drive to carry water toward the washes. However, because they have been excavated repeatedly over decades, it is not known which may be historic. View to the north.

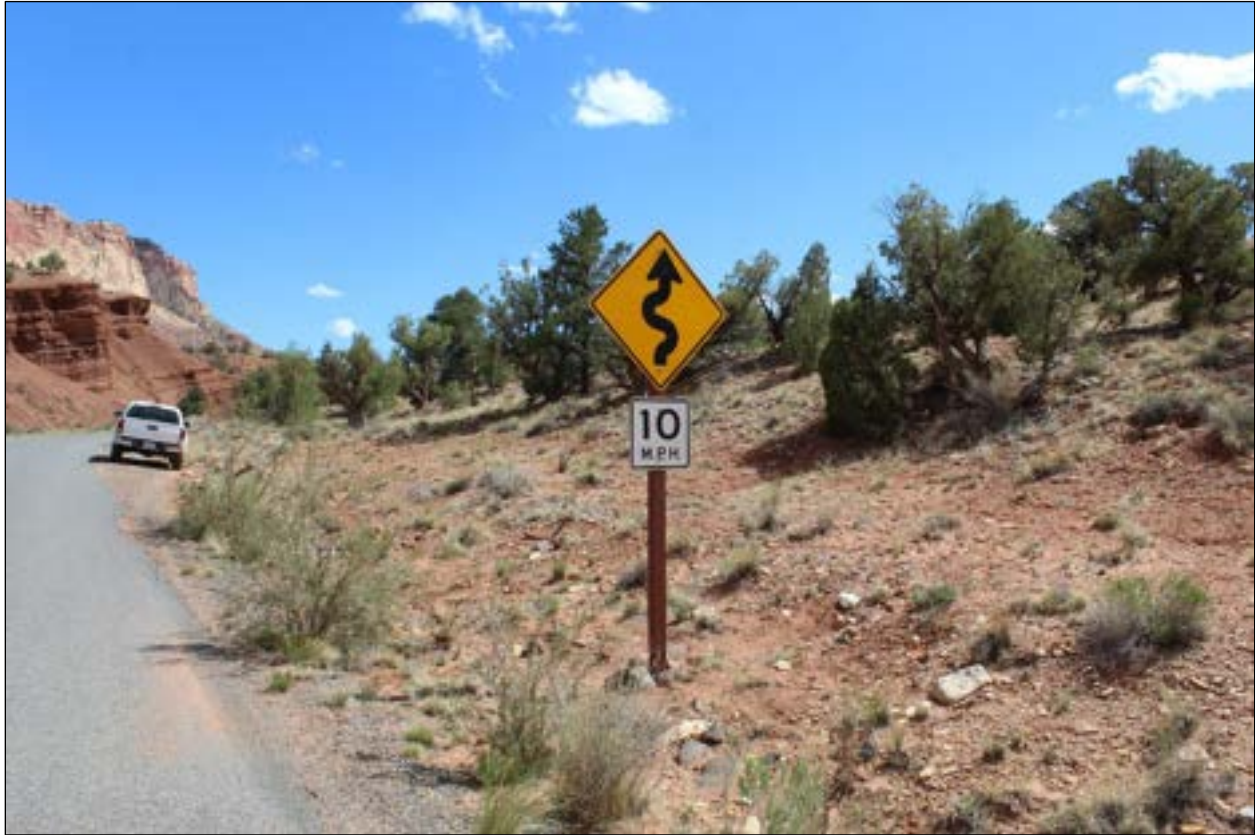
Photo 022. Non-historic road signs stand along Scenic Drive and are compatible with the district. View to the south.

Traffic signs such as stop signs, speed limit signs, directional signs, and indicators of upcoming curves are found on both sides of Scenic Drive. These are standardized regulatory signs mounted to square wooden posts painted brown (Photo 22). Carsonite delineators with upper reflective tape also mark many culvert headwalls on both sides of Scenic Drive. Several wayside exhibits stand along the route and are clustered at the interpretive shelters in Capitol Gorge. All are considered non-contributing because they were installed after the period of significance and are elements in the landscape that are replaced regularly due to general wear and tear. The signs and wayside exhibits are compatible with the district.

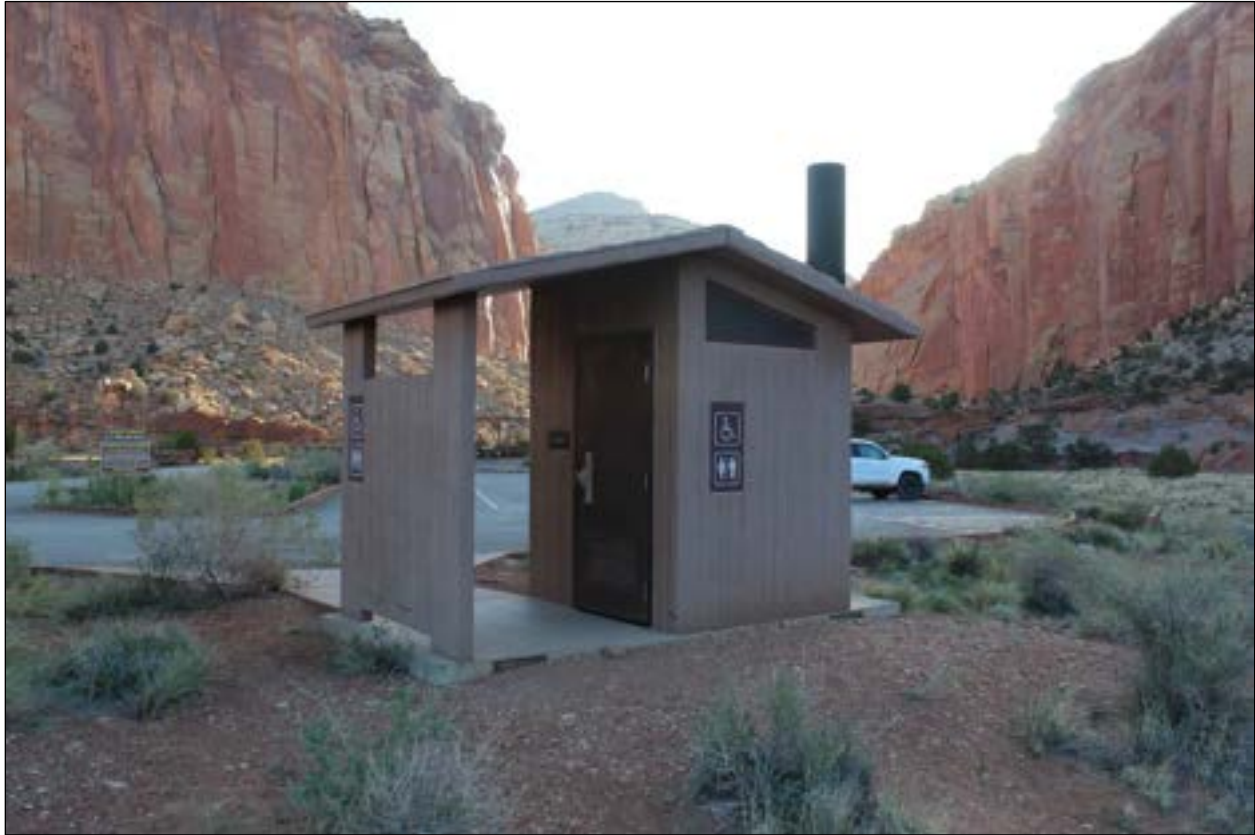
Photo 023. One vault toilet stands at each interpretive shelter in Capitol Gorge. This one is at the southern end of the Upper Interpretive Shelter's parking area. View to the east.

The district has two vault toilets, one at each interpretive shelter. Both were constructed in 1997 and replaced four chemical toilets installed in 1963. Each vault toilet has a rectilinear concrete foundation, a gabled roof with synthetic shakes, a single vault toilet enclosed by walls clad in vertical cast concrete siding, a steel door, and a cast concrete privacy wall that screens the door (Photo 23). Both toilets are considered non-contributing because they were installed after the period of significance. The vault toilets are compatible with the district because of their relatively small size, and the design mimics natural materials.

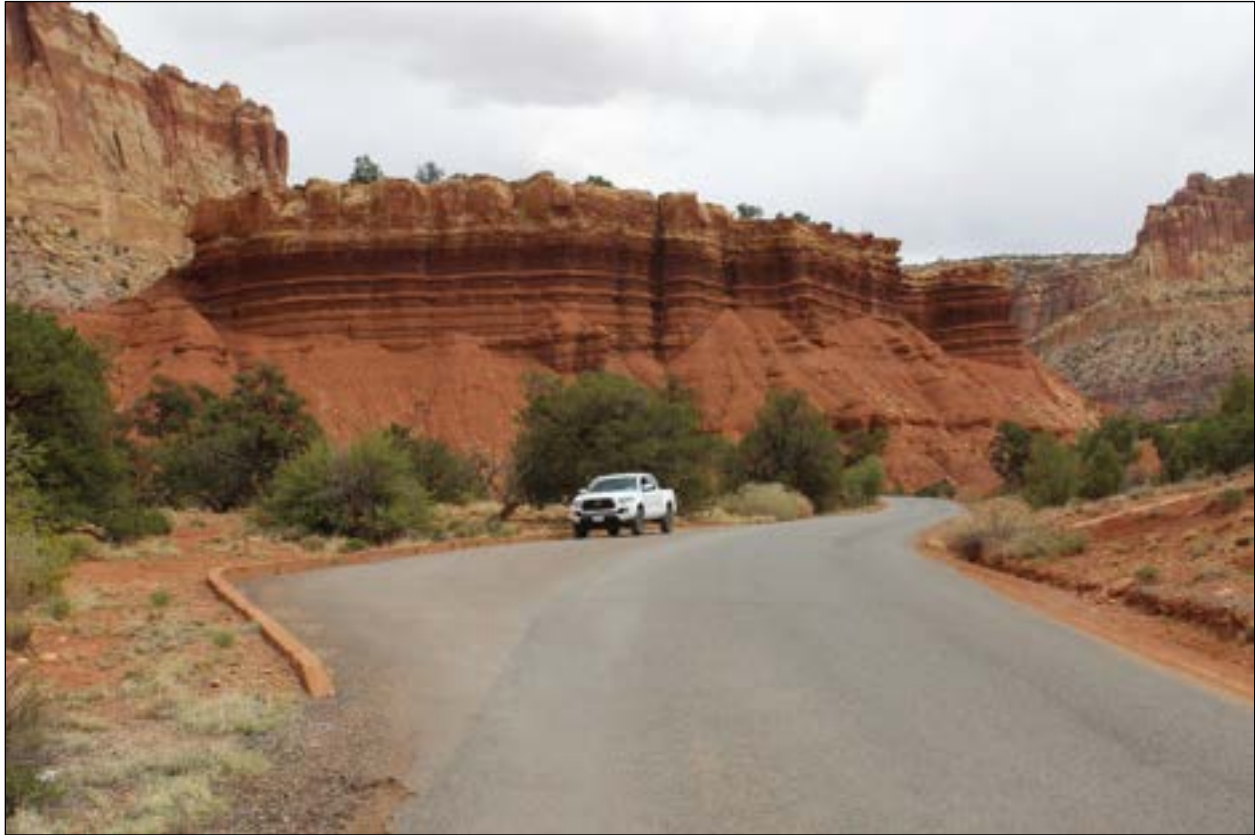
Photo 024. Paved parking pullouts are scattered along Scenic Drive. Although some date to the period of significance, they have lost much of their historic integrity. View to the south of the pullout at milepost 7.10.

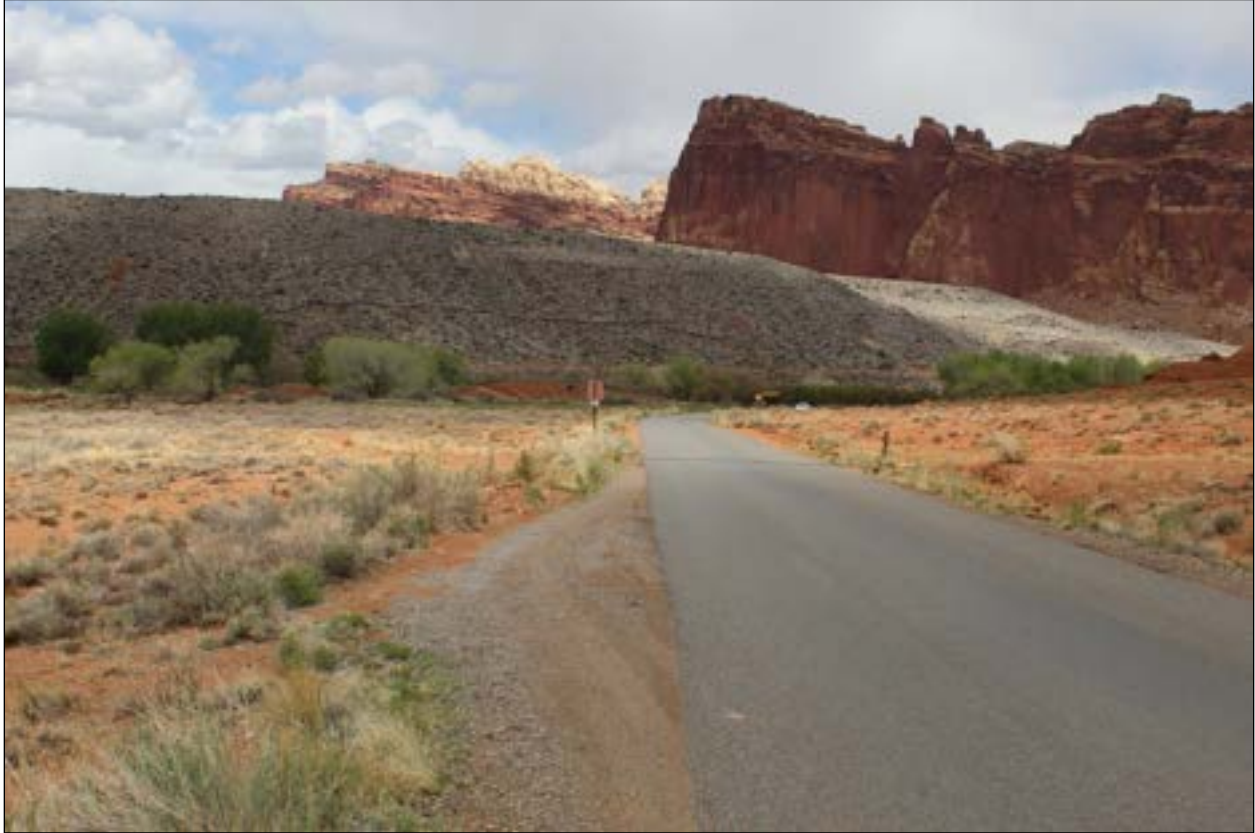
Photo 025. Many visitor-created parking pullouts that provide room for one or two cars to park are found along Scenic Drive. View to the north.

Between the fee station and Capitol Gorge Road, dozens of visitor-created parking pullouts line both sides of Scenic Drive. The earthen pullouts are small and can accommodate one or two vehicles at most (Photo 25). They are frequently found in flatter sections of topography, such as north and south of Danish Hill. All are non-contributing to the district.

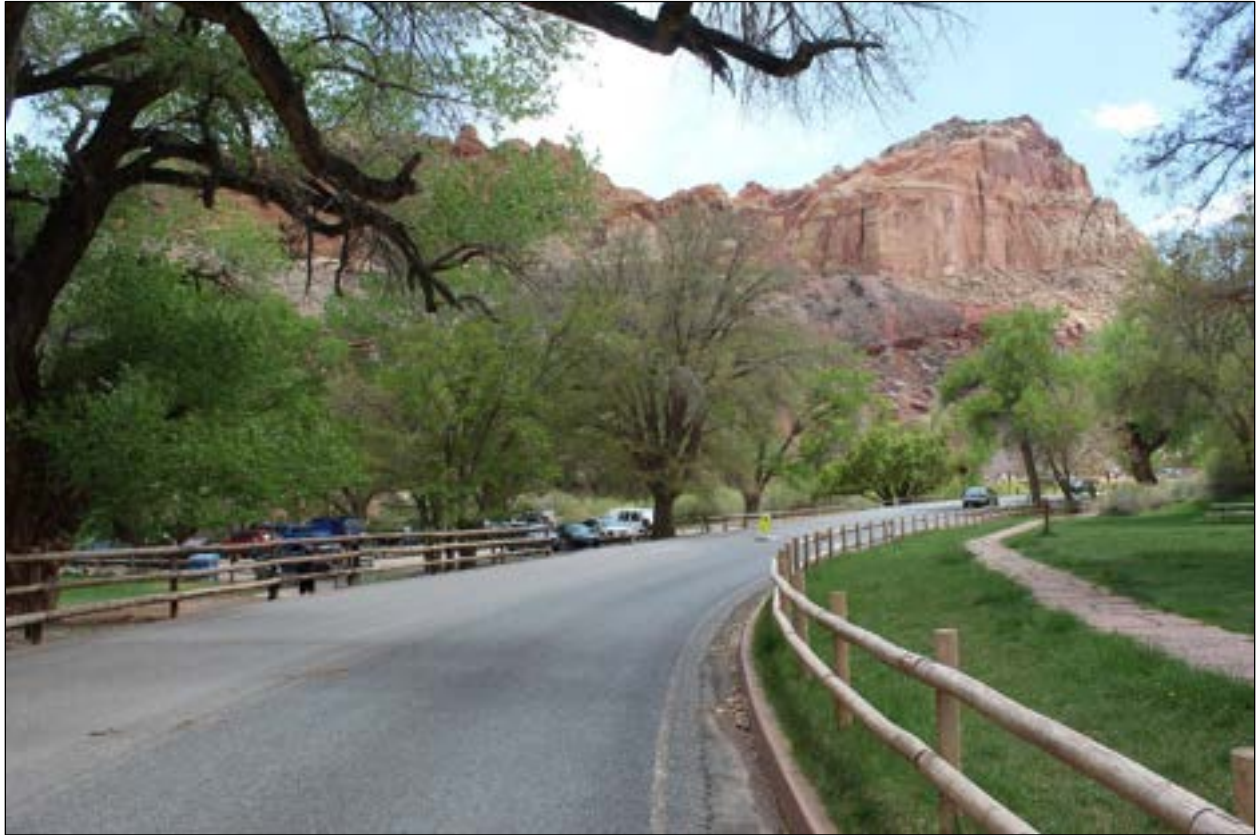
Photo 026. Non-historic post and rail fences line the sides of Scenic Drive through Fruita. View to the southeast.

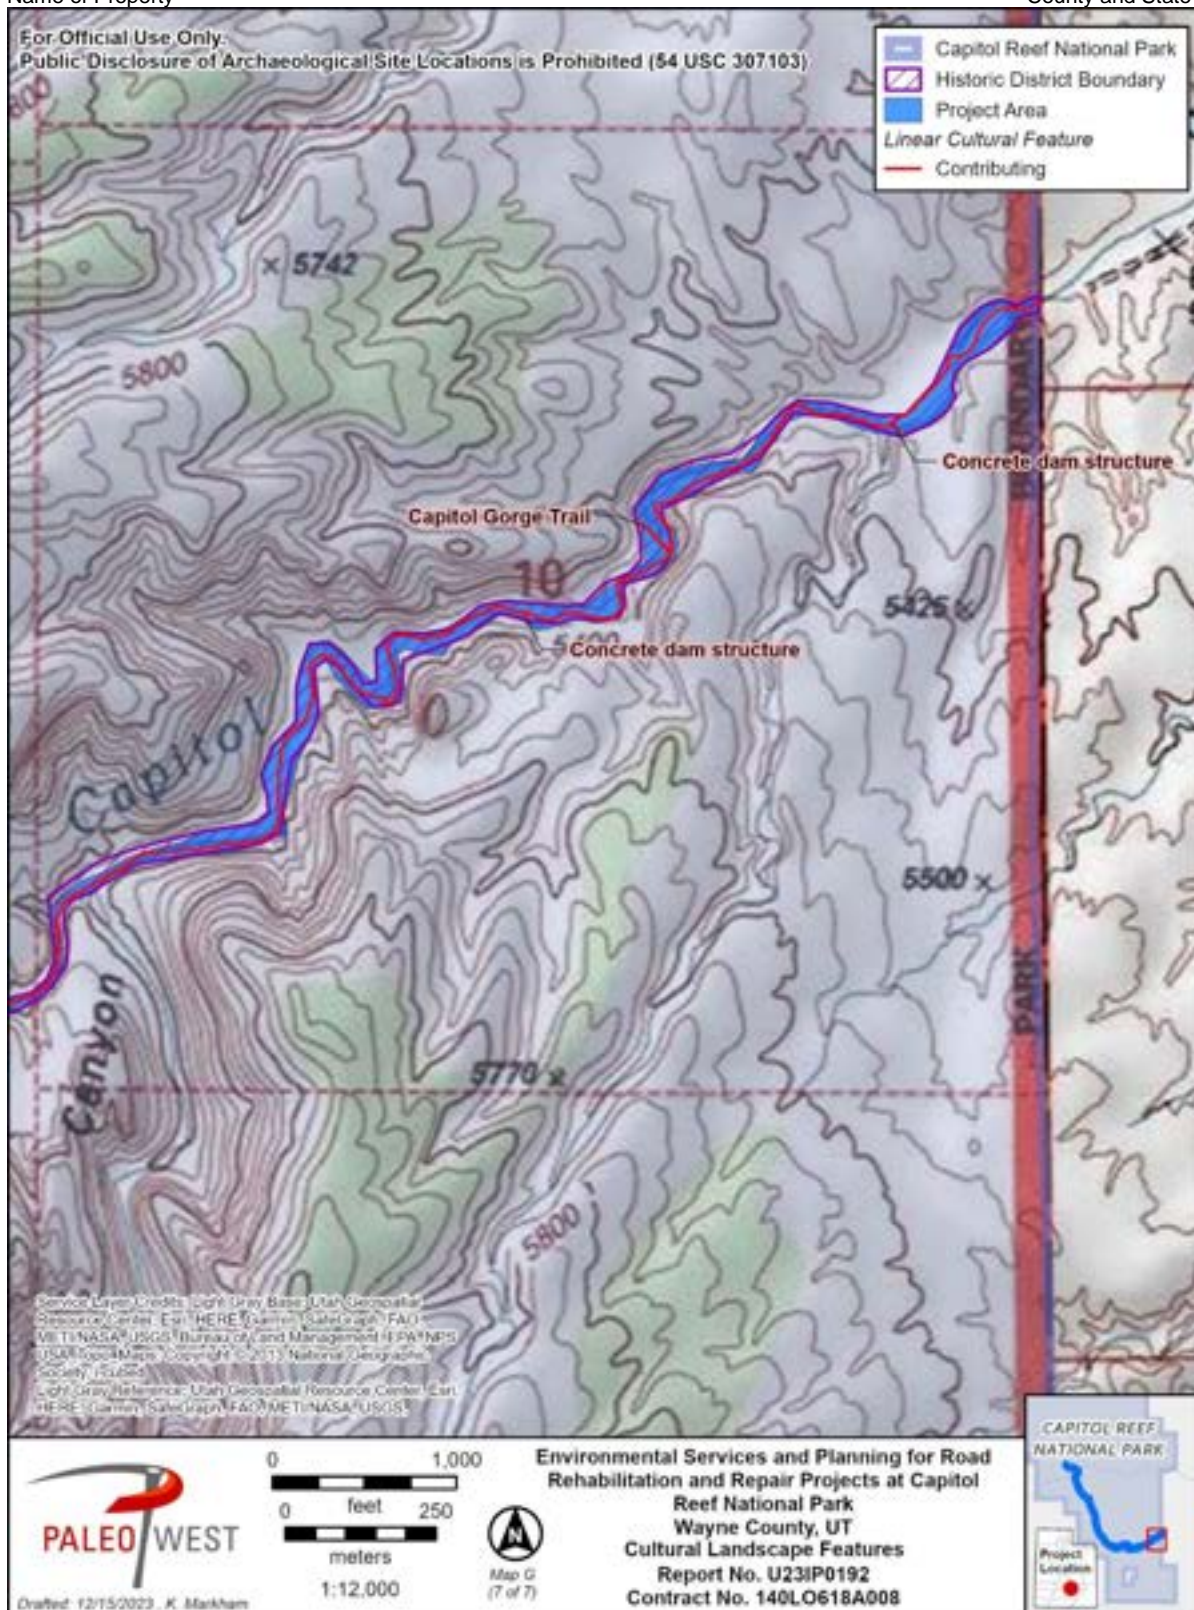
Map 15. Location of Scenic Drive and Capitol Gorge Historic District with corresponding contributing and non-contributing features, map 7 of 7.

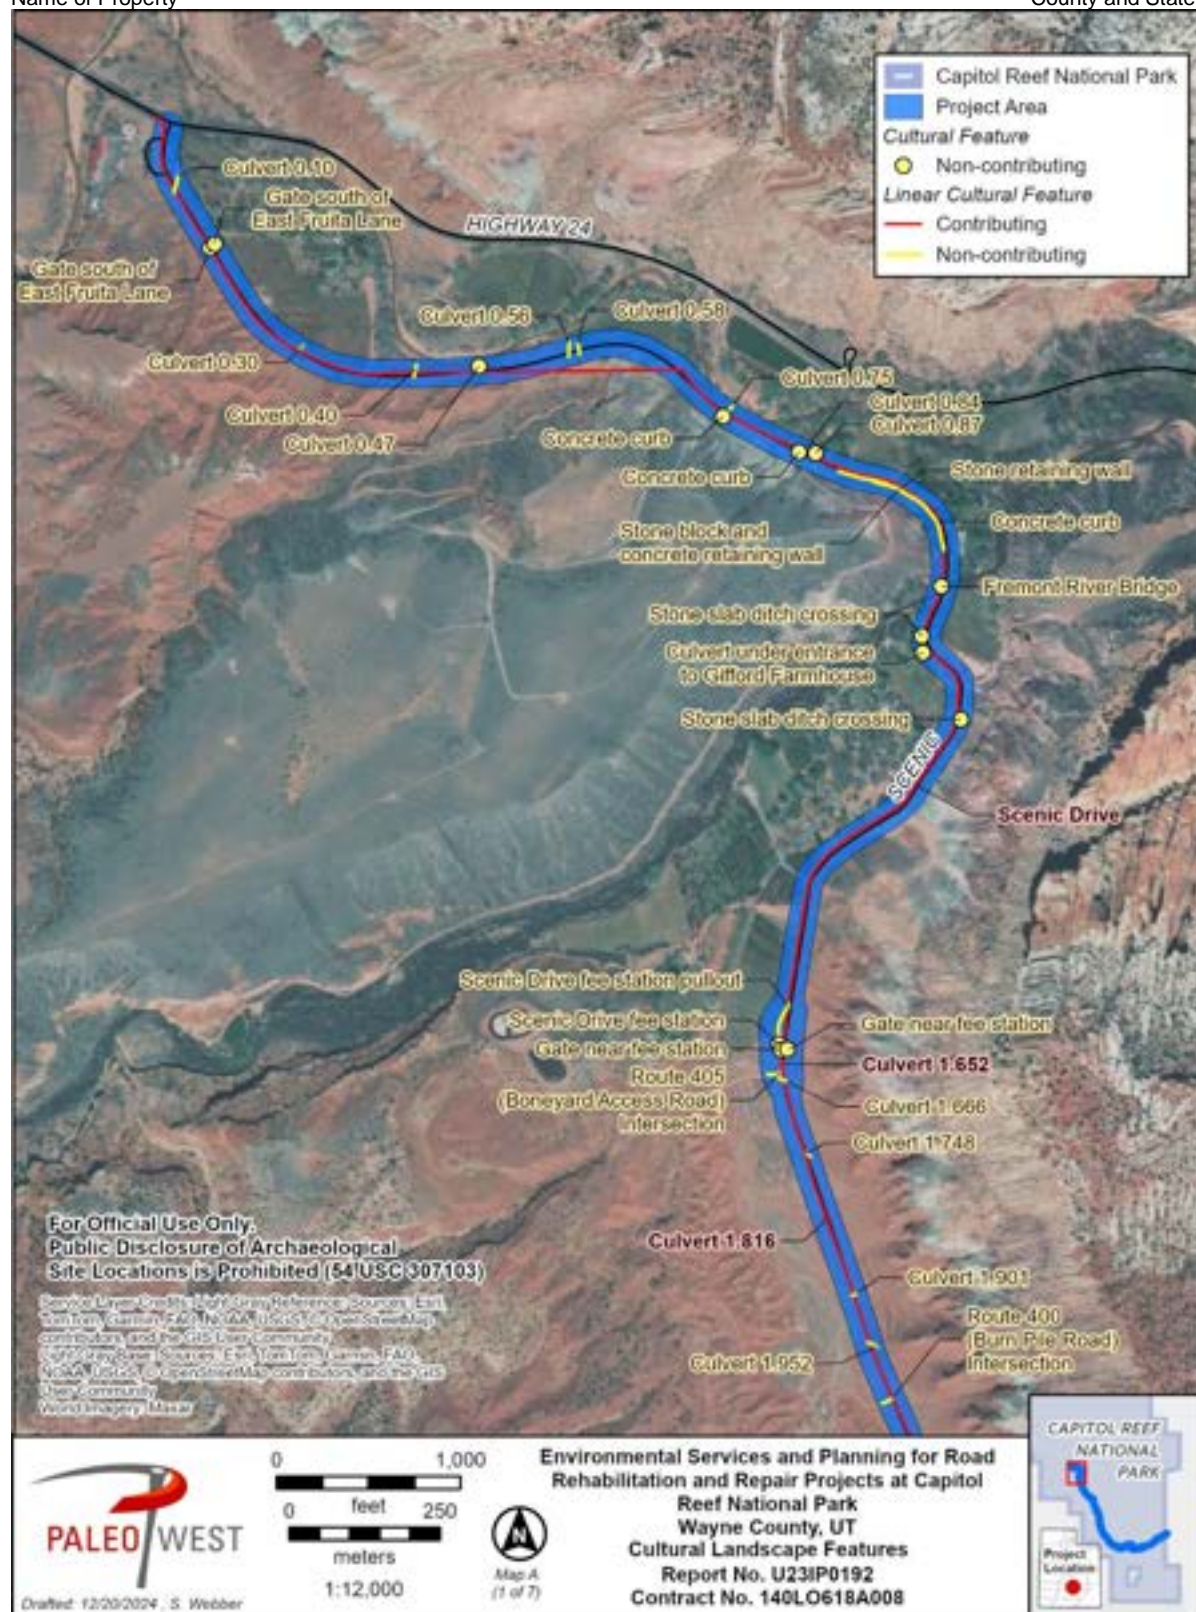
Map 16. Location of Scenic Drive and Capitol Gorge Historic District with corresponding contributing and non-contributing features, map 1 of 7.

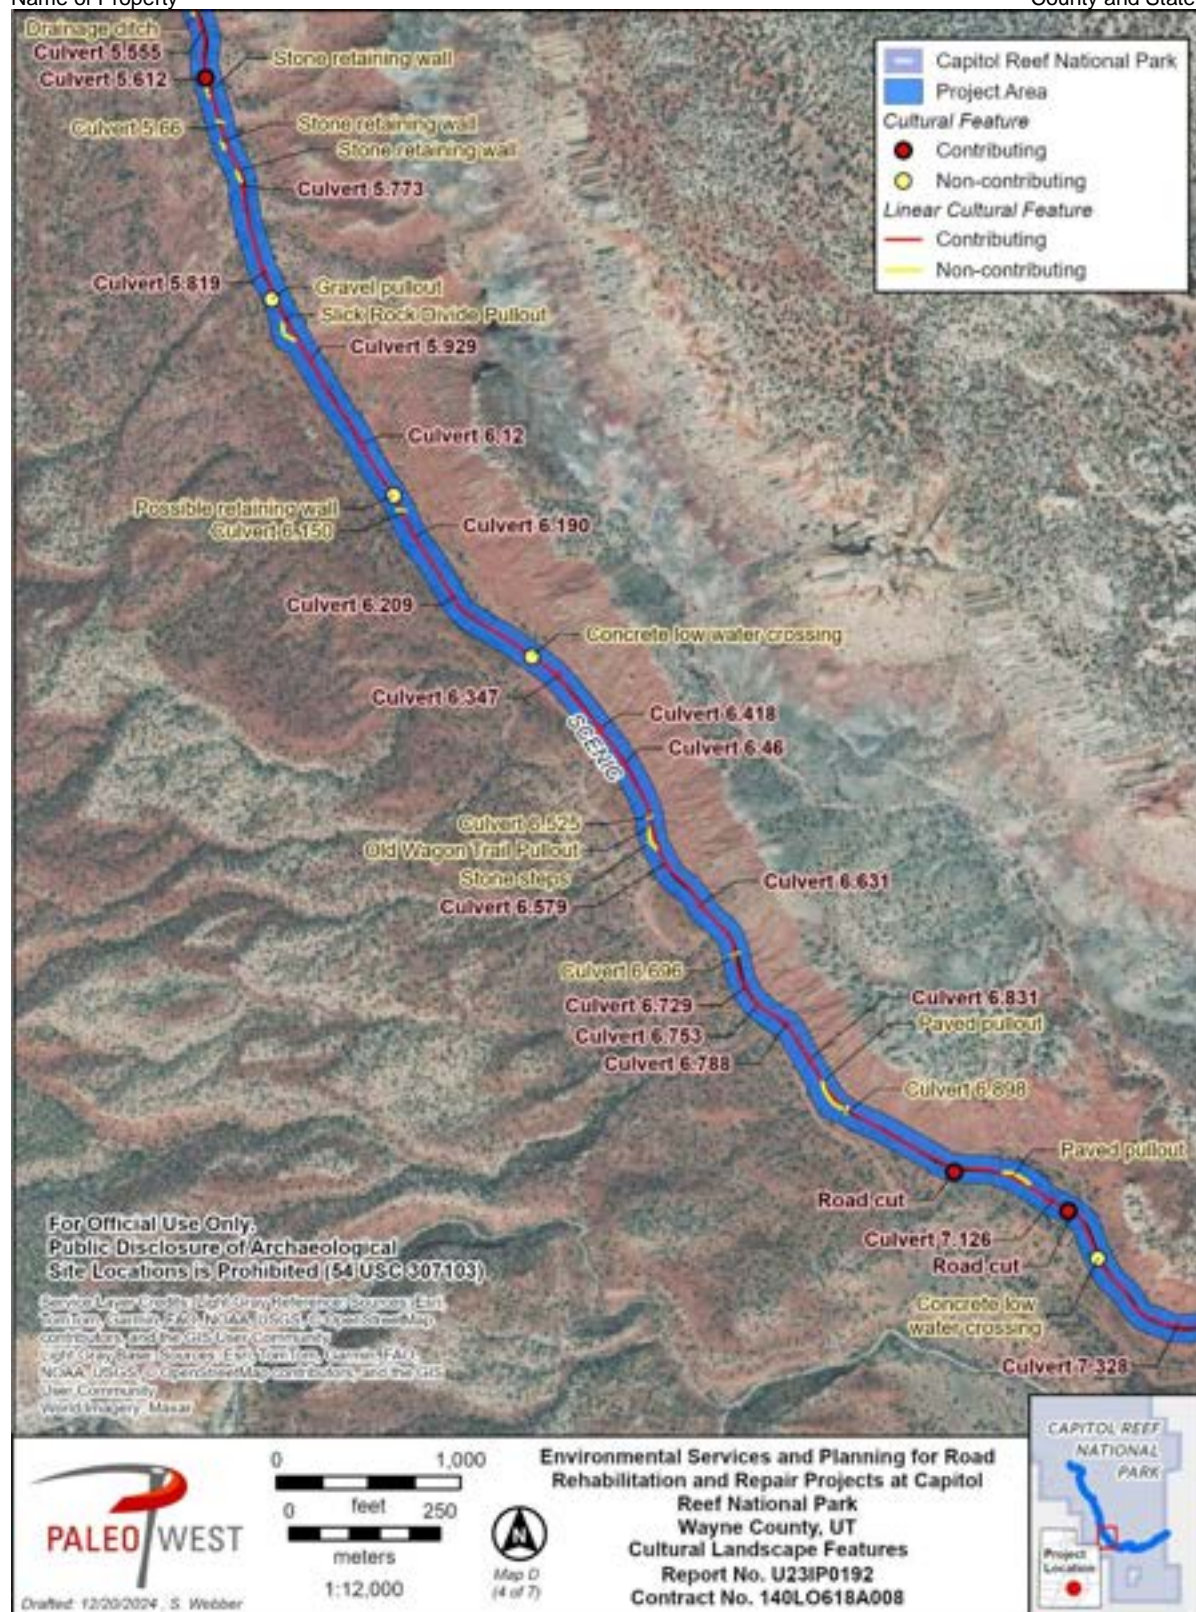
Map 19. Location of Scenic Drive and Capitol Gorge Historic District with corresponding contributing and non-contributing features, map 4 of 7.

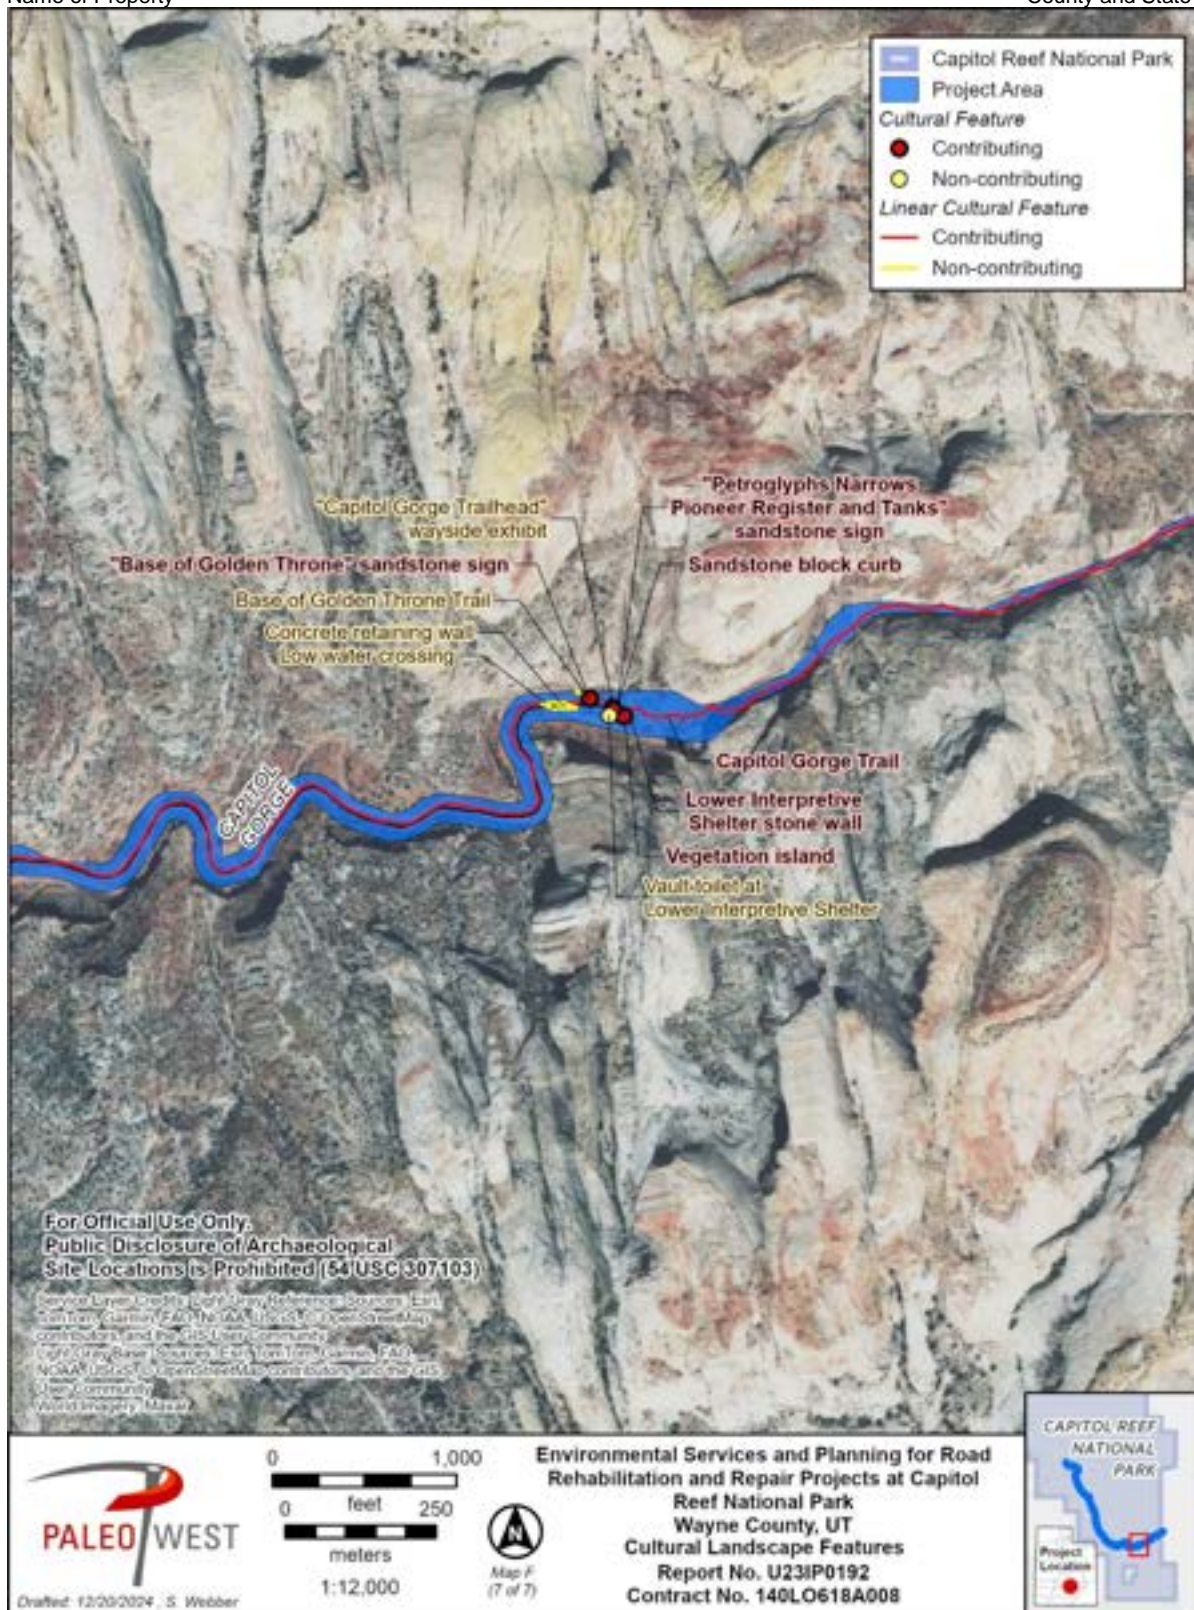
Map 21. Location of Scenic Drive and Capitol Gorge Historic District with corresponding contributing and non-contributing features, map 6 of 7.
