# National Register of Historic Places Registration Form

Historic name: Dale's Sinclair Service Station

Street & number: 96 E. Center Street

City or town: Logan State: UT County: Cache

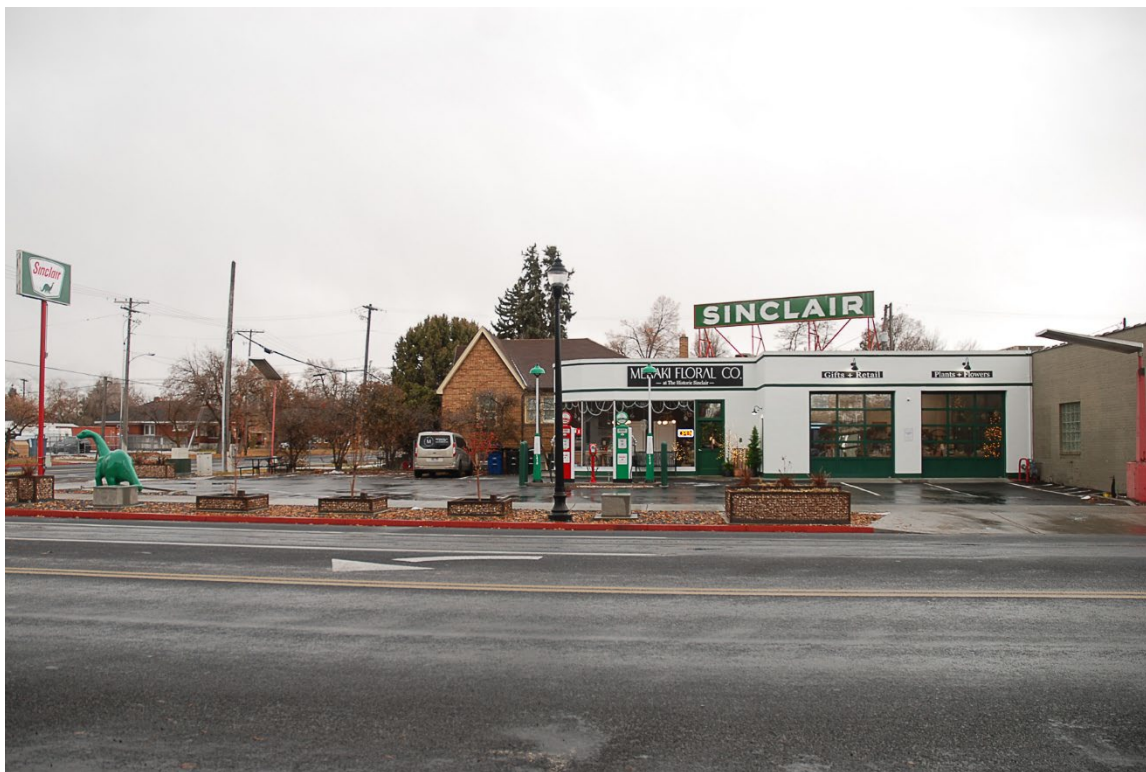
**Photograph 1**

View of site and north elevations of Dale's Sinclair Service Station. Camera facing south.

The footprint of the Dale's Sinclair Service Station is divided into two sections [Figure 1, Photographs 1-3, Map #3 exterior photo key]. The storefront section measures roughly 23 feet by 20 feet minus the curve of the windows at the northeast corner [Photographs 3-4, 6]. The service bay section is nearly square at 30 feet by 28 feet [Photograph 5]. The building sits on a concrete pad. The walls are constructed of concrete block laid in a running bond with slightly raked mortar joints visible on the rear (south) elevation [Photograph 7]. The west elevation completely abuts the adjacent building. The north and east elevations were originally covered in a smooth stucco, painted white. The woodwork, bulkhead, and rowlock-brick stringcourses were painted dark green. The current white stucco and green accents recreate the building's appearance during the period of significance. The flat roof was originally built-up. During the recent rehabilitation, a circa 2015 membrane roof was replaced with a new white membrane.

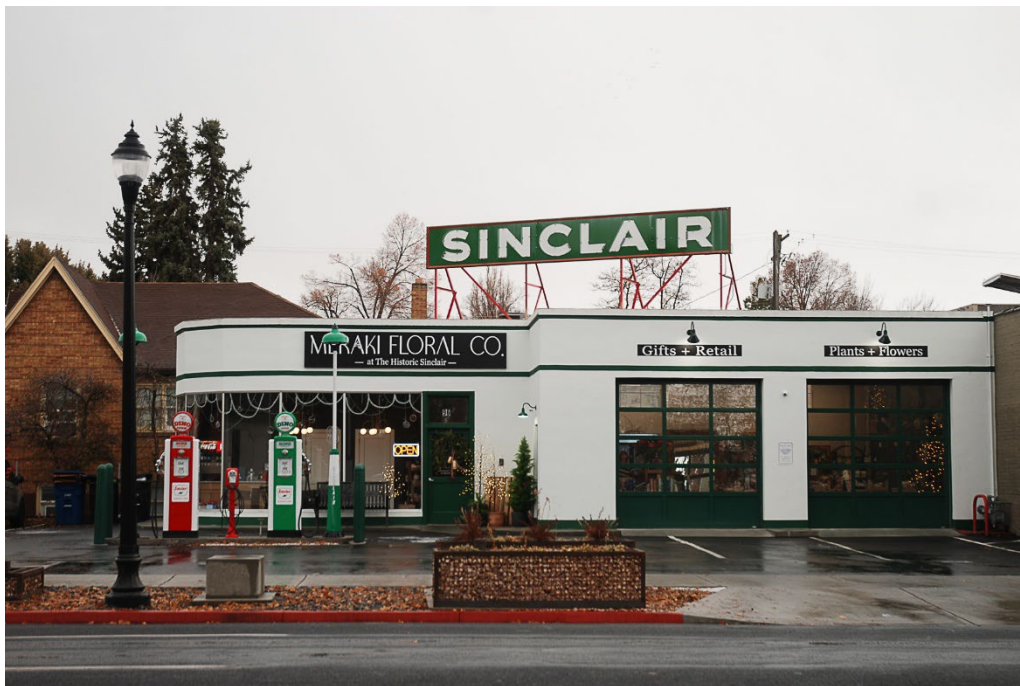
**Photograph 2**

North elevations of Dale's Sinclair Service Station. Camera facing south.

The storefront wing is setback from the service bay section. The façade is unified by the stucco and the brick string courses [Photographs 2-3]. There is a pedestrian half-glass wood door leading directly into the interior of the service bays near the storefront entrance (a recent replacement for the damaged original door). The north elevation of the service wing is divided into two service bays. The original overhead wood doors featured twelve horizontal lights (arrange in three columns and four rows) with lower panels of wood (fifth row). These doors were intact until the late 1980s when they were replaced with aluminum sided doors with a centered ribbon of three windows) [Figures 1, 3-4]. During the recent rehabilitation, the non-historic service bay doors were replaced with overhead rolling wood doors matching the configuration of the originals [Photograph 5].

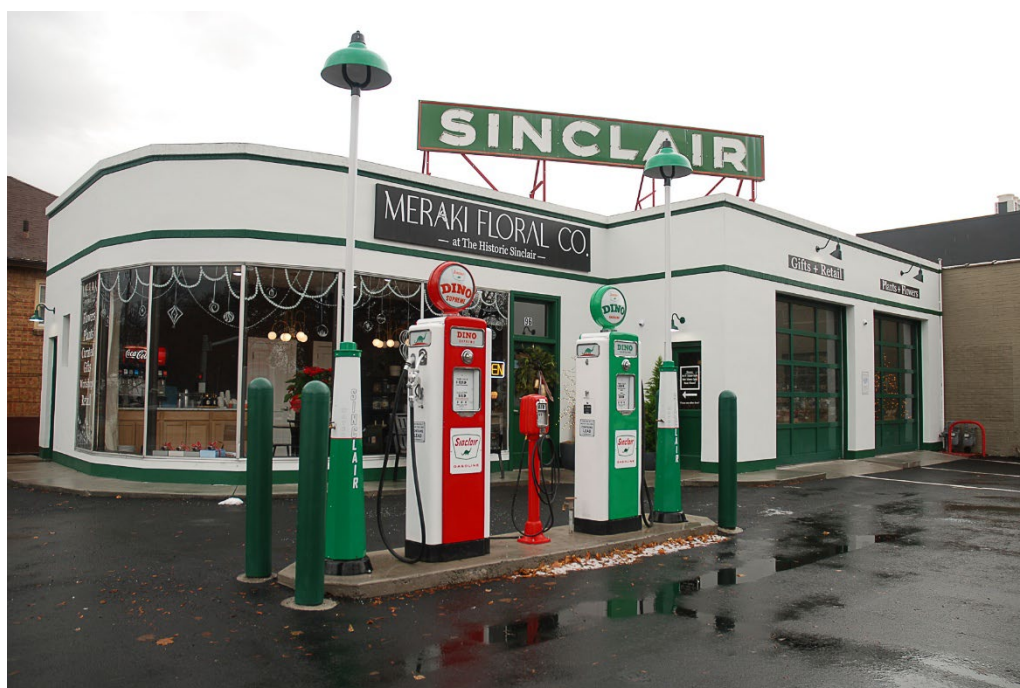
**Photograph 3**

North and east elevations of Dale's Sinclair Service Station. Camera facing southwest.

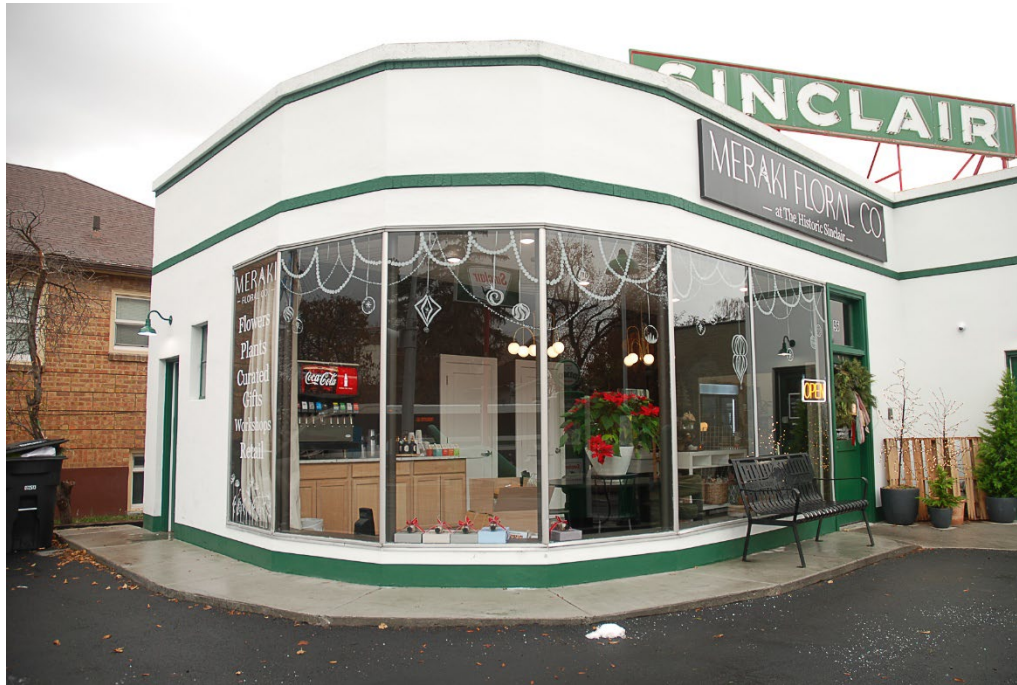
**Photograph 4**

North and east elevations of the Dale's Sinclair Service Station storefront. Camera facing southwest.

one about a foot above the storefront windows and one just under the parapet coping. The main entrance is located at the west end of the north elevation. The three-quarter glass door and square transom appear original. On the south half of the east elevation, there is a door to a patron restroom and a small window [Photograph 4].

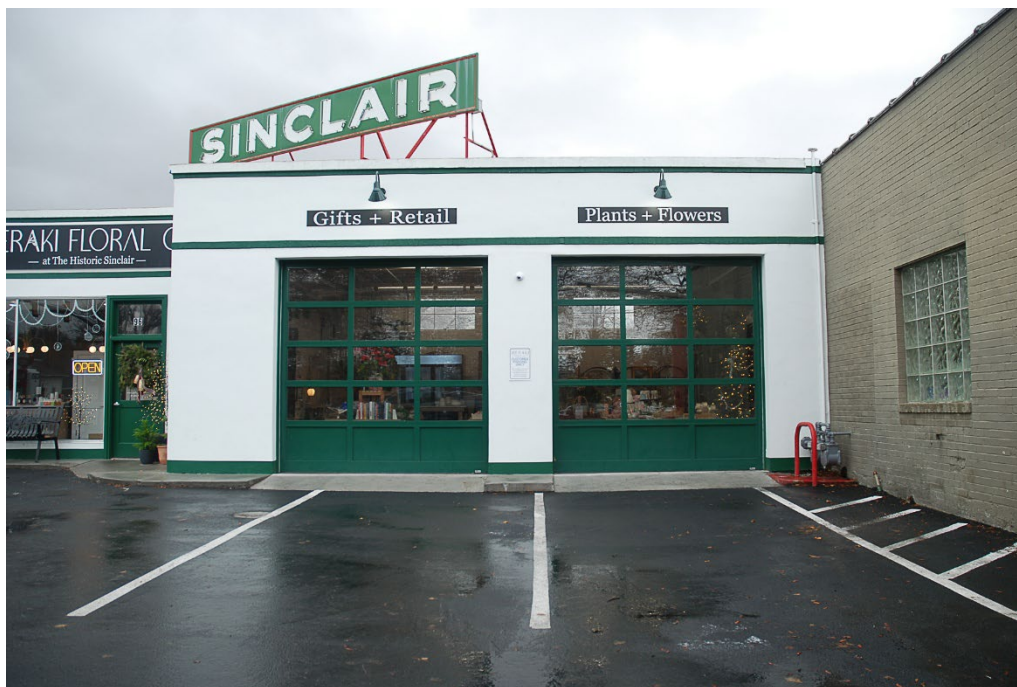
**Photograph 5**

North elevation of the Dale's Sinclair Service Station service bays. Camera facing south.

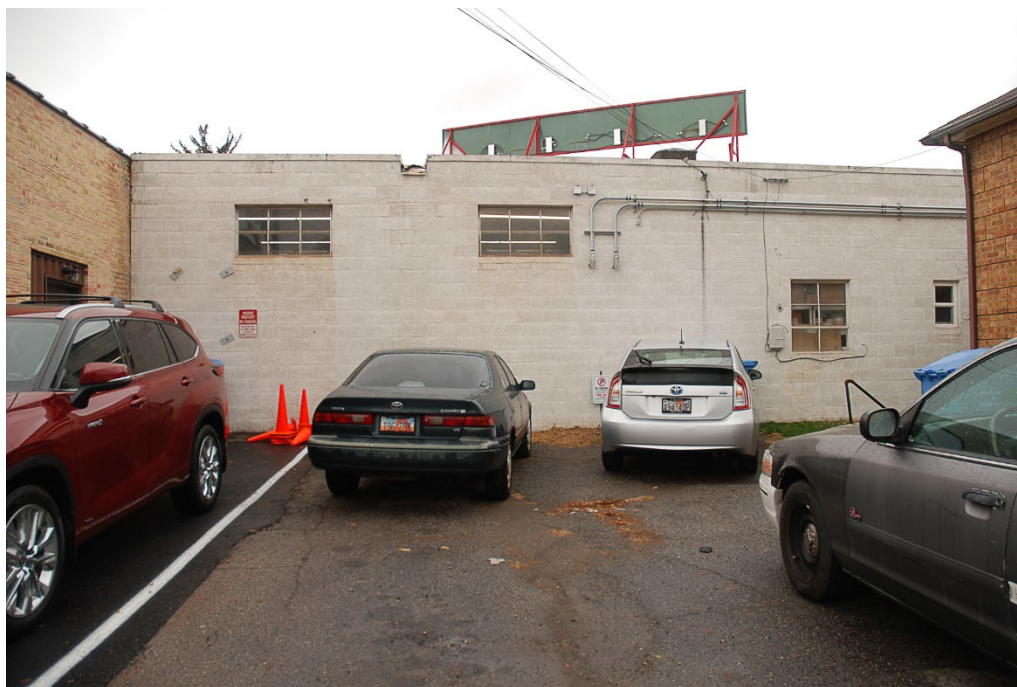
**Photograph 7**

South elevation of Dale's Sinclair Service Station. Camera facing north.

The rear (south) elevation has never been covered in stucco and the original concrete block masonry is visible. There are two rectangular six-light steel windows near the top of the service bay section. A vertical six-light steel window and a small two-light window provide natural light to a storage room and interior restroom, respectively. The original steel windows were retained during the rehabilitation, but the restroom window is a slightly shorter vinyl and textured glass replacement (circa 2000) for the original metal sash window [Photograph 7].

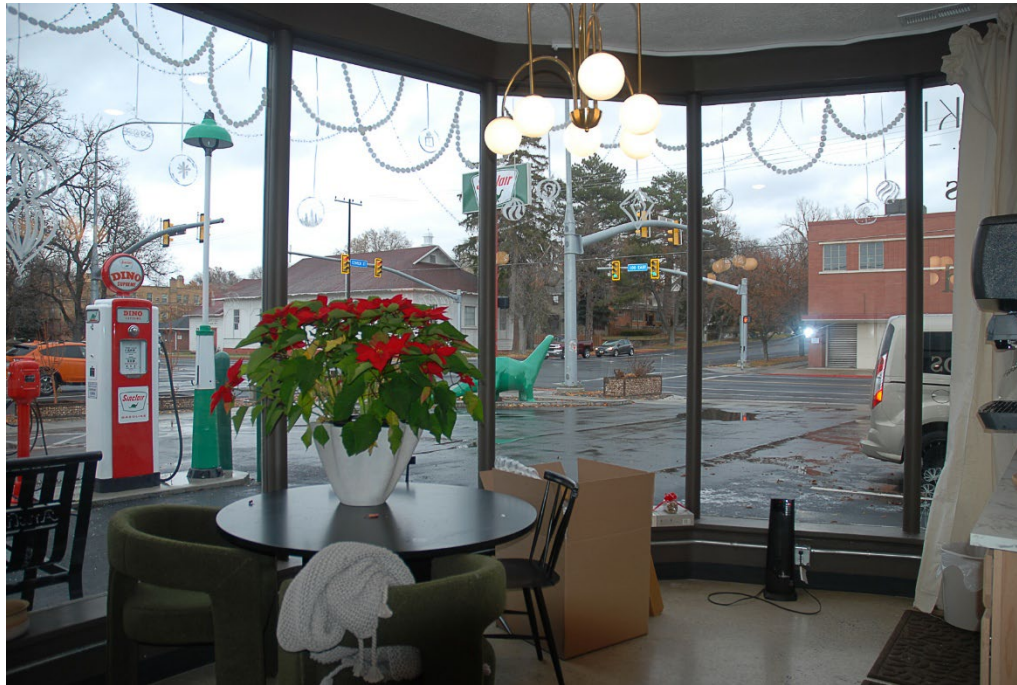
**Photograph 10**

Dale's Sinclair Service Station, interior, storefront window detail. Camera facing northeast.

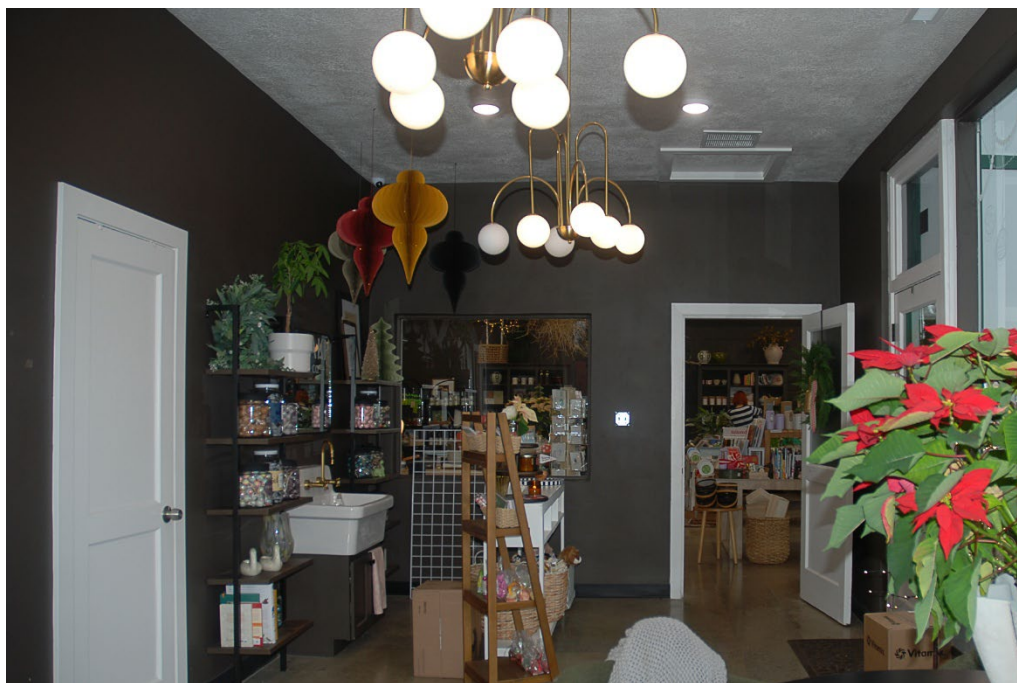
**Photograph 11**

Dale's Sinclair Service Station, interior, storefront. Camera facing west.

The ceiling and walls have been repaired from water damage and replastered. The ceiling is painted white with recently installed light fixtures [Photograph 11]. The walls are painted a dark grey. The west wall features an interior window and a half-glass door into the service bay area. A two-panel wood door with newer hardware leads into the center restroom. The storage room is in the storefront wing, but originally only accessible from the service bay area. A new door has been added to the storeroom [Photograph 9]. There is no interior access to the restroom in the southeast corner of the building. Both restrooms feature original green tile with newer fixtures.

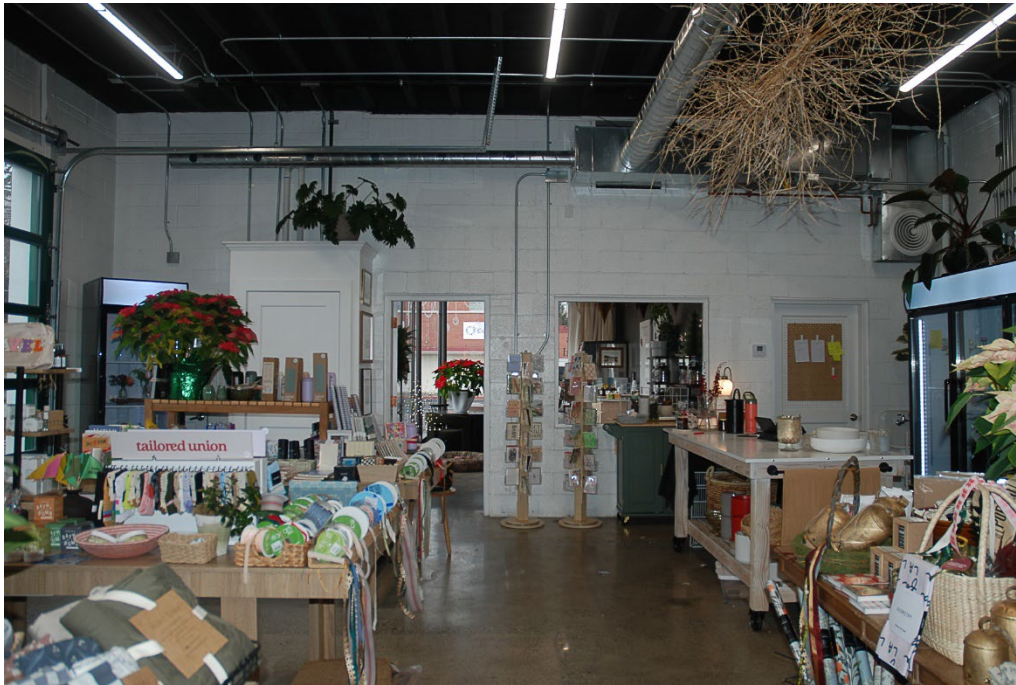
**Photograph 12**

Dale's Sinclair Service Station, interior, service bay area. Camera facing east.

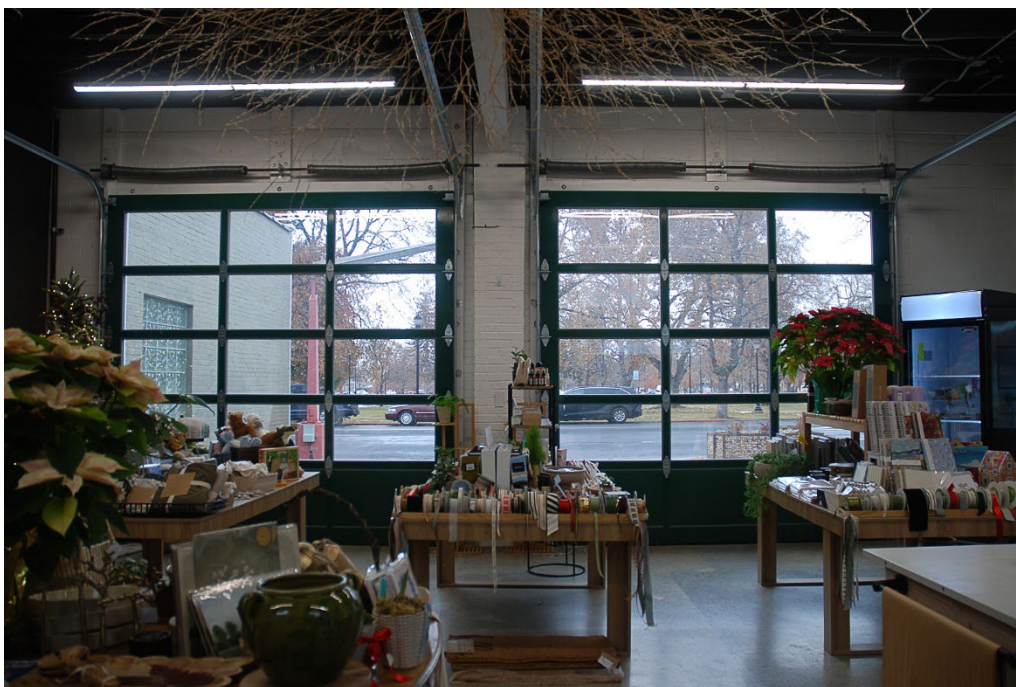
**Photograph 13**

Dale's Sinclair Service Station, interior, service bay area. Camera facing north.

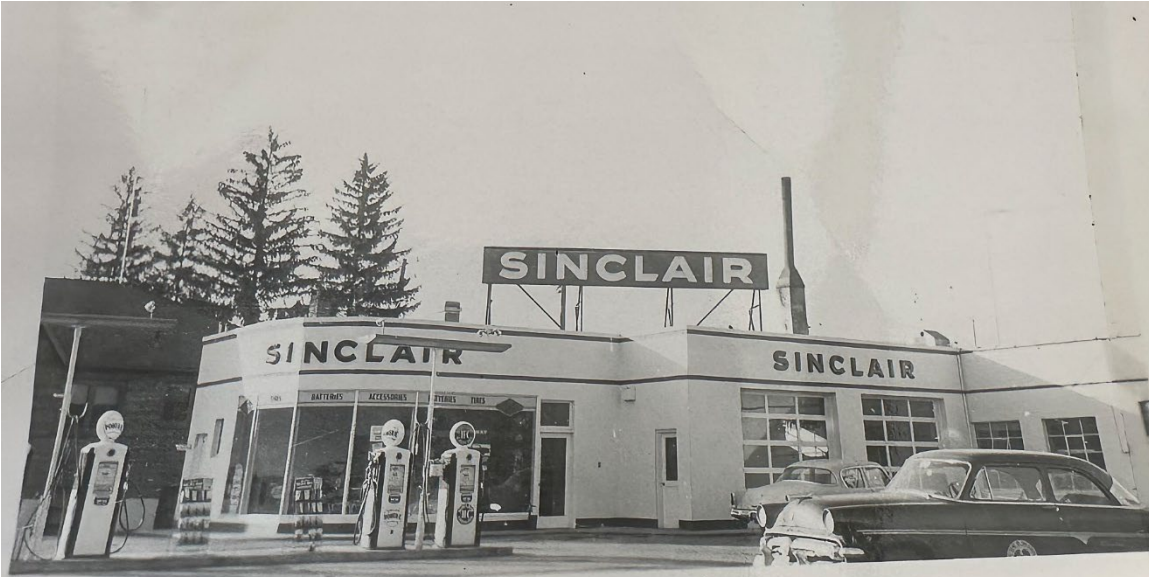
**Figure 1**

Dale's Sinclair Service Station, photographed circa 1955.  
Courtesy Cache County Tax Assessor's Office.
