# National Register of Historic Places Registration Form

Historic name: Tuttle, Franklin and Arletta Cox, House

Street & number: 482 West 400 North

City or town: Manti State: UT County: Sanpete

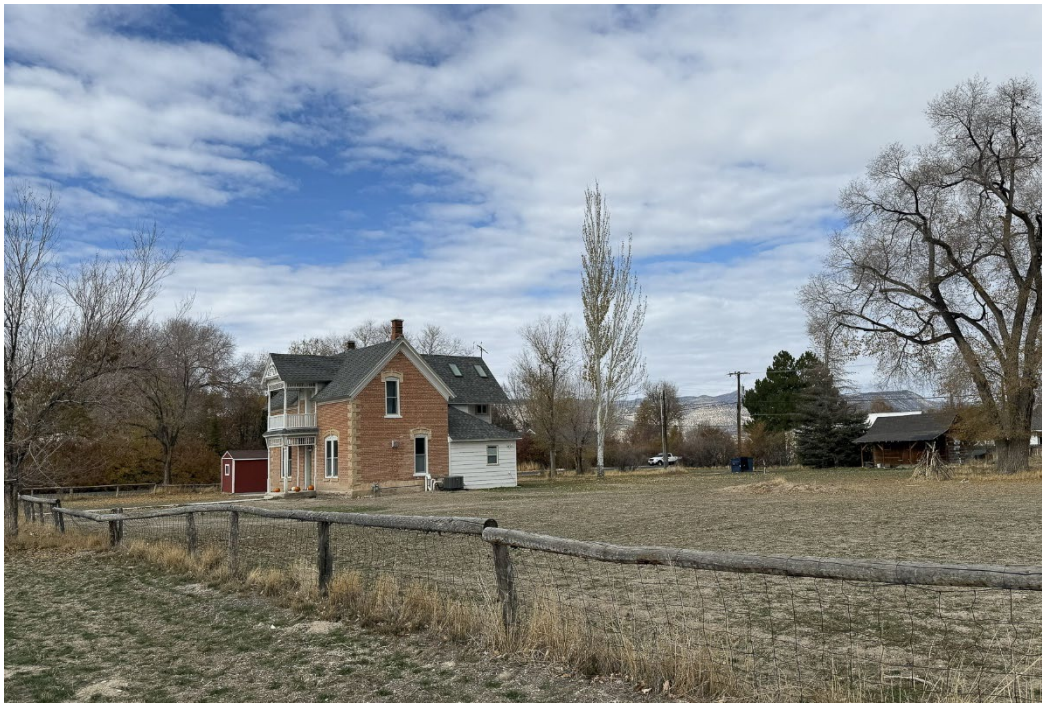
**Photograph 1**

View of 482 W. 400 North with outbuildings. Camera facing northwest.

The footprint of the brick section of the house measures 36 feet wide by eighteen feet deep. The wide façade faces south to 400 North street [Photographs 1-2]. According to tax records, the one-story frame addition was built in 1948. The addition is fourteen feet square and was built on the east third of the rear (north) elevation. The foundation for the house is rock-faced sandstone laid in ashlar courses on the exterior. The stone foundation is rubble on the interior of the cellar, which is excavated only at the east end of the house. The fired brick masonry is laid in American (common) bond with headers every sixth course. A circa 1900 historic photograph shows a light-colored mortar in contrast to the brick [Figures 1, 4-5]. The flush mortar has somewhat darkened with age. The brick has never been painted [Photographs 2, 6-7]. The three street-facing corners of the house feature sandstone quoins. The quoins include both rock-faced and rubbed (smooth) rectangular blocks laid in alternating courses.

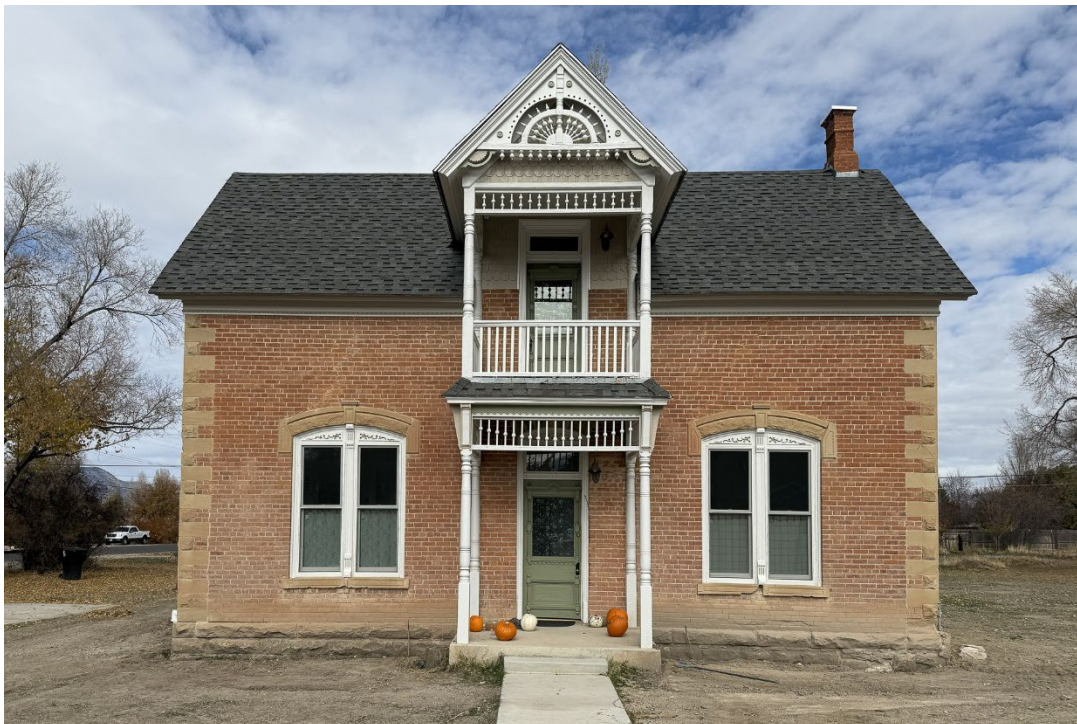
**Photograph 2**

South elevation. Camera facing north.

The symmetrical façade features two coupled double-hung windows flanking the central porch [Photograph 2]. A fluted classical-style mullion divides each pair. Each window has a scroll-cut arched header. The original windows were in poor condition and have been replaced by compatible double-hung wood windows. The mullions, headers and casings were retained. Each pair has an elaborate hood/drip molding and sills made of sandstone. There are four sandstone sills, one for each window and dressed with a dotted draft line. One broken sill was replaced with matching stone during the rehabilitation. The hood moldings feature elements of both rock-face and draft line dressed stone. There is a center keystone for each pair. There are no windows on the upper level of the façade.

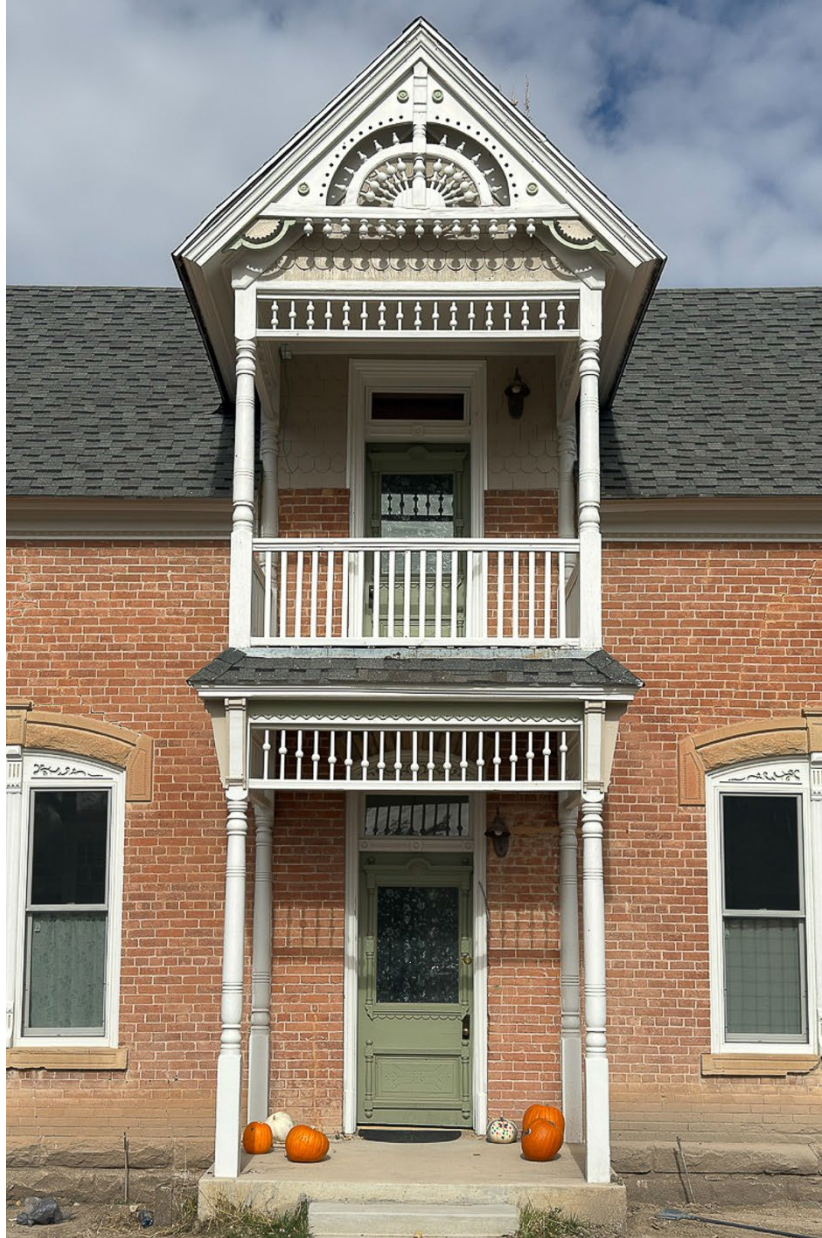
**Photograph 3**

South elevation, details of porch and balcony. Camera facing north.

The main simple gable roof has a ridgeline parallel to 400 North. A small projecting gable on the façade shelters the upper-story balcony [Photograph 3, Figures 8-9]. A larger simple cross gable is located where the original the rear addition was attached [Figure 6]. Currently, the roof is sheathed in small, dark blue, asphalt shingles (circa 1995). Under the eaves is a boxed and beaded cornice with decorative dentils on the south and west elevations. The house has two brick chimneys, one at the east end (original) and one in the center (circa 1940s). The east chimney still has its corbelled top. The later center chimney is shorter. The chimneys were repaired and repointed during the current rehabilitation. A decorative carved crest along the ridgelines was removed sometime before the 1980s.

The façade (south elevation) is symmetrical with the two-story porch as the focal point [Photographs 5-6]. The porch measures eight feet wide by six feet deep. The balcony is supported on two lathed-turned columns in the front and two similar engaged columns attached to the brick. As revealed in the circa 1900 photograph, the main level balustrade originally featured a semi-closed, jig-sawn pattern on two sides, wrapping slightly with lathe-turned newel posts on the front. The cuts in the balustrade were foliate, a characteristic of the Eastlake style. The porch frieze is a spool & spindle decoration sheltered by slanted roof extensions on three sides supported by scrolled brackets. The porch deck was originally wood with two steps [Figures 2-3]. The current concrete deck was poured in the 1990s. Sometime in the 1970s, the main level of the front porch was enclosed and the balustrade removed [Figures 4-5]. When the enclosure was removed in the 1990s, the support posts and the spool & spindle decoration had survived [Figure 8]. The original half-glass front door with transom also survived, but a few of the decorative elements were removed. Replica wood elements were recreated during the rehabilitation using outlines left on the door (and the upper-story door) as a guide. The doors are currently painted light green [Photographs 3-4].

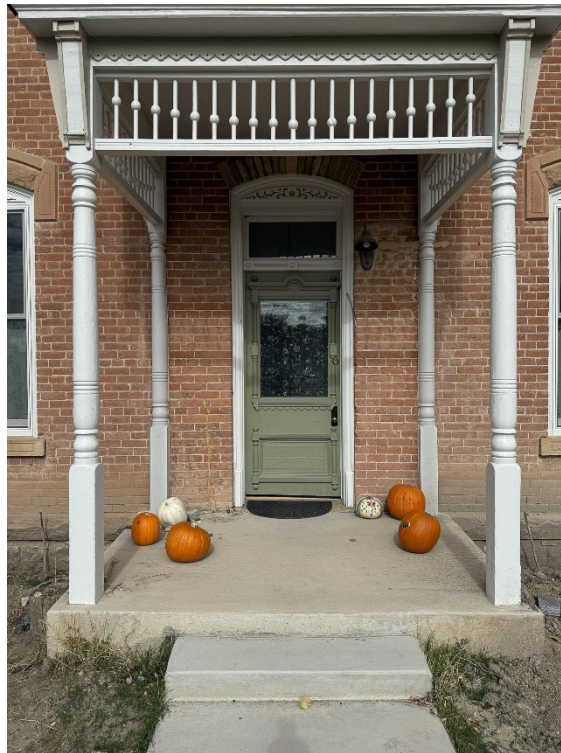
**Photograph 4**

South elevation, porch and door details. Camera facing north.

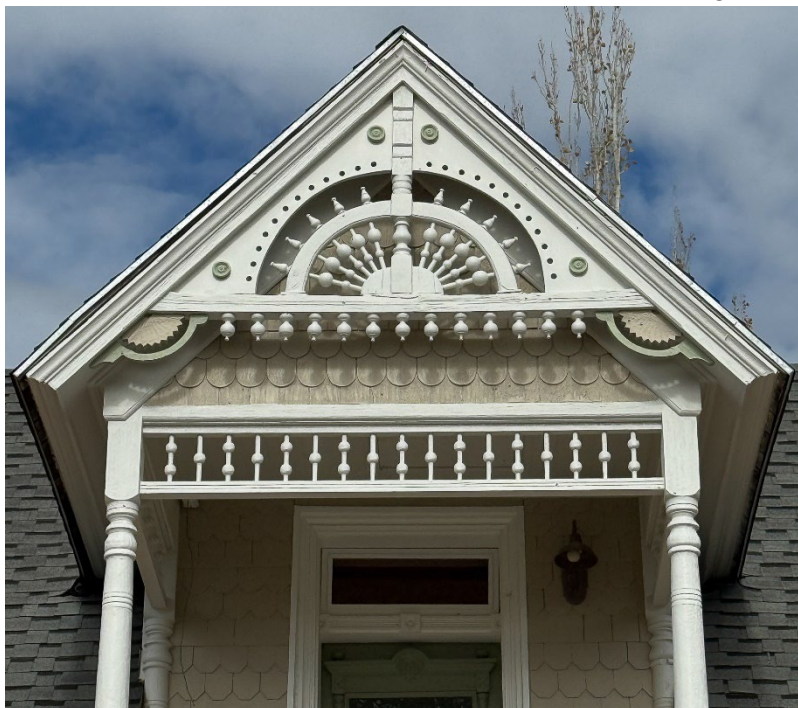
**Photograph 5**

South elevation, balcony ornamentation details. Camera facing north.

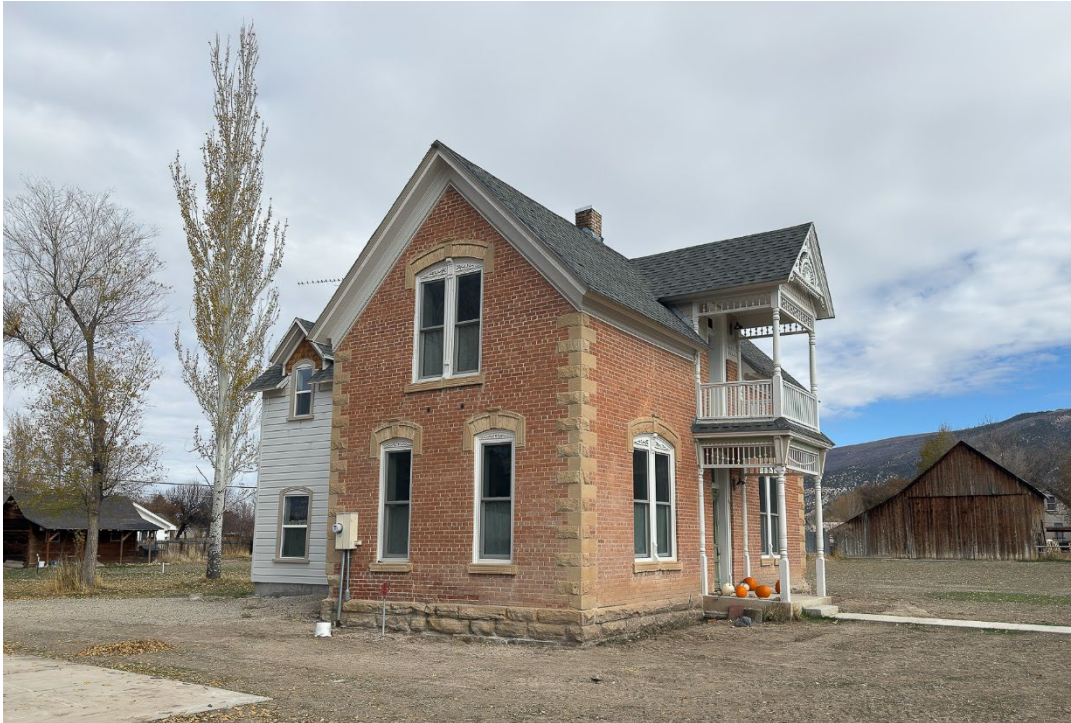
**Photograph 6**  
South and west elevations of house. Camera facing northeast.

The west and east elevations are similar. The brick masonry reaches the apex of the gable. The west elevation faces 500 West and has quoins at both corners, as well as a denticulated cornice [Photographs 6-7]. The hood moldings and sills are similar to the façade, but with rowlock brick taking the place of the rock-face stone in the molding. There are two double-hung wood sash windows on the main level and a narrow coupled window on the upper level. The original southwest window was in good condition and was rehabilitated. The other windows were damaged and replaced with windows similar to the façade. The east elevation does not face a street and has quoins at the south corner only. An out-of-period concrete block chimney was attached and later removed from the east elevation [Figure 7]. There is one double-hung wood sash window on each level, offset from center, one north and one south [Photograph 8]. The hood moldings are brick and the sills are wood. There are no quoins at the northeast corner and the foundation has been braced with later concrete.

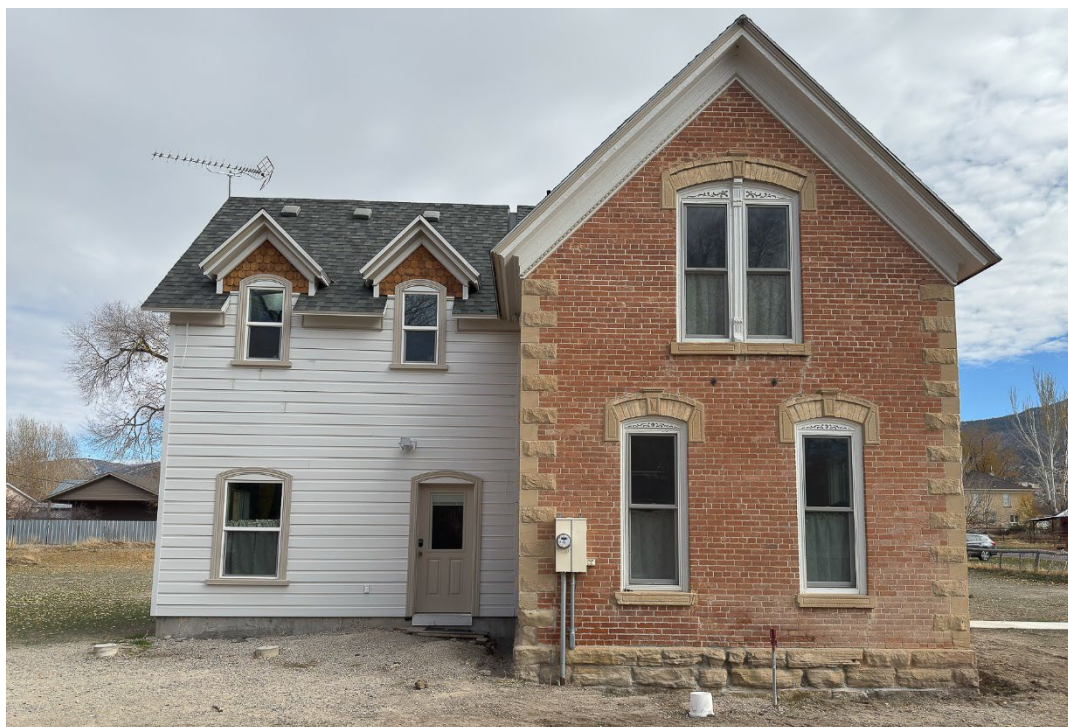
**Photograph 7**  
West elevation of house and addition. Camera facing east.

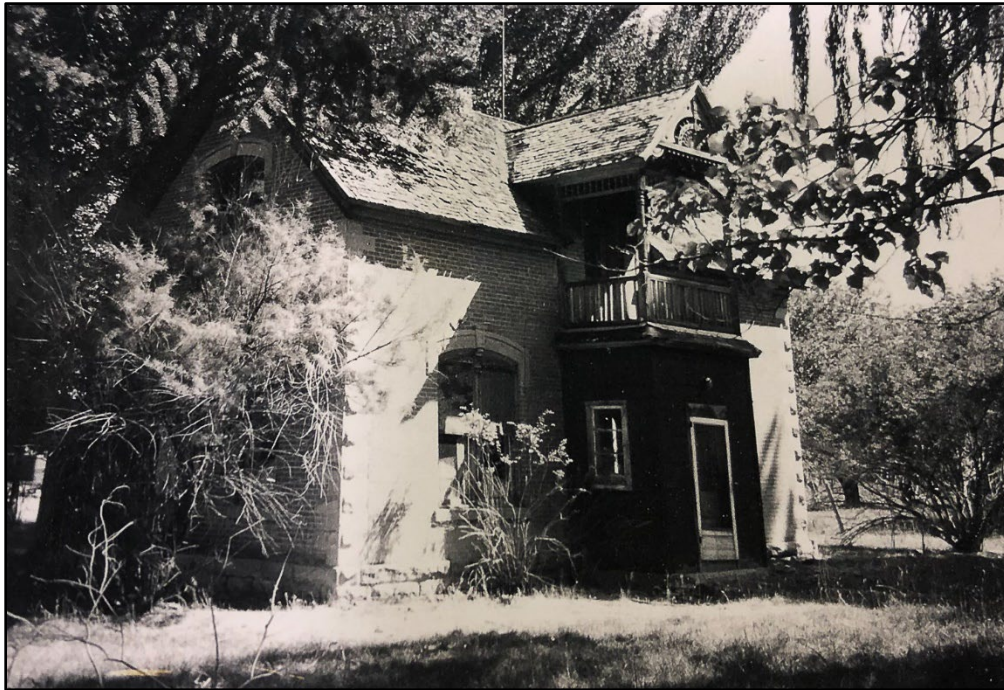
**Figure 4**  
South and west elevations (circa 1980). Camera facing northeast.

On the upper balcony, the support posts are duplicated in a slightly shorter version. Prior to 1980, the jig-sawn balustrade was also removed and replaced with square posts, although the upper balcony was never enclosed [Figures 4-5]. The upper frieze also features spools & spindles. Under the simple gable projecting roof, the gable trim is fish-scale shingles. In front of the shingles is an elaborate Eastlake spool & spindle fan with drop ornaments, jig-sawn bracket fans, and paterae [Photograph 5]. Flanking the upper portion of the upper-story door is an imbrication pattern of octagonal and square-butt shingles. All of the above woodwork is currently painted white (circa 1990s). The upper-story door is the original half-glass wood door with a Victorian Eclectic classical surround.

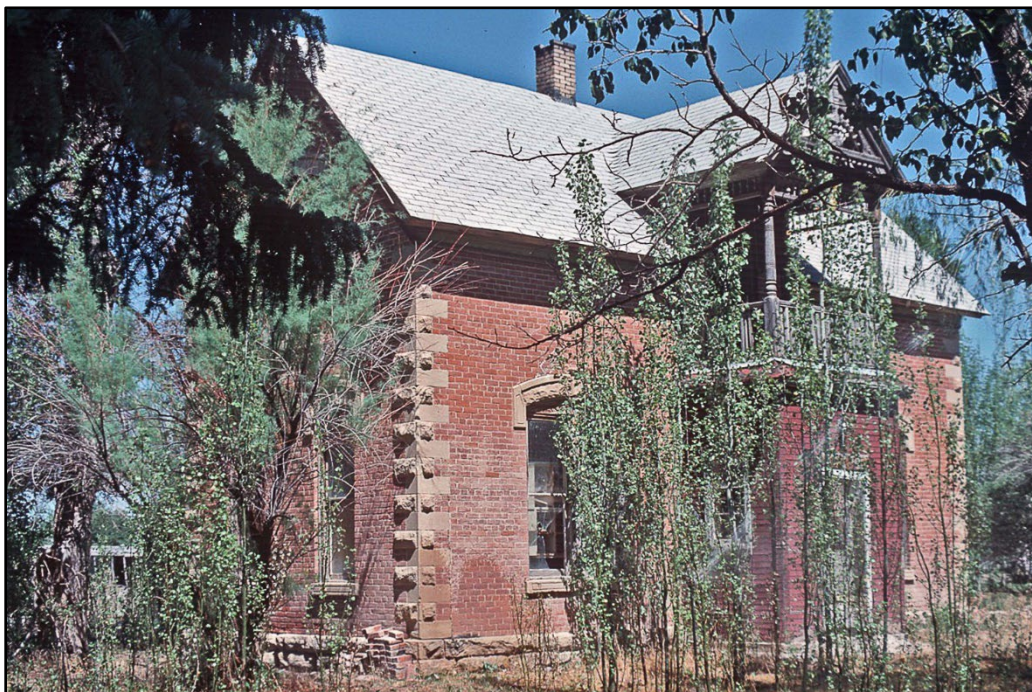
**Figure 5**  
South and west elevations (circa 1985). Camera facing northeast.

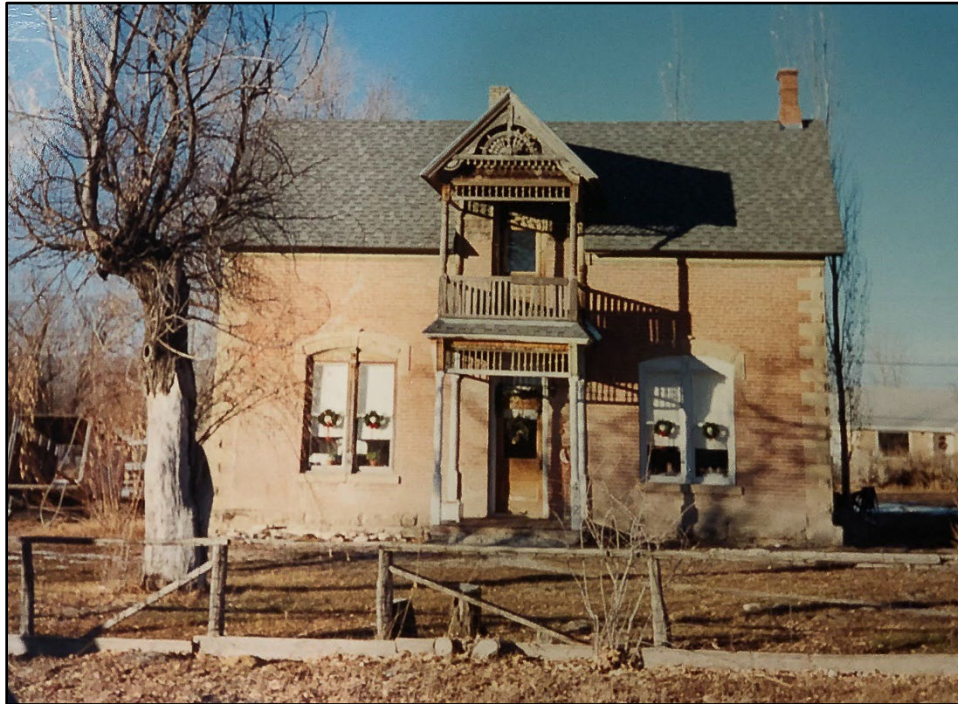
**Figure 8**  
South elevation (circa 1995). Camera facing north.

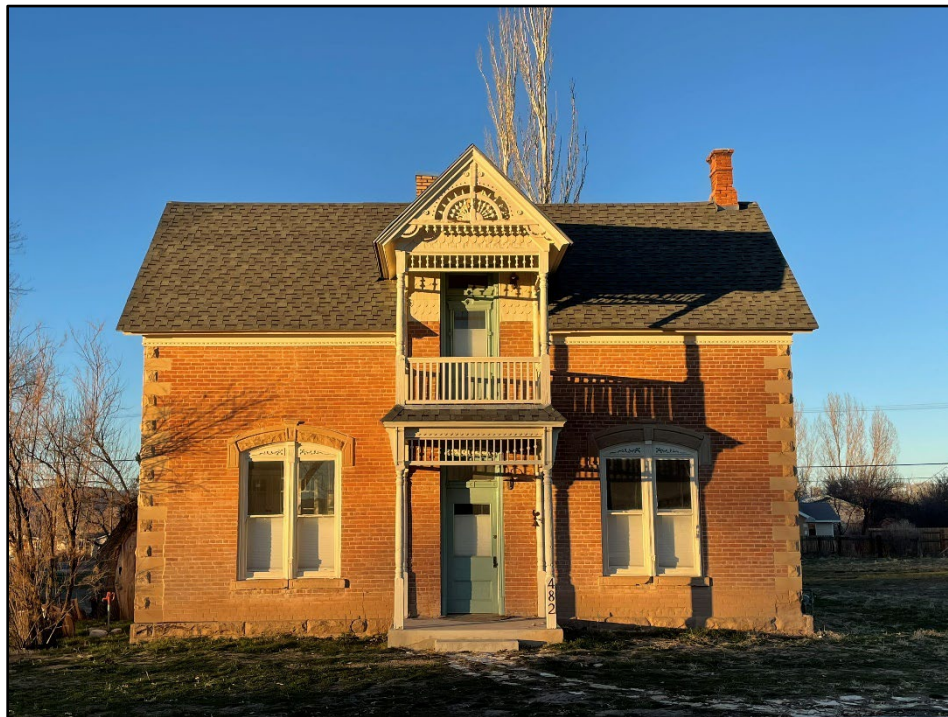
**Figure 9**  
South elevation (2021). Camera facing north.
