**7/15/2025**United States Department of the Interior  
National Park Service**National Register of Historic Places Registration Form**

**1. Name of Property**Historic name: Clover Ward LDS MeetinghouseOther names/site number: Rush Valley Fire Station #1Name of related multiple property listing: N/A

**2. Location**Street & number: 630 S. West Shambip Rd.City or town: Rush ValleyState: UtahCounty: TooeleNot For Publication: ☐Vicinity: ☐**3. State/Federal Agency Certification**

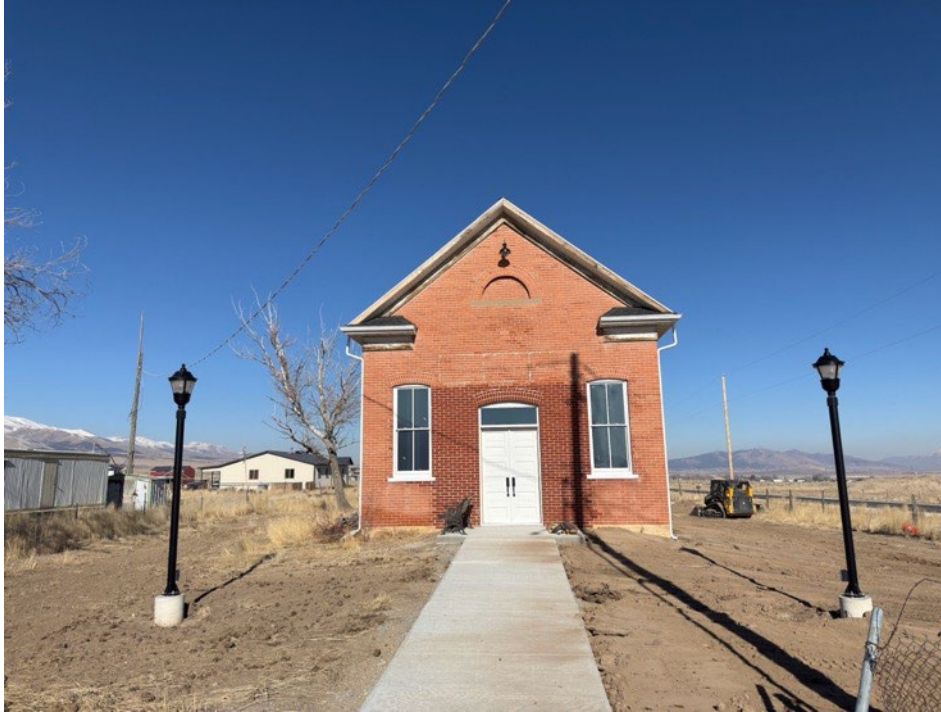
**Photograph 1 of 19.** Exterior, south (main) façade. Camera facing north.

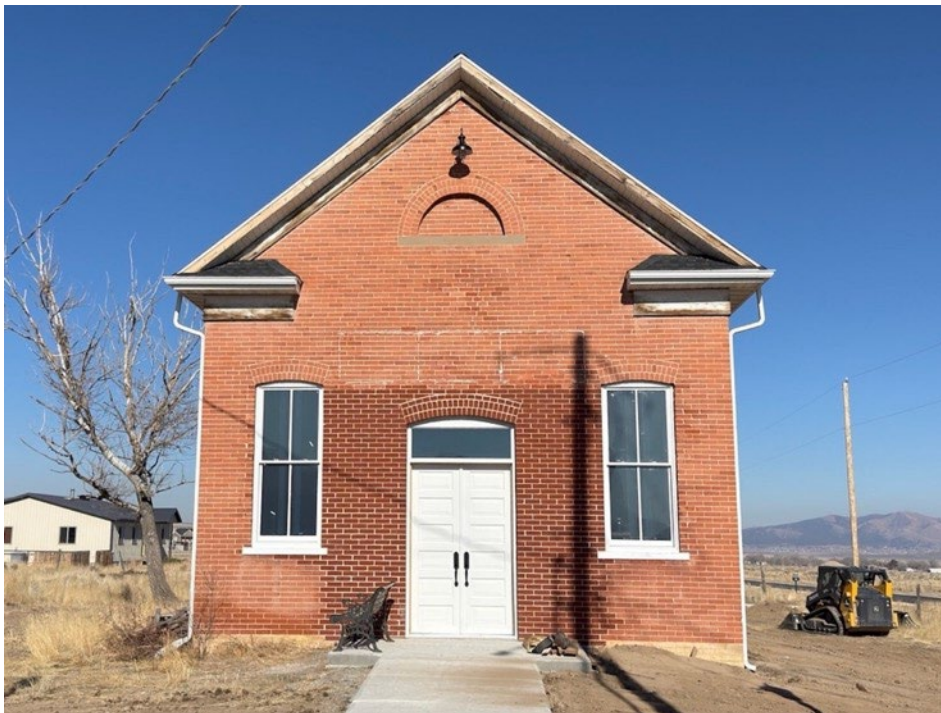
**Photograph 4 of 19.** Exterior, south (main) façade. Camera facing northwest.

The church's south elevation serves as its primary façade and retains many of its original materials. Historically, it housed a pair of centrally located double doors surmounted by a two-light transom and brick segmental arch. (Figure 1) These were removed, the opening enlarged, and a roll-up garage door inserted for the fire engine circa 1970. (Figure 4) The original entryway and brick surround were recently replicated with new materials, using a concrete block substrate and exterior brick selected to appear as much like the original as possible. The doorway has been replicated to match its historic opening size and original location within the south facade. Wood double doors, painted white, feature six panels divided by raised wood trim. The entry is surmounted by a single-light transom. (Photo 4)

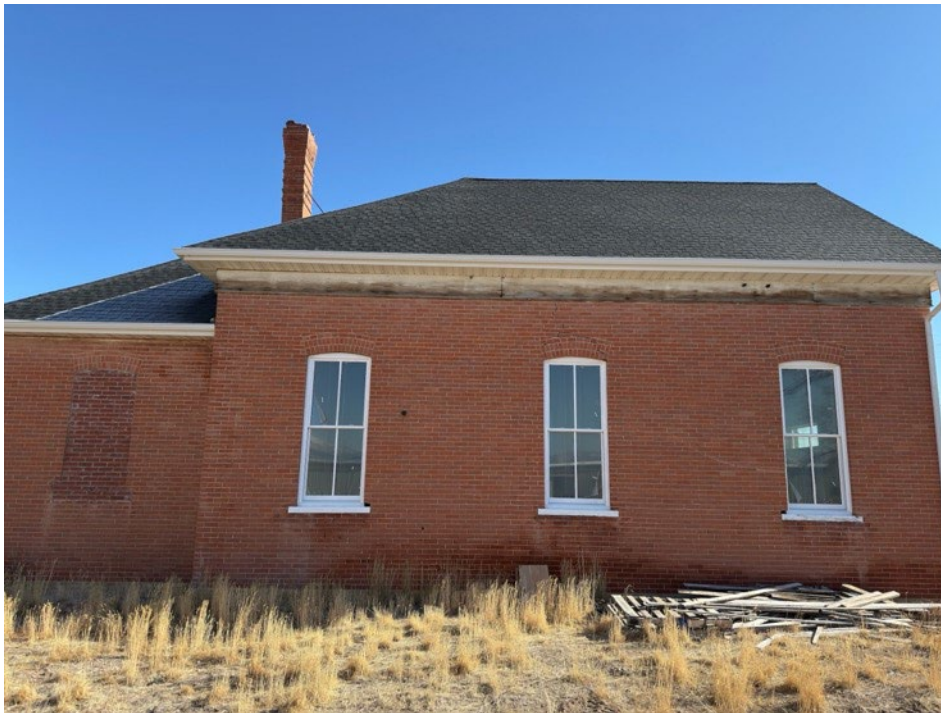
**Photograph 6 of 19.** Exterior, west facade. (Property boundary created a limitation to a clearer straight-on view of this façade.) Camera facing east.

The west facade is composed of brick with three symmetrically placed 2-over-2 double-hung wood frame windows. The rear addition is recessed approximately one foot from the west facade and extends 16'7" to the north. The addition originally housed another window of similar size. The window was removed, and the opening was bricked in at an unspecified date, likely concurrent with the construction of the fire station in the early 1970s. Each window is framed by a rounded lintel topped by a segmental arch. The arches are composed of two rows of stacked header course bricks surmounted by a single row of horizontal headers. The windows are underscored by simple wood lug sills. (Photo 6) Discoloration is notable on the masonry near the west foundation. Some of the damaged bricks on the west addition facade near the northwest corner foundation were replaced at an unspecified time, likely during its period of use as a fire station, circa 1976-1993.

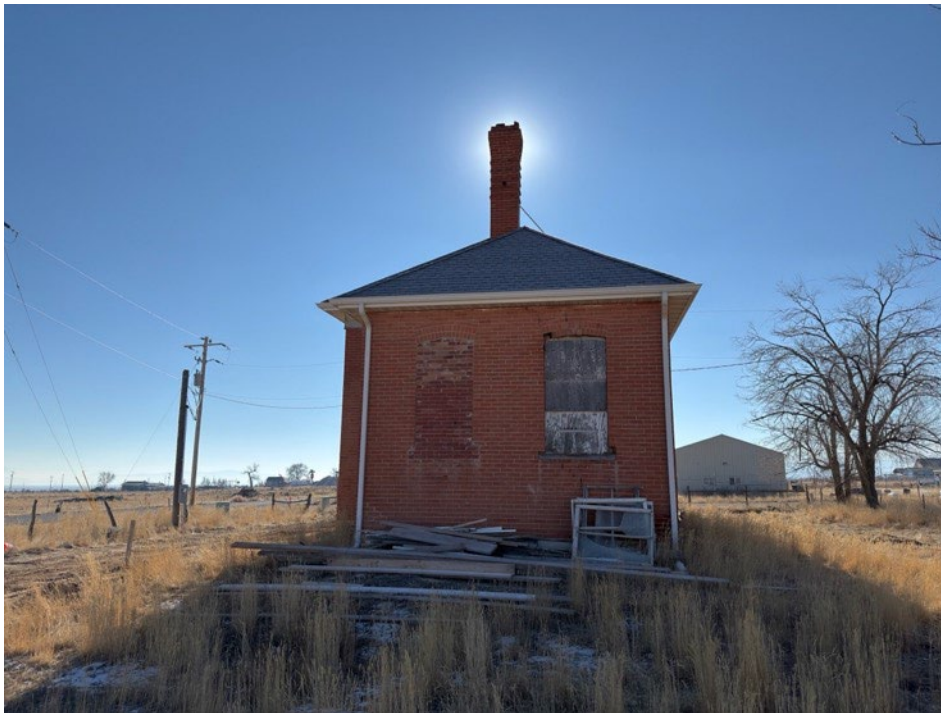
**Photograph 8 of 19.** Exterior, north facade. Camera facing south.

The north facade is dominated by the rear addition, which spans 12'5" of the 24-foot facade. Originally, the addition's north facade included two windows with openings similar to the others around the building. These were removed and bricked at an undetermined date. One of the openings is currently boarded. Several cracks in the masonry have formed around the westernmost opening. The north facade of the main structure originally contained a door that granted exterior access to the stage. The outline of the opening remains intact but was bricked in at some point, likely when the structure became a fire station, circa 1976-1993. The opening, like all features of the building, is surmounted by a segmental arch composed of brick headers. The building retains one of its original brick chimneys, which rises from the north slope of the hipped roof. (Photo 8) The chimney is most visible from the north (rear) facade. Five courses of brick corbelling add interest to the elongated feature and visually balance its verticality.

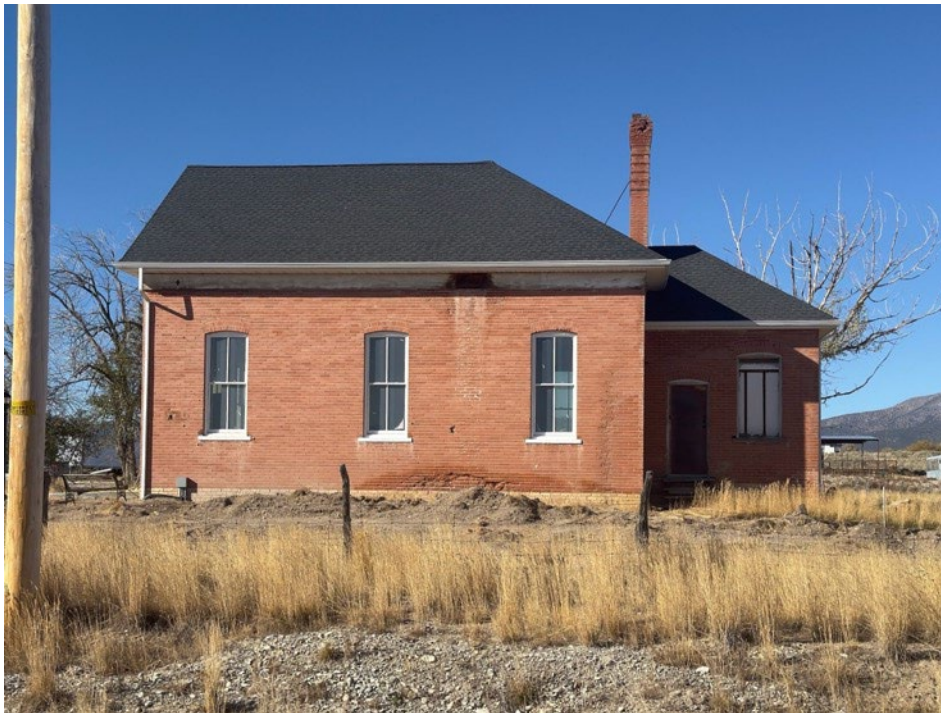
**Photograph 10 of 19.** Exterior, east facade. Camera facing west.

The east facade is like the west, with three double-hung two-over-two wood frame windows spaced symmetrically along the facade. A brick stove chimney originally rose from the east facade and connected to an interior pot-belly stove between the two northernmost windows. The chimney rose approximately six feet above the roofline. (Figure 2) It was removed during the 1970s remodeling for the fire engine. At that time, central heating was installed in the building.<sup>3</sup> The east facade of the rear addition includes an extant entrance to the former vestry, which is currently accessed by a makeshift metal door. However, the frame is original and is composed of wood. The door is elevated approximately two feet from the ground and is reached by a weathered wood staircase. (Photo 10) A single window formerly flanked the door to the north. The window has been removed, and the opening is bricked in, but the wood encasement and sill are original. Two areas of the east facade masonry have been damaged by drainage from the roof. Near the foundation, areas of the original brick are discolored and crumbling.

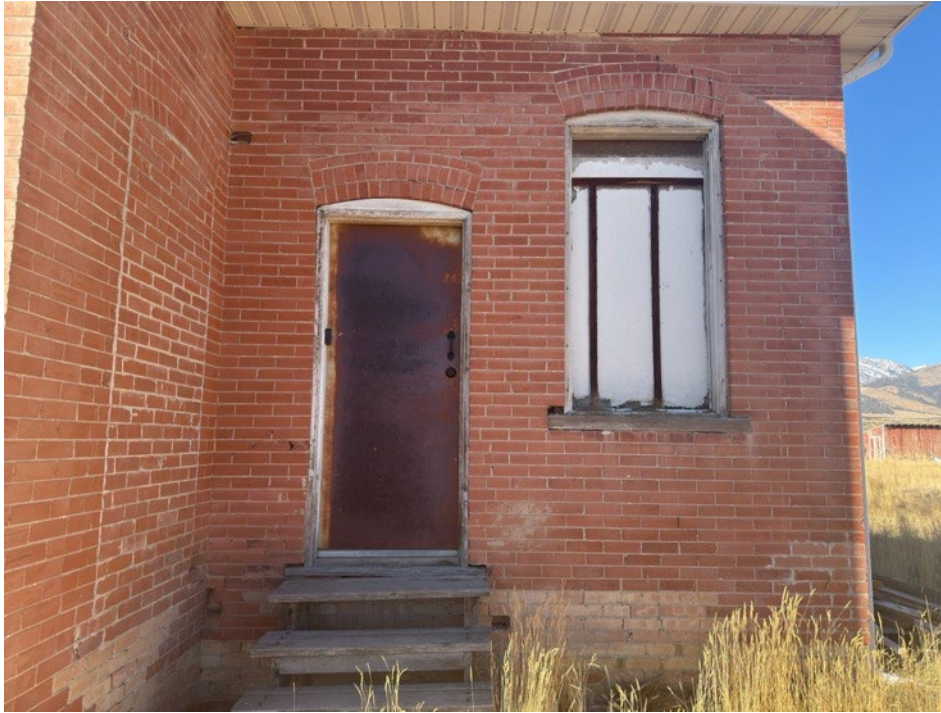
**Photograph 11 of 19.** Exterior, east facade, details of vestry addition. Camera facing west.

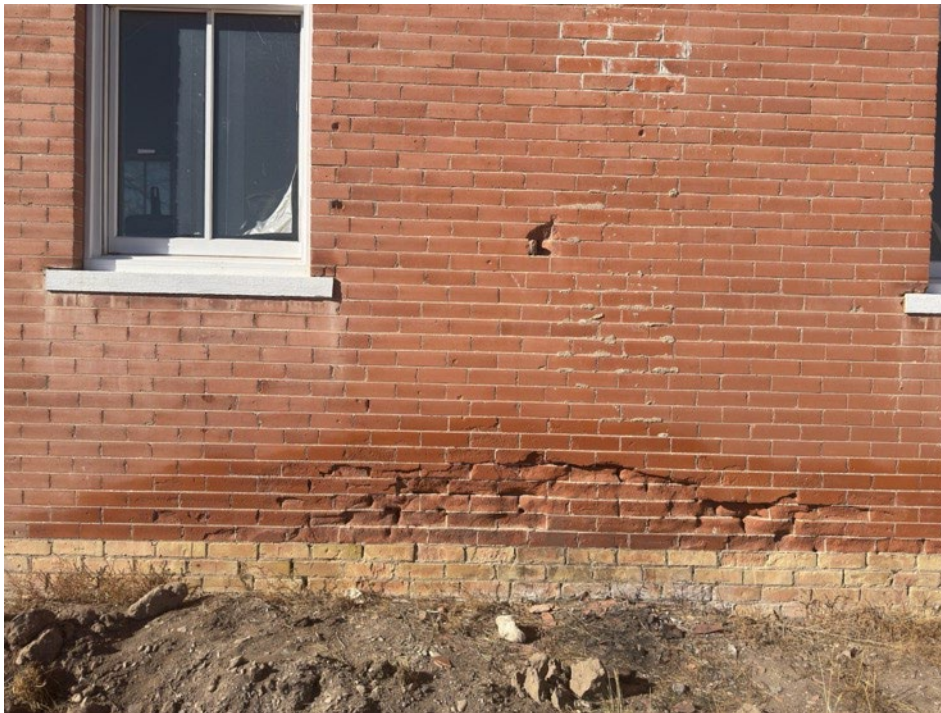
**Photograph 12 of 19.** Exterior, detail of brick deterioration, east facade. Camera facing west.

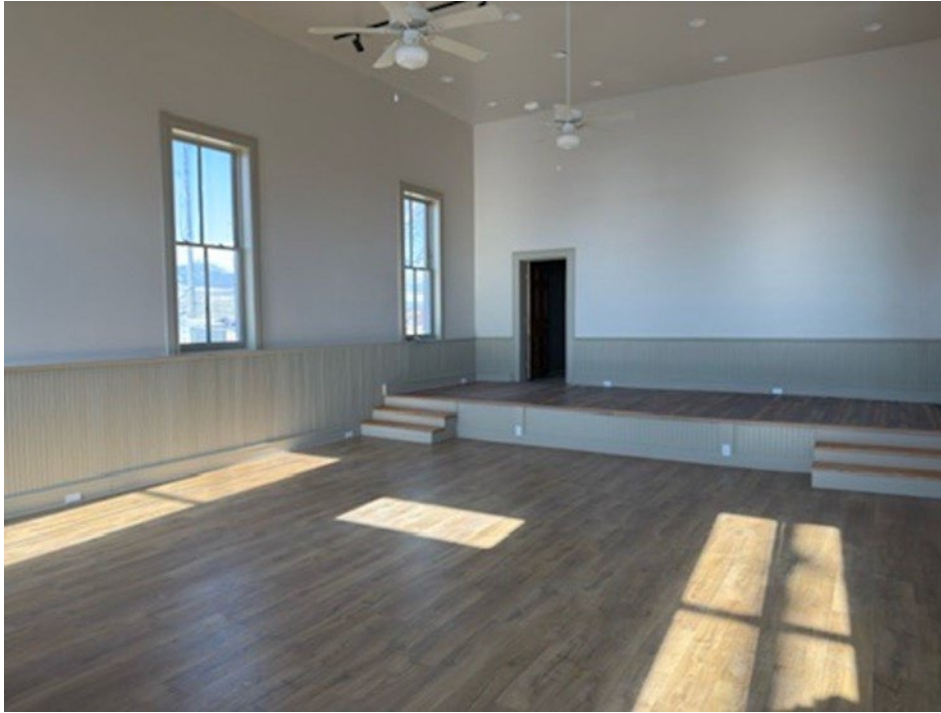
**Photograph 13 of 19.** Interior, refinished floor and stage. Camera facing northwest.

Clover Meetinghouse is a rectangular structure with a small vestry located off the rear (north) facade, that measures approximately 811 square feet on one level. The interior space of the chapel has been renovated and no known historical photos of the interior exist (Photo 13-15). Inside the chapel, pews or chairs would have faced the north end of the room where there was a stage for presentations. The furnishings and stage were likely removed between 1970 and 1976 when the building was remodeled to house a fire engine. The stage has been recreated, and the size and height were determined by “ghost lines” (figure 12) left when the original stage was removed.<sup>4</sup> The stage is 19 inches in height off the main chapel floor. Behind the stage are two entryways: one on the east and another on the west. The western entryway was probably used as a separate entrance to the chapel. It was filled with brick at some unknown time and covered with plaster and wood panel siding. The eastern entryway behind the stage measures 2’11” wide and 7’ tall and retains original trim (photo 13).

On the main floor of the chapel, a concrete floor, installed for the fire truck in the 1970s, is covered with vinyl planks with a wood finish. The stage, measuring 21’9” long, 8’7” wide, and 1’7” tall, was replicated with wood and has small wood stairways from the main floor to the raised stage on both the east and west ends. The ceiling is covered with drywall and contains 24 recessed can lights, three hanging ceiling fans, and three stage lights above the stage area. Wainscoting paneling follows every wall of the main chapel area and rises from the main floor to the base of the eight windows of the main chapel and stage areas. According to exterior historical images, a brick chimney adorned the east facade, which probably heated the chapel. No evidence of the stove and chimney remains on the interior. Along the east interior wall and bordering the main entrance façade is a small electrical control box (photo 16). On both the west and east facades are six double-hung wood frame windows that were custom-built to replicate the original windows.

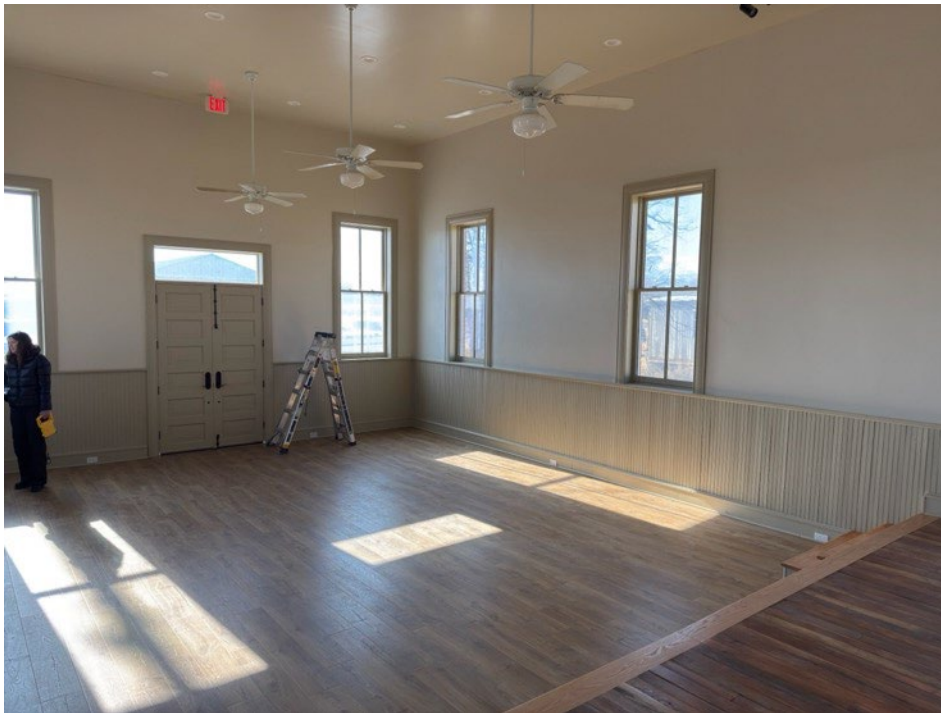
**Photograph 14 of 19.** Interior, showing wainscoting, windows, plaster, and replicated main entryway. Camera facing southwest.

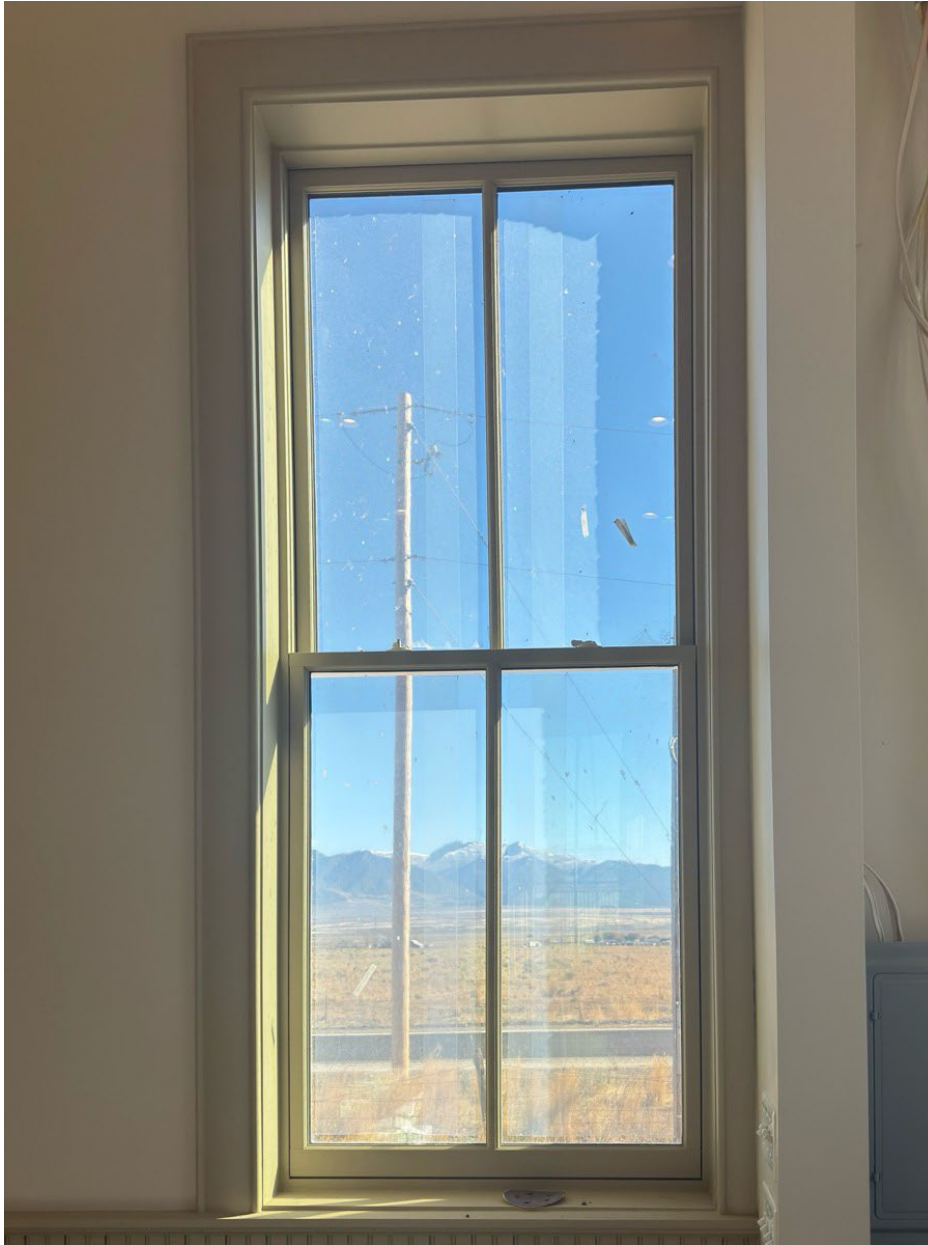
**Photograph 16 of 19.** Interior, detail of replicated windows and power box can be seen to the right. Camera facing east.

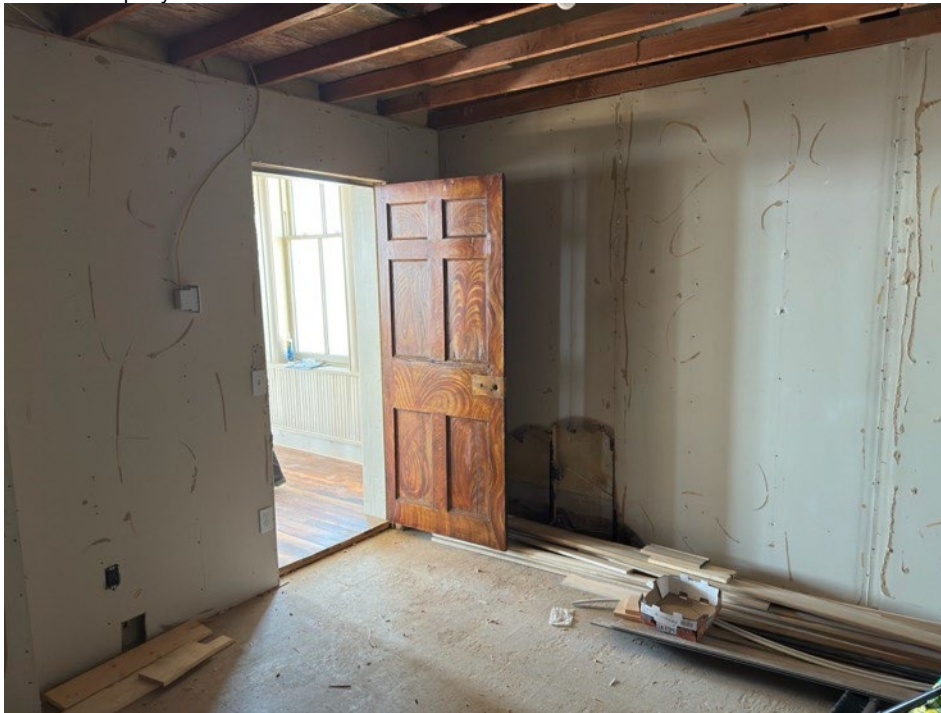
**Photograph 17 of 19.** Interior, vestry addition, detail of removed panels, and exposed rafters. Camera facing southwest.

Behind the stage rear wall, in the north addition, is the vestry. The vestry currently houses construction equipment and is used as a general storage area for the rehabilitation project. All of the interior walls are exposed drywall in various states of repair (photos 17-19). In the 1980s, wood paneling was installed by the Beehive Telephone Company (figure 14) when the building housed telephone equipment during the construction of the telephone building to the south. Interviews conducted with local history expert and site coordinator, John Cluff, indicate that the Beehive Telephone Company only utilized the vestry. Additionally, only small changes to the exterior, including a small power box and telephone lines placed underground, had been made, and all of which have been removed. This paneling has since been removed.<sup>5</sup> The wood-paneled, faux-grained door that leads to the vestry is not original and was salvaged from another historic building. The ceiling is presently exposed rafters with exposed electrical work. The original brick of the remaining chimney can be seen along the south wall of the vestry and above the exposed rafters.

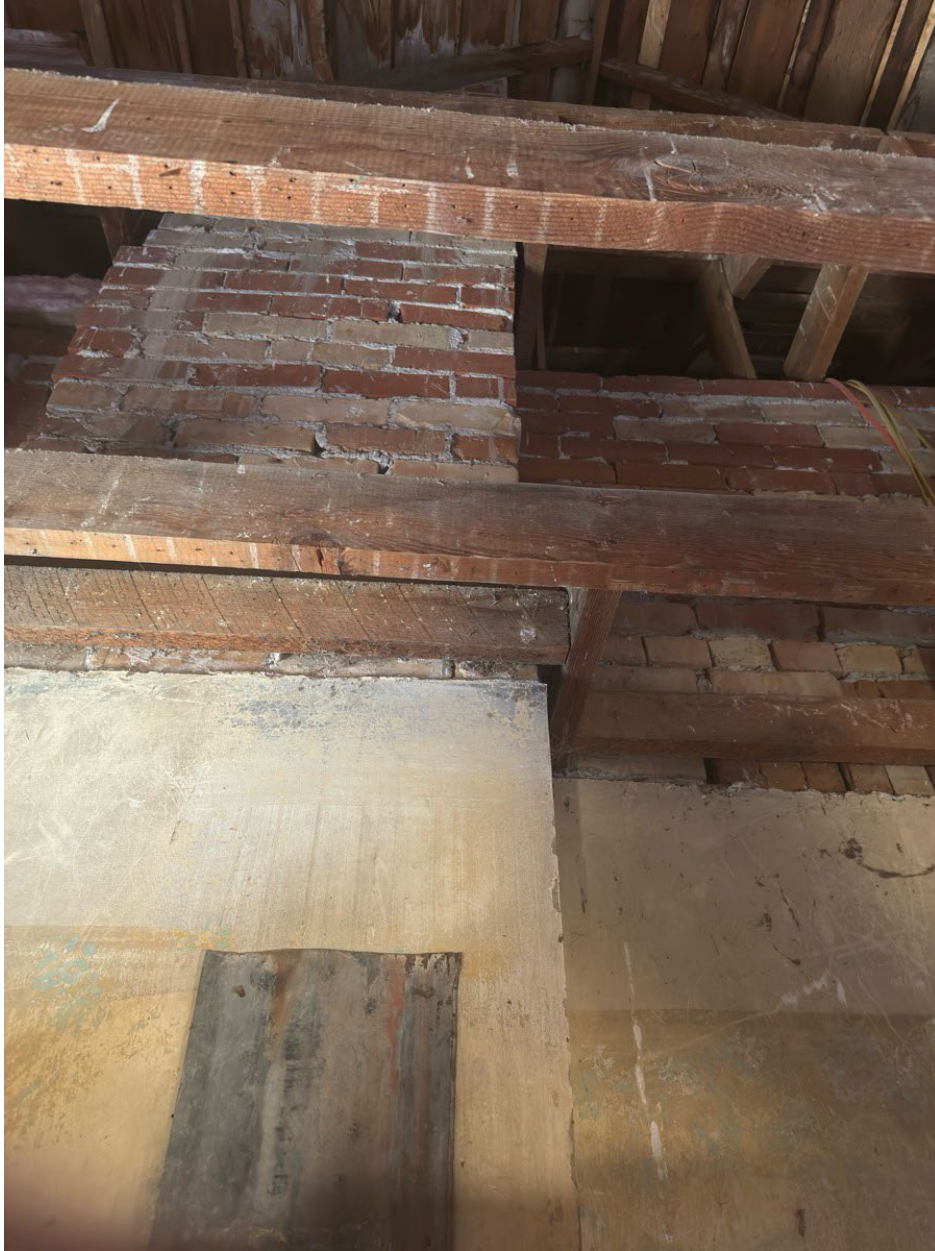
**Photograph 19 of 19.** Interior, vestry addition, detail of exposed rafters and original masonry. Camera facing up.

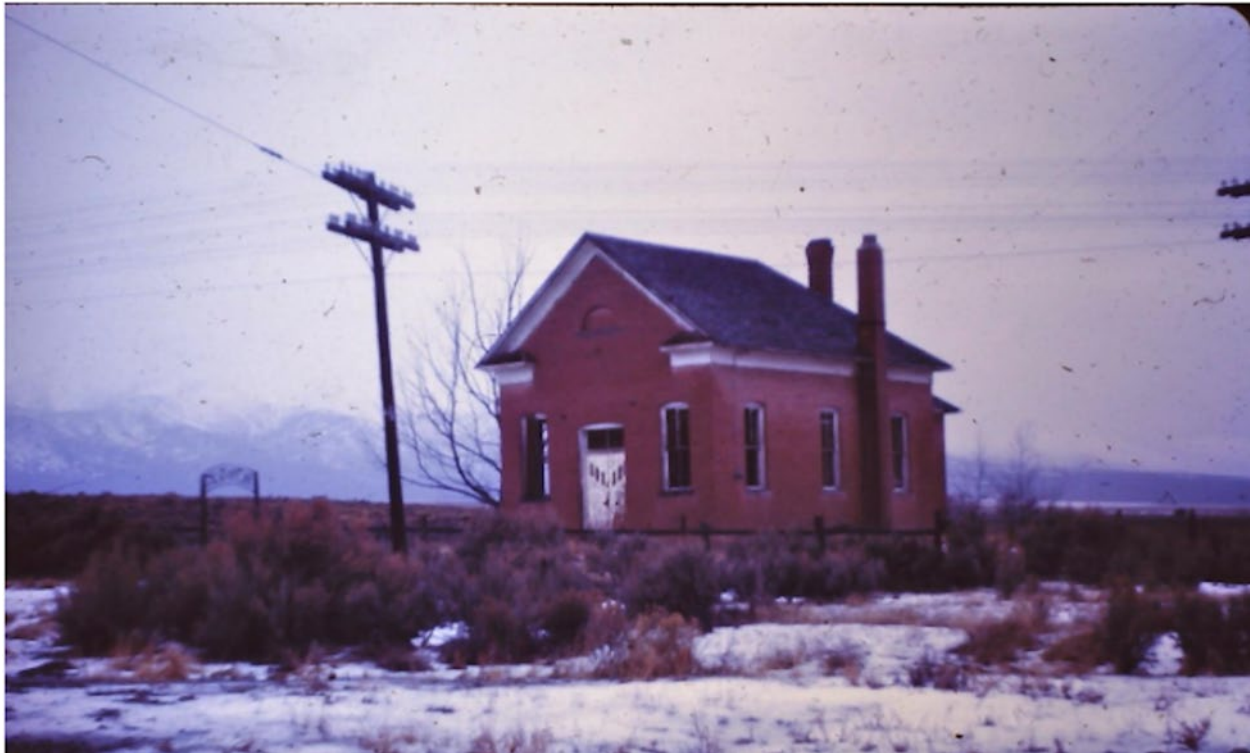
**Figure 4 of 14.** Clover Meetinghouse, ca. 1960. Note the power lines, replaced entryway doors, and removal of the bell tower. Camera facing northwest. Source: John Cluff.

<sup>2</sup> Historic photos show the extant cupola as late as 1944. The tower is absent in a photograph from 1960.

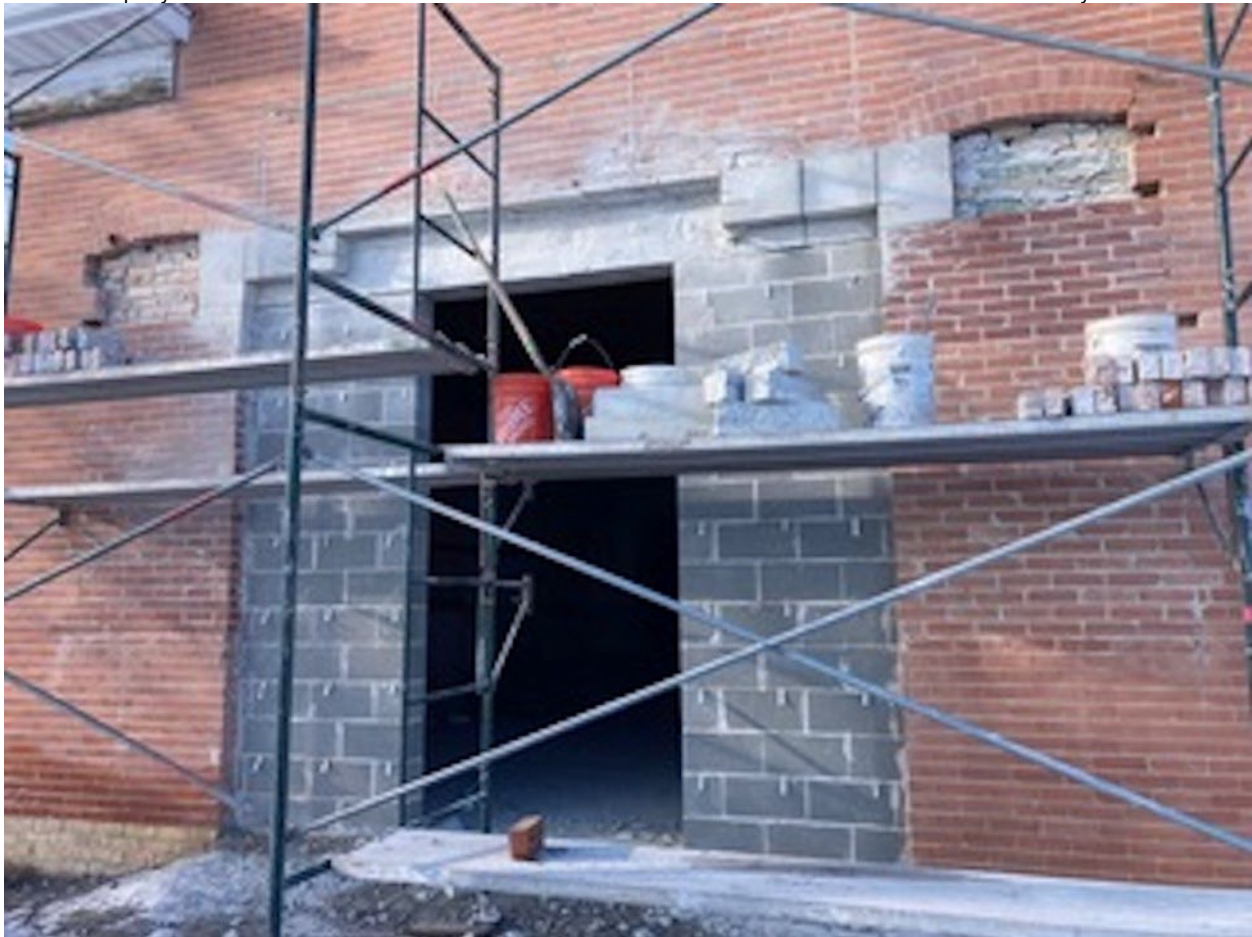
**Figure 8 of 14.** Restoration of the main (south) façade entryway, ca. 2022. Camera facing north. Source: Clover Church Restoration Committee.

The scope of work for the rehabilitation included replicating the original appearance on the south elevation including bricking in the larger opening and replicating the original fenestration, including the double doors, transom window, and segmental arch. Deteriorated mortar joints have been repointed on all facades in critical areas.<sup>6</sup> The project also entailed installation of custom-made wood-sash and frame windows to match the originals based on photographs. Other exterior directives included the replacement of aluminum gutters and restoration of the original wood cornice and entablature along the roofline. In a future phase, the committee plans to replicate the bell tower that was removed.

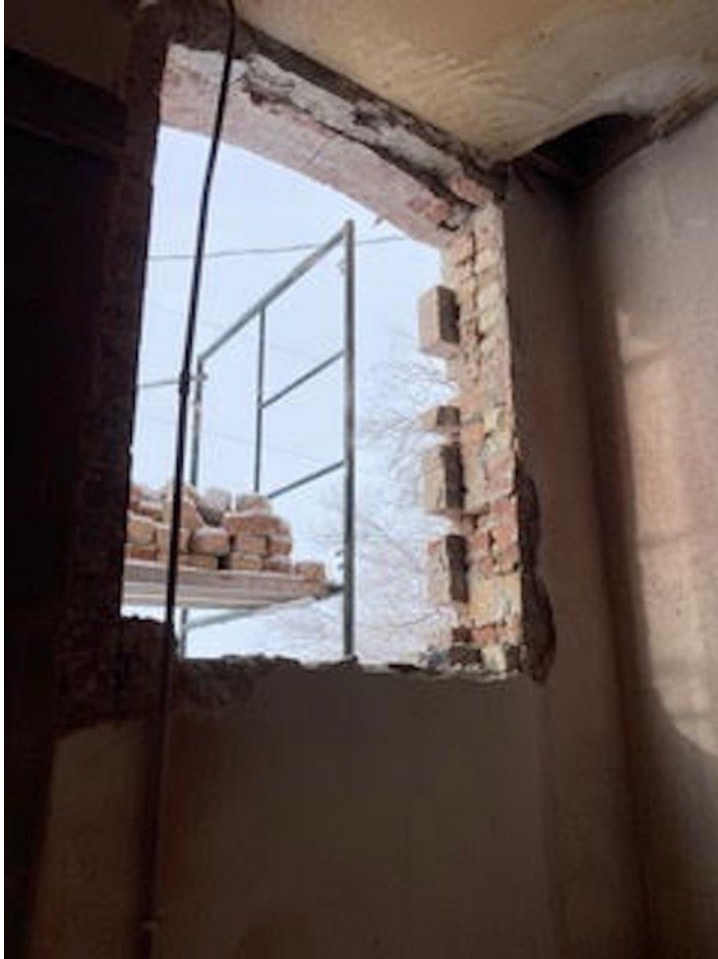
**Figure 9 of 14.** Interior photo of the south façade window restoration, ca. 2022. Camera facing south.  
Source: Clover Church Restoration Committee.

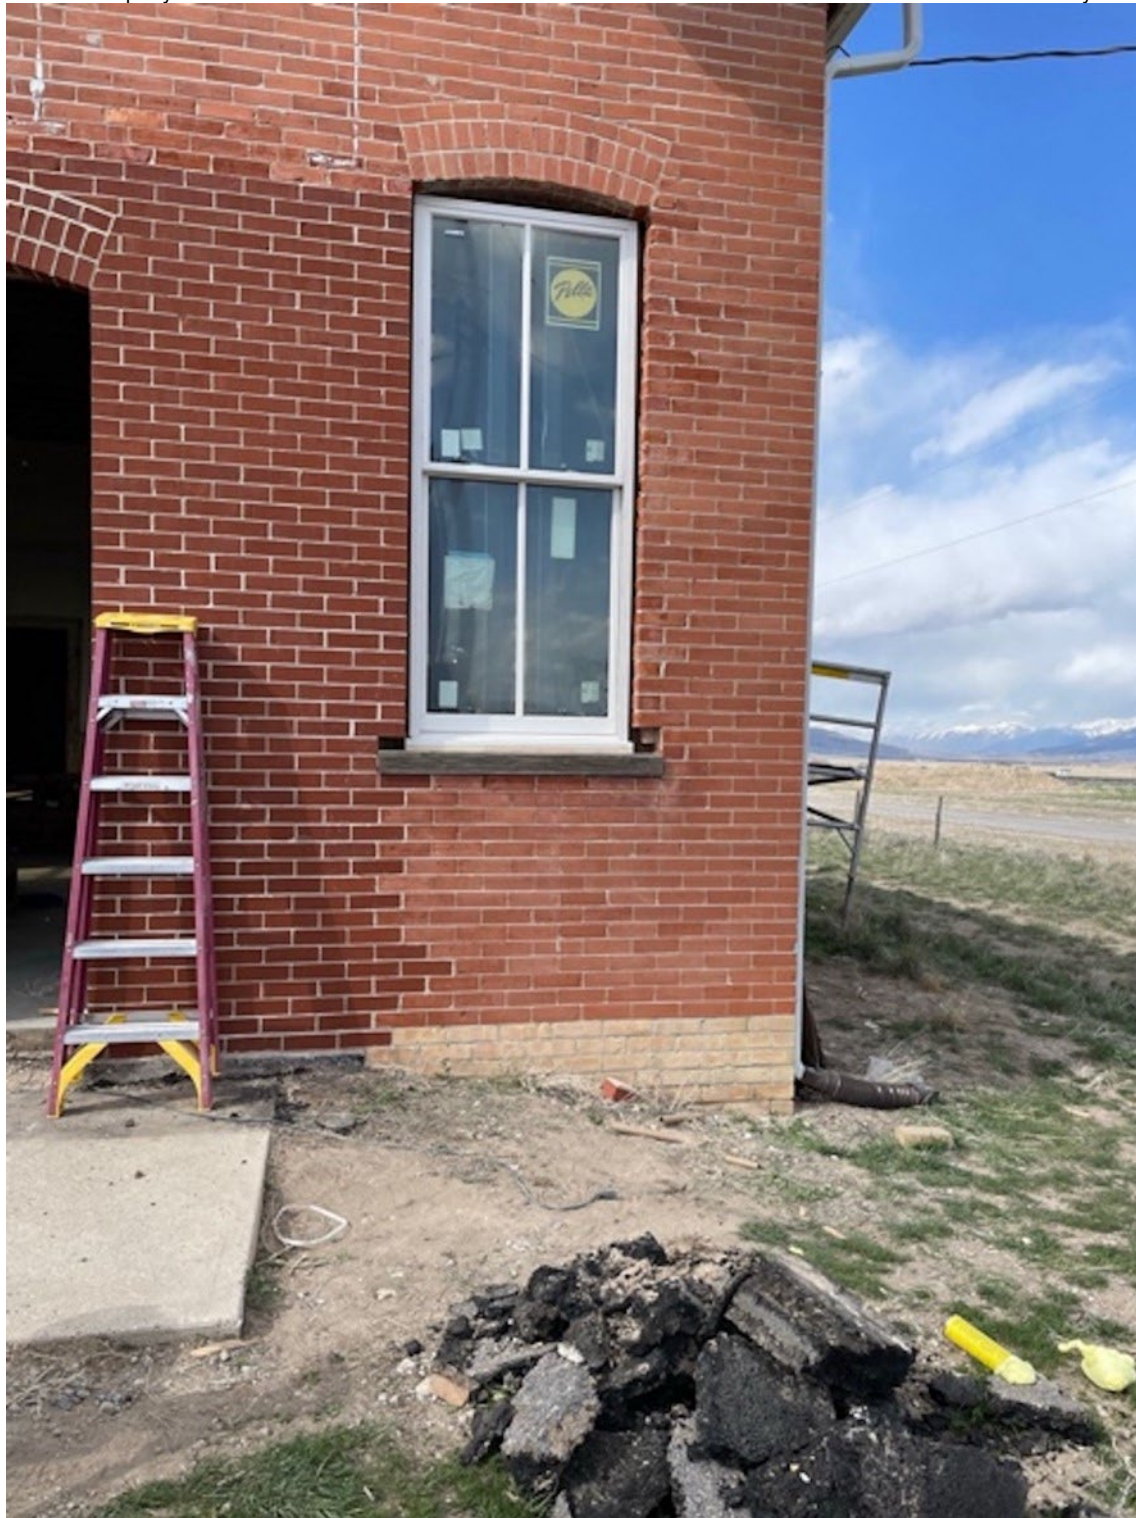
**Figure 10 of 14.** Restored brick and masonry on the Clover Meetinghouse main (south) façade, ca. 2022. Camera facing north. Source: Clover Church Restoration Committee.

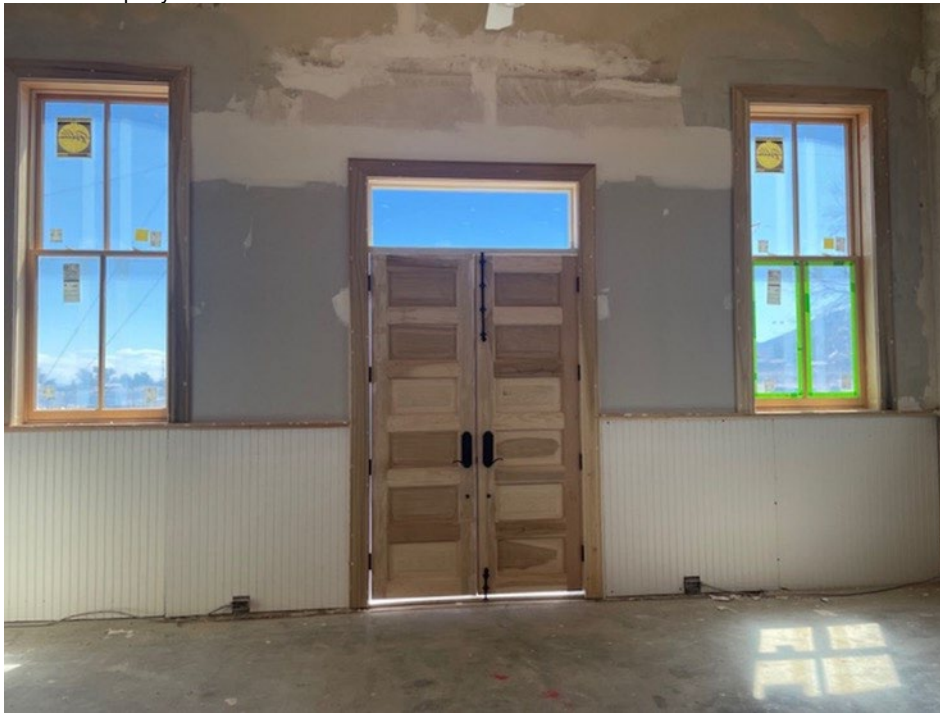
**Figure 11 of 14.** Interior renovations of the south façade, showing window and entryway replacements, ca. 2022. Camera facing south. Source: Clover Church Restoration Committee.

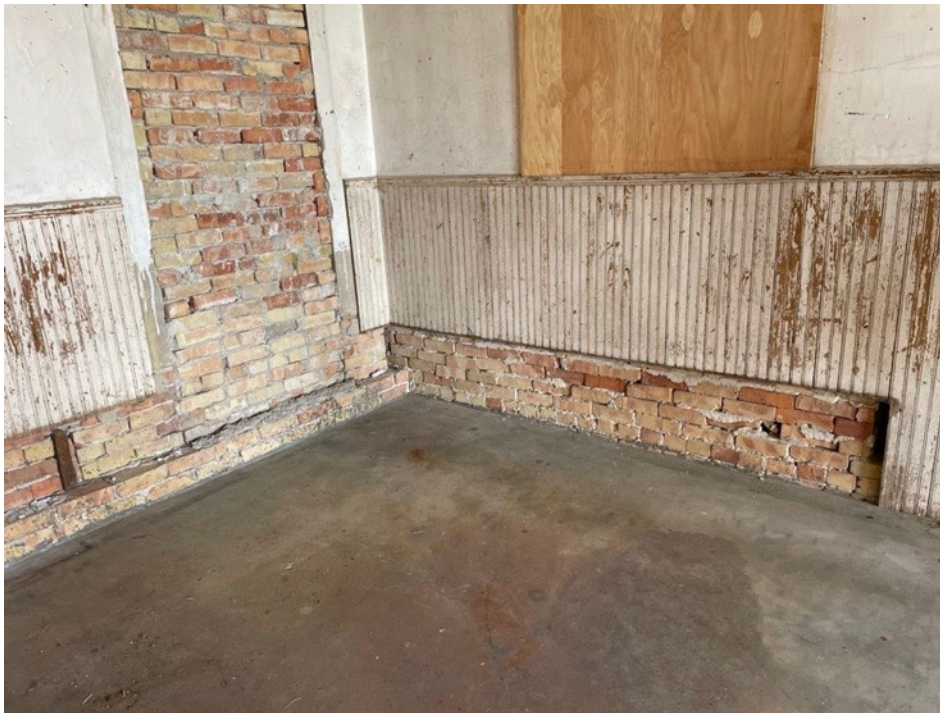
**Figure 12 of 14.** Photograph of the stage area prior to reconstruction, ca. 2022. Note the extant “ghost lines” of the original stage and the bricked doorway. Camera facing northeast. Source: Clover Church Restoration Committee.

<sup>4</sup> Images provided by local historian, and site coordinator, John Cluff, show the exposed brick from the original stage removal, and the height of the stage can be identified.

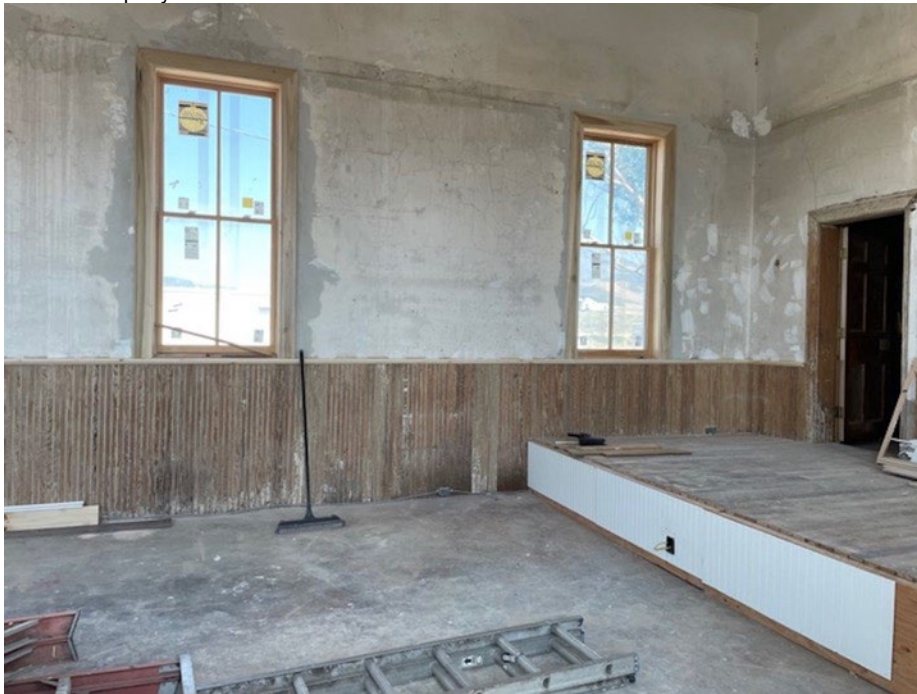
**Figure 13 of 14.** Interior renovations to the west façade and stage reconstruction, ca. 2022. Note the replacement windows and new stage. Camera facing west. Source: Clover Church Restoration Committee.

The firehouse concrete slab was leveled and covered by vinyl flooring that approximates the building's original wood. The stage was reconstructed of reclaimed tongue-in-groove wood from buildings at the Dugway Proving Ground, a nearby U.S. Army facility. The committee led a grassroots effort to power wash the wood and reassemble the stage in its original height and location. The acoustic tile ceiling installed during the fire station era was removed and the original height from the period of significance restored. Above the ceiling, the rafters and beams of the roof are original to the building. The interior walls are largely original. The beadboard wainscoting has been repaired/replaced in kind to its appearance during the period of significance.<sup>7</sup> The plastered walls are original. Cracks have been repaired, the walls skim coated, and restored to their original color, which was matched to an early layer of paint discovered during the process.

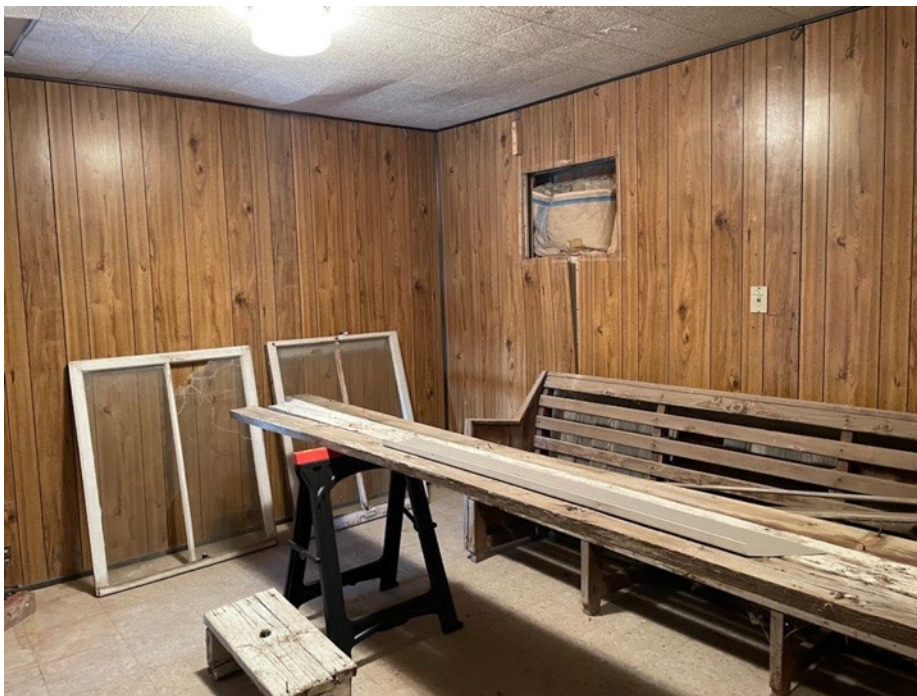
**Figure 14 of 14.** Interior of vestry prior to renovations, ca. 2022. Note the wood paneling installed by Beehive Telephone Company in the 1980s. Camera facing northwest. Source: Clover Church Restoration Committee.
