United States Department of the Interior  
National Park Service**NRHP Listed Date:****7/27/2026****National Register of Historic Places Registration Form**

**1. Name of Property**Historic name: Tenth East Senior CenterOther names/site number: Elder Citizens Center; Senior Citizens CenterName of related multiple property listing: N/A

**2. Location**Street & number: 237-239 South 1000 EastCity or town: Salt Lake CityState: UtahCounty: Salt Lake CountyNot For Publication: ☐Vicinity: ☐**3. State/Federal Agency Certification**

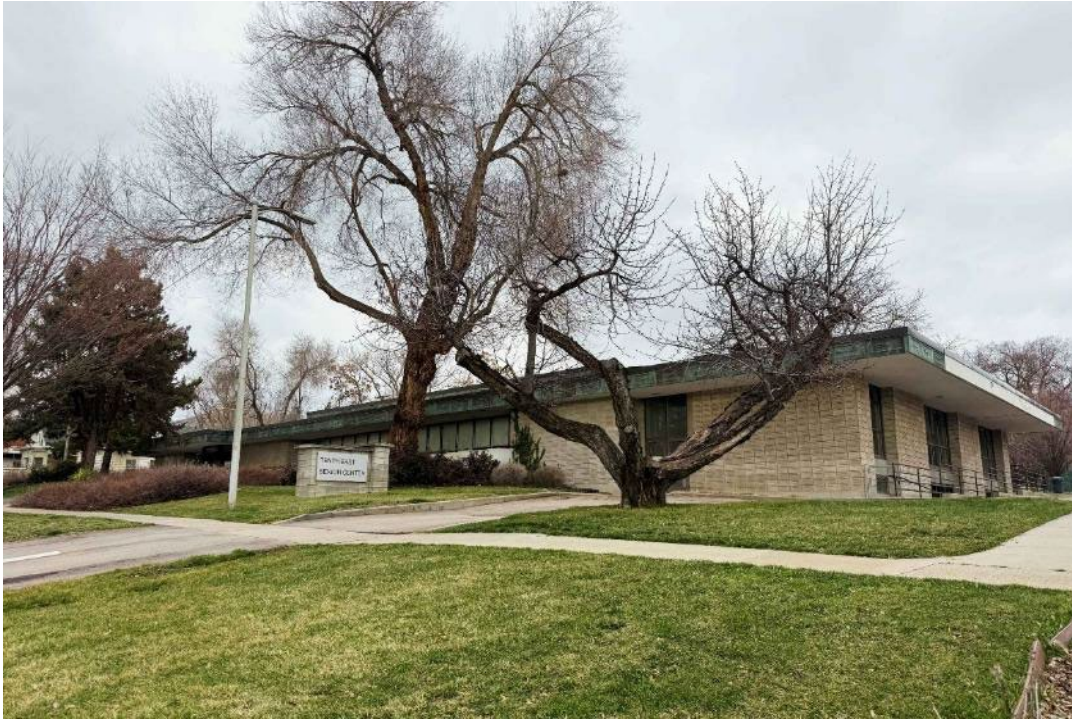
**Photograph 1**

The west elevation of the Tenth East Senior Center [Photograph 1] is the building's primary public façade and is characterized by a long, low horizontal composition defined by a deep roof overhang, patterned concrete masonry walls, and extensive dark-framed glazing [Photographs 1, 3, 4, and 5]. The elevation is capped by a continuous band of metal panel fascia set within a dark frame, visually unifying the roofline and reinforcing the building's mid-century modern horizontality. The underside of the overhang is a flat concrete soffit with regularly spaced recessed light fixtures that illuminate the sheltered walkway below.

West elevation of the Tenth East Senior Center. Camera facing northeast.

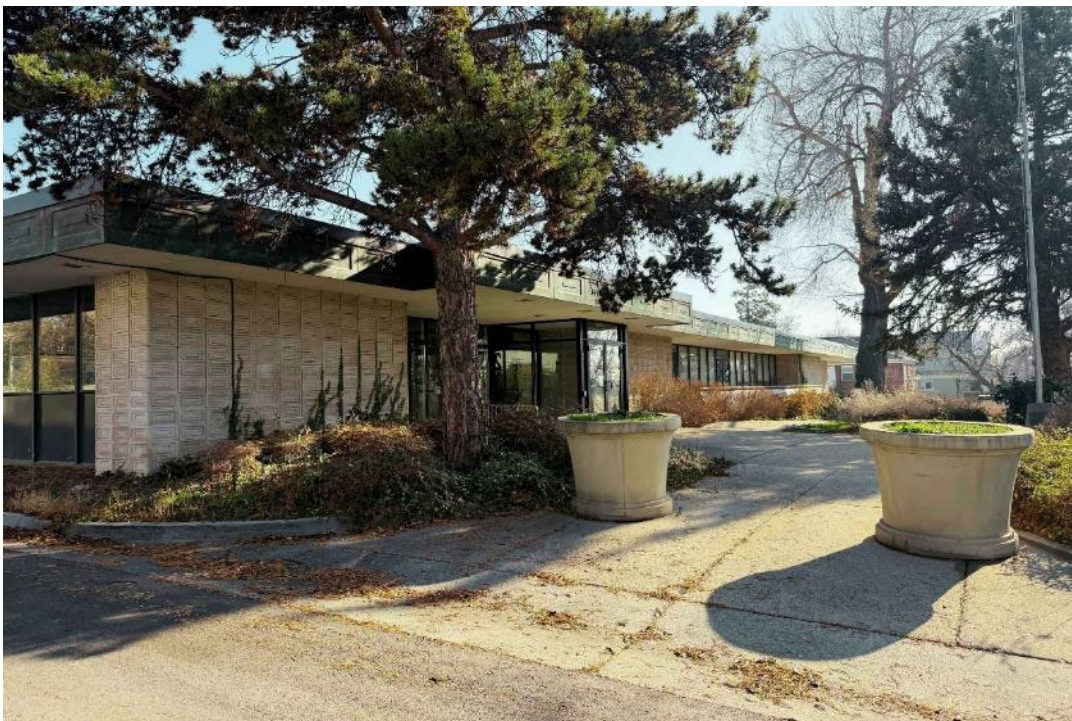
**Photograph 2**

The northern portion of the west elevation [Photographs 2 and 3] consists of a broad expanse of decorative concrete masonry units (CMU), each with a recessed rectangular relief pattern that creates a textured, shadowed surface. This masonry field transitions into the primary glazed zone at the center of the elevation, where a deep recessed entry bay contains two large window groupings set within black metal frames. Each window assembly follows the "small-over-large" proportion, with a narrow upper pane above a larger fixed pane.

Part of north and west elevations of the Tenth East Senior Center. Camera facing southeast.

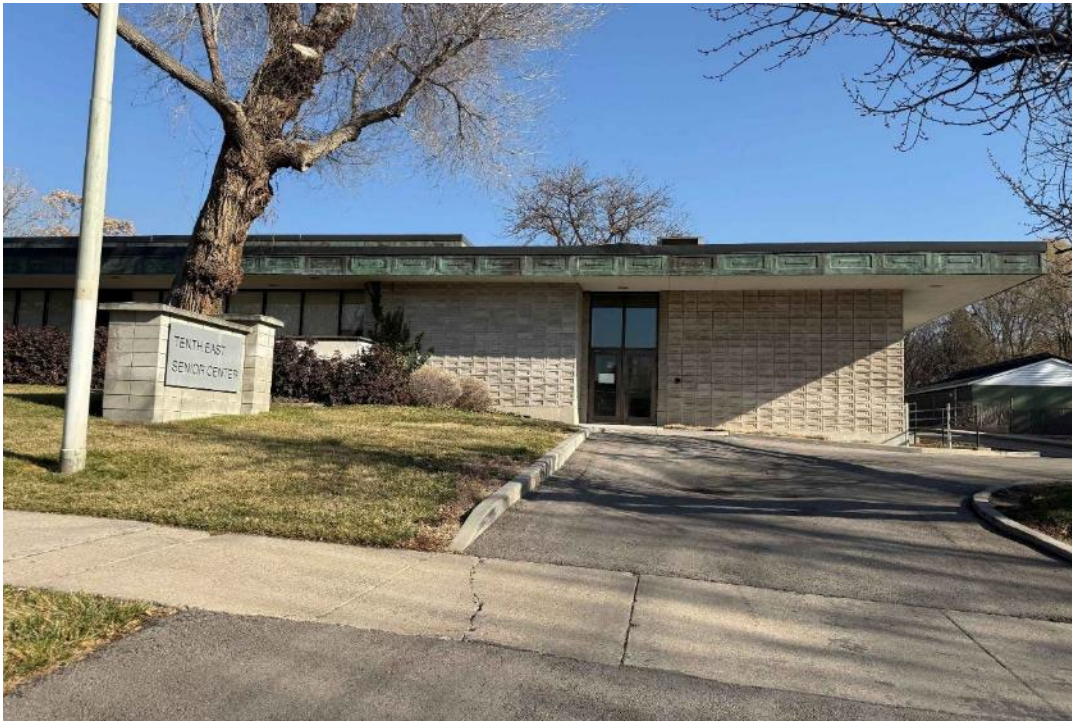
**Photograph 5**

The west elevation of the addition is set back slightly from the original façade and continues the patterned CMU, broad eaves and metal panel fascia [Photograph 5]. Near the northern end of this recessed plane is a set of double doors, each with an individual glazed panel above, providing secondary access to the building. The 1983 addition closely matches the original 1963 construction in its materials, massing and detailing [Photograph 5].

A gently sloping grade along the west side of the building causes the perceived height of the patterned masonry wall and metal railing to vary from north to south. A freestanding concrete sign identifying the Tenth East Senior Center is located in the lawn area west of the elevation and is not physically connected to the building [Photograph 5]. Overall, the west elevation retains

West elevation including the 1983 addition (right). Camera facing east.

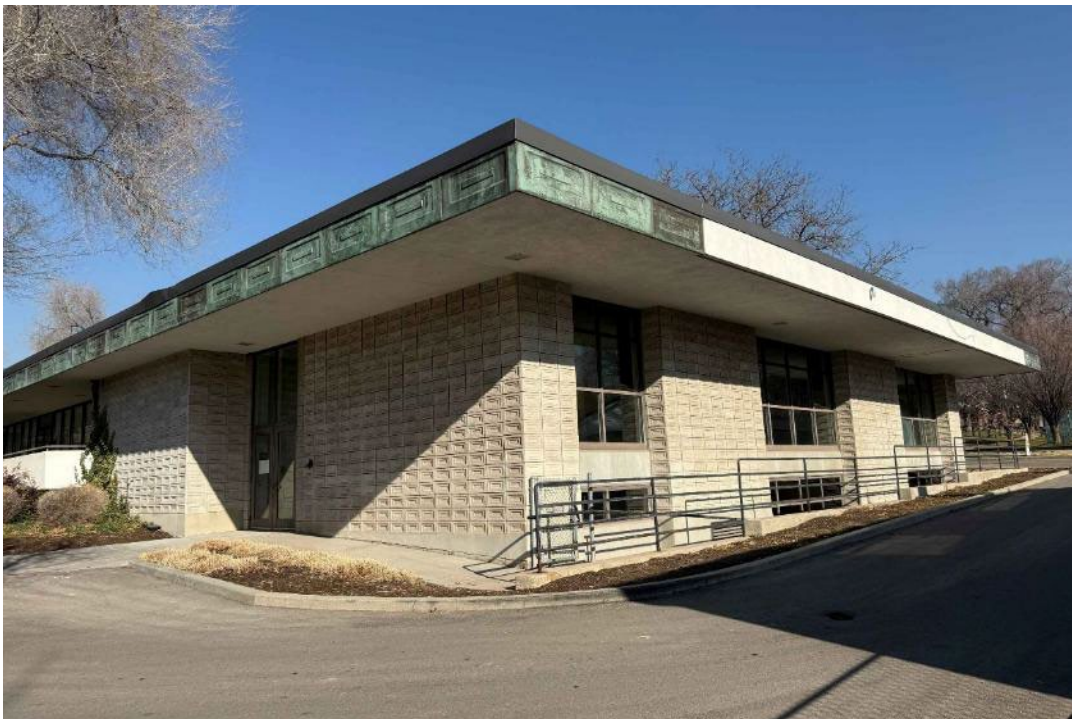
**Photograph 6**

South of the primary entrance, the west elevation returns to a solid expanse of patterned concrete masonry before transitioning to a raised concrete terrace and platform that fronts a band of aluminum-framed windows and a set of double secondary entrance doors [Photograph 4]. The window assemblies are set between vertical bands of patterned CMU, and the secondary entrance consists of paired glazed doors positioned within this southern glazing zone. Beyond this area, the elevation concludes with another section of patterned masonry before stepping back at the point where the 1983 addition begins [Photographs 5 and 6].

West and south elevations including the 1983 addition (right). Camera facing northeast.

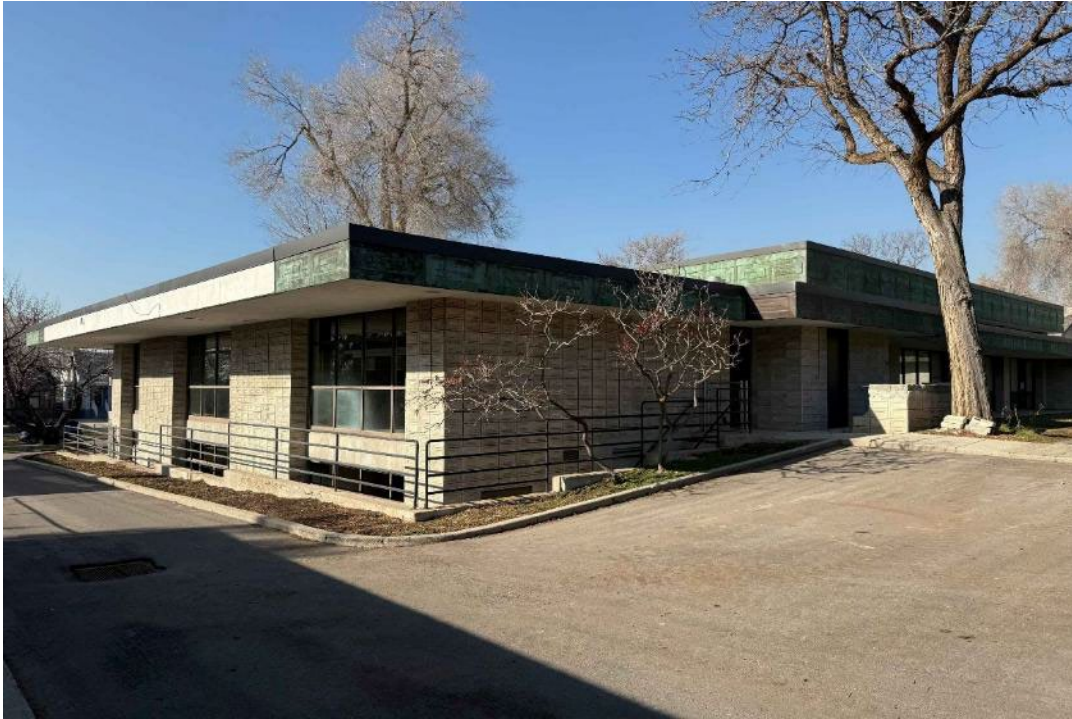
**Photograph 7**

The western portion of the south elevation consists of the 1983 addition, which extends the original building's program space while maintaining the overall character of the 1963 design [Photographs 6 and 7]. Like the original construction, this elevation is defined by a deep concrete roof overhang, patterned CMU walls, and dark-framed glazing set into a thickened masonry envelope. The roofline continues the building's modular fascia system incorporating metal panels; although much of the fascia at the center of this elevation is obscured by a later covering that interrupts the otherwise continuous appearance of the roofline [Photographs 6 and 7].

Immediately north of the addition, two brown metal service doors are set within shallow masonry recesses, accompanied by mechanical vents inserted into the surrounding masonry field [Photograph 7]. The northernmost of the two doors is bordered by a low concrete masonry wall that exhibits localized cracking and displacement, a condition visible during the building's current renovation period [Photographs 7 and 8].

South and east elevation including the 1983 addition (left). Camera facing northwest.

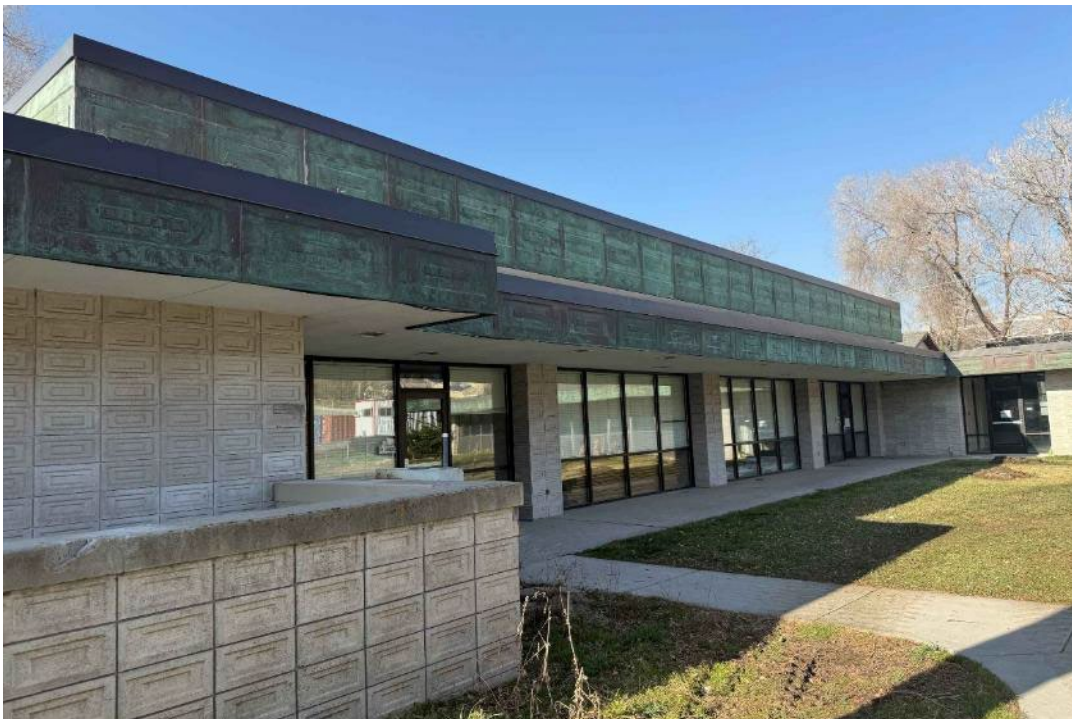
**Photograph 8**

The inner east elevation includes the 1983 addition on the southern portion and faces the building's courtyard [Photographs 7, 8, and 9]. Although not prominently visible, this elevation retains the building's characteristic mid-century modern design, including a deep concrete roof overhang, patterned concrete masonry walls, and dark-framed glazing set into a thickened masonry envelope. The roofline's continuous fascia panels are set within a dark frame, visually unifying the elevation with the rest of the building.

East and south elevation of the Tenth East Senior Center. Camera facing northwest.

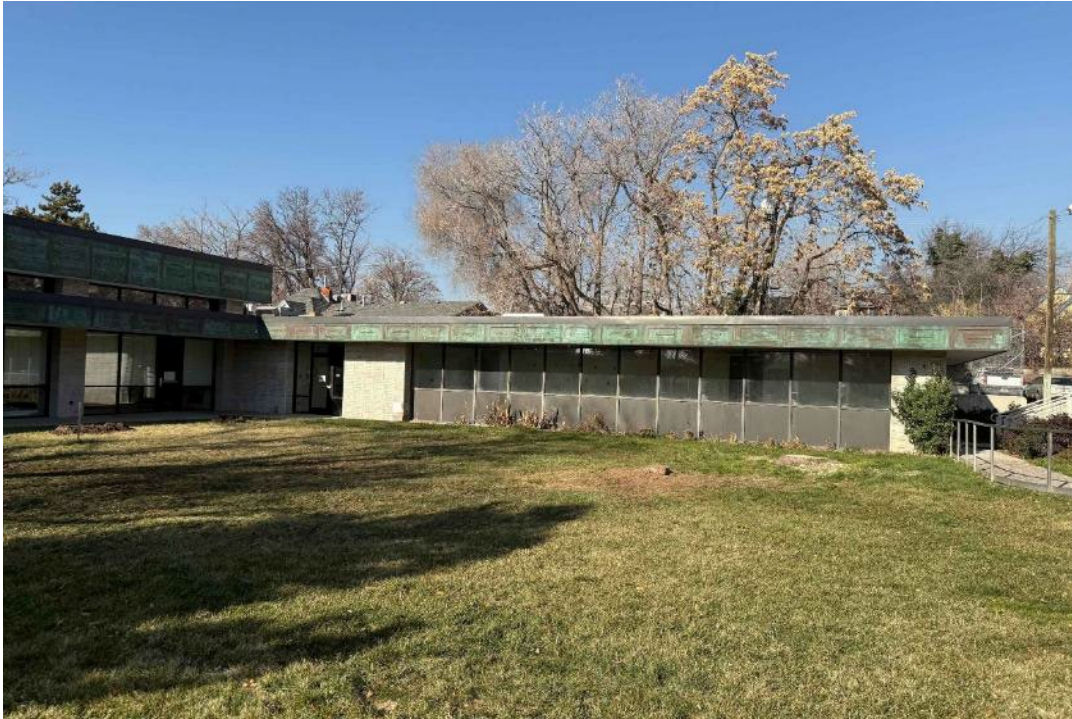
**Photograph 9**

East and south elevation of the Tenth East Senior Center. Camera facing northwest.

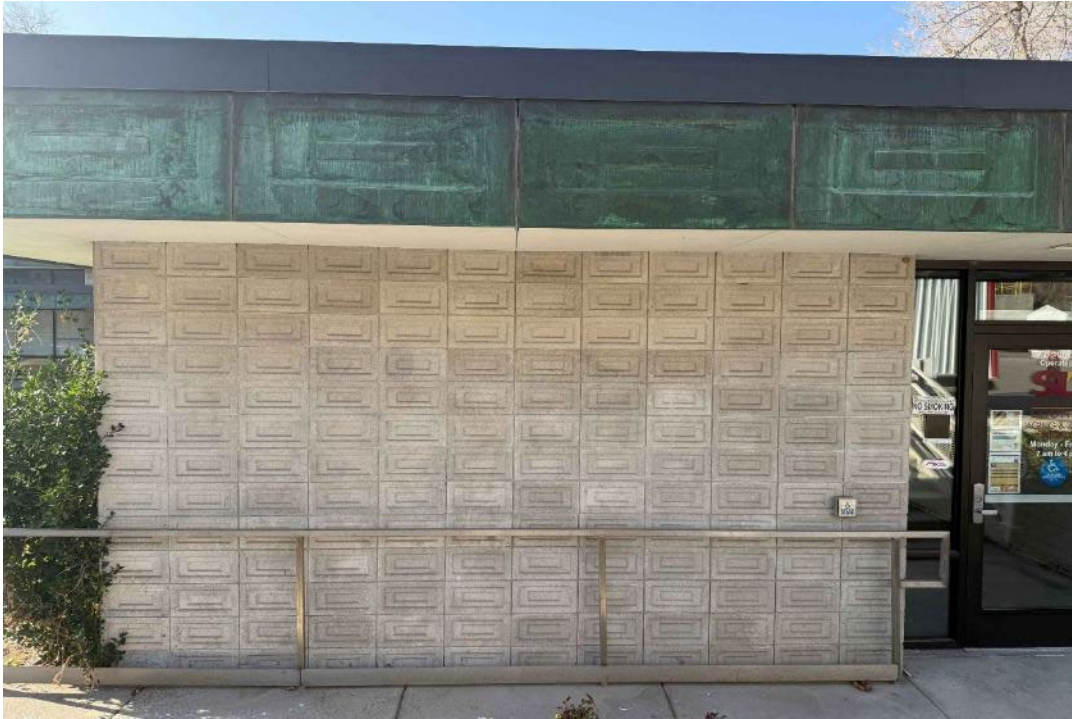
**Photograph 11**

East elevation showing detail of decorative concrete units and metal fascia. Camera facing west.

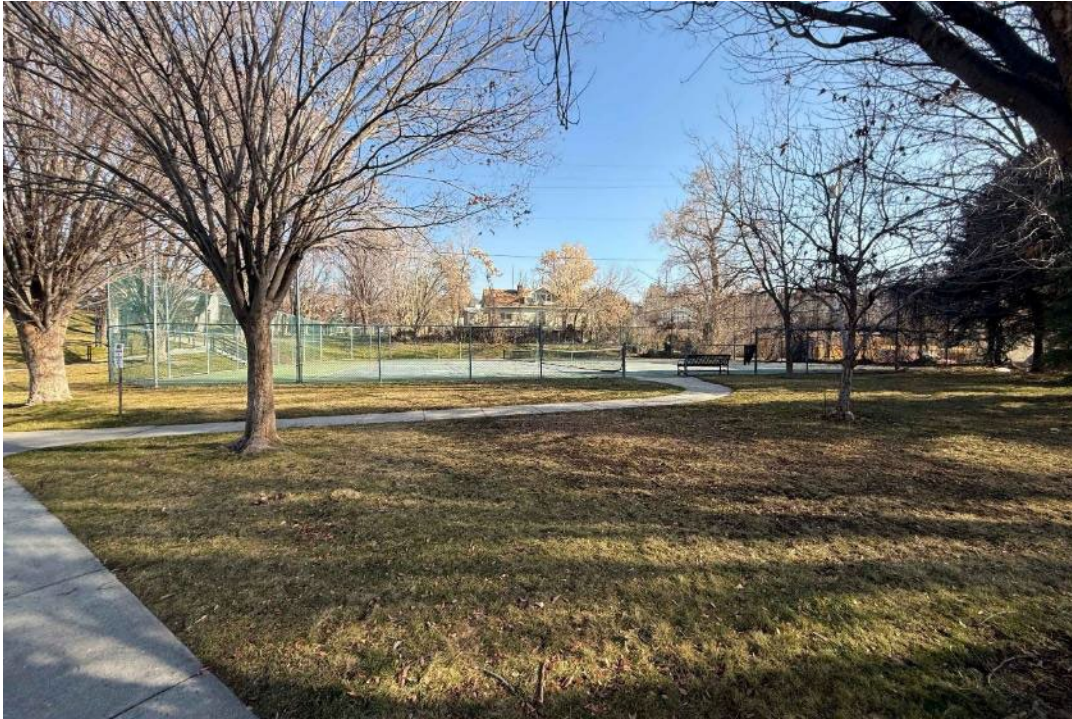
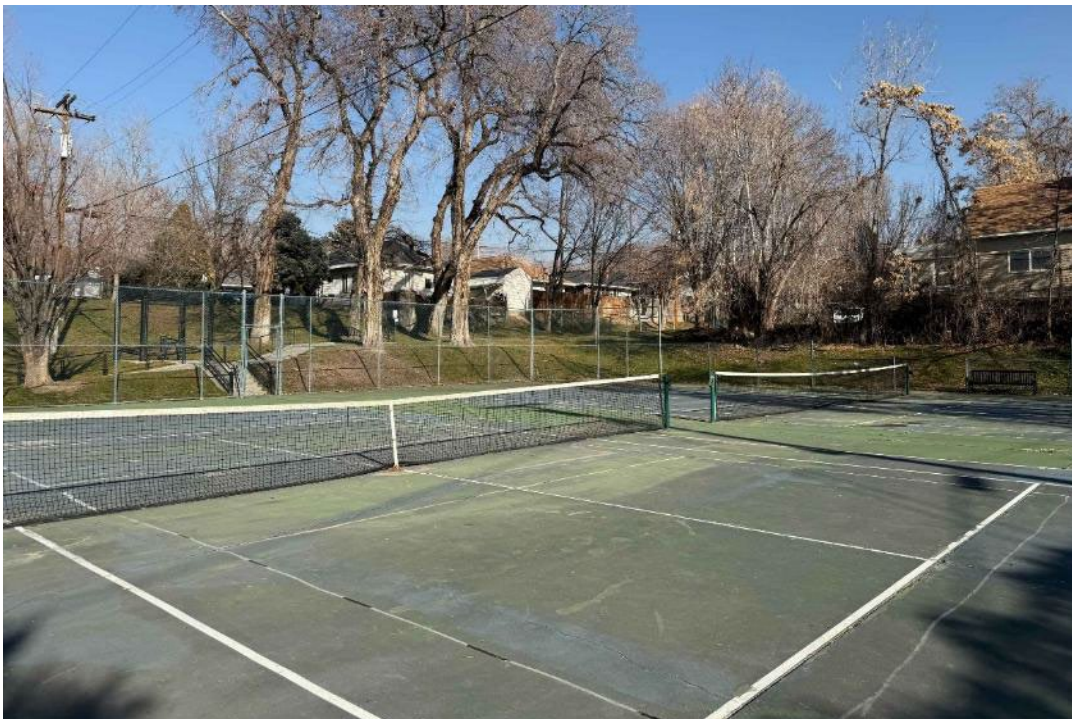
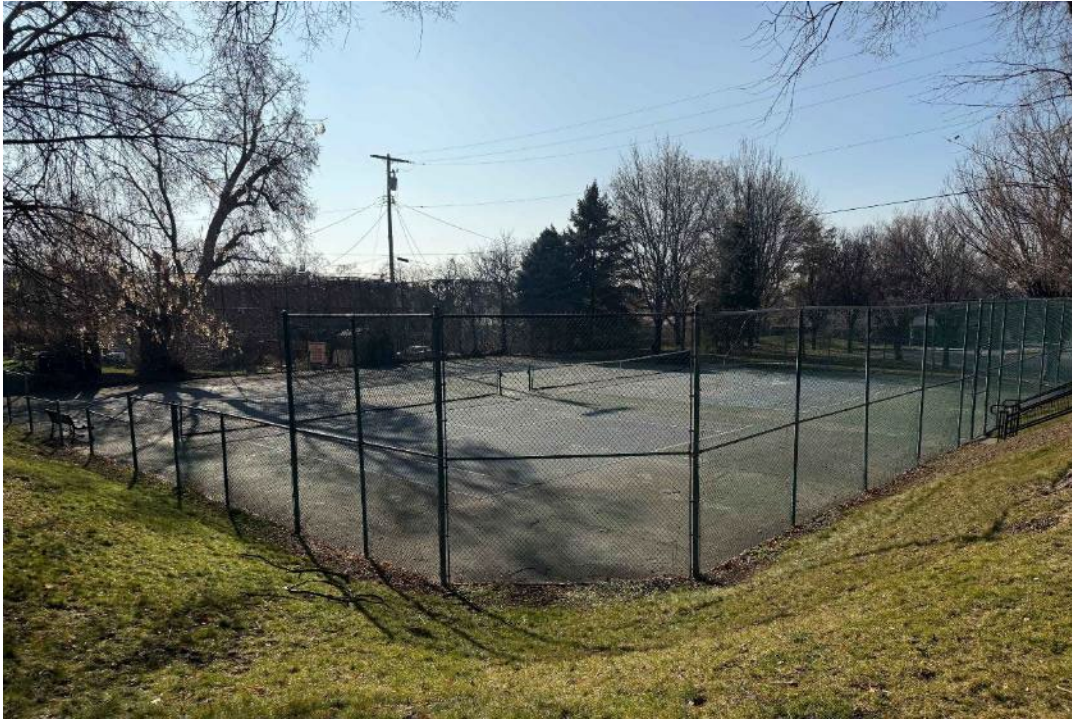
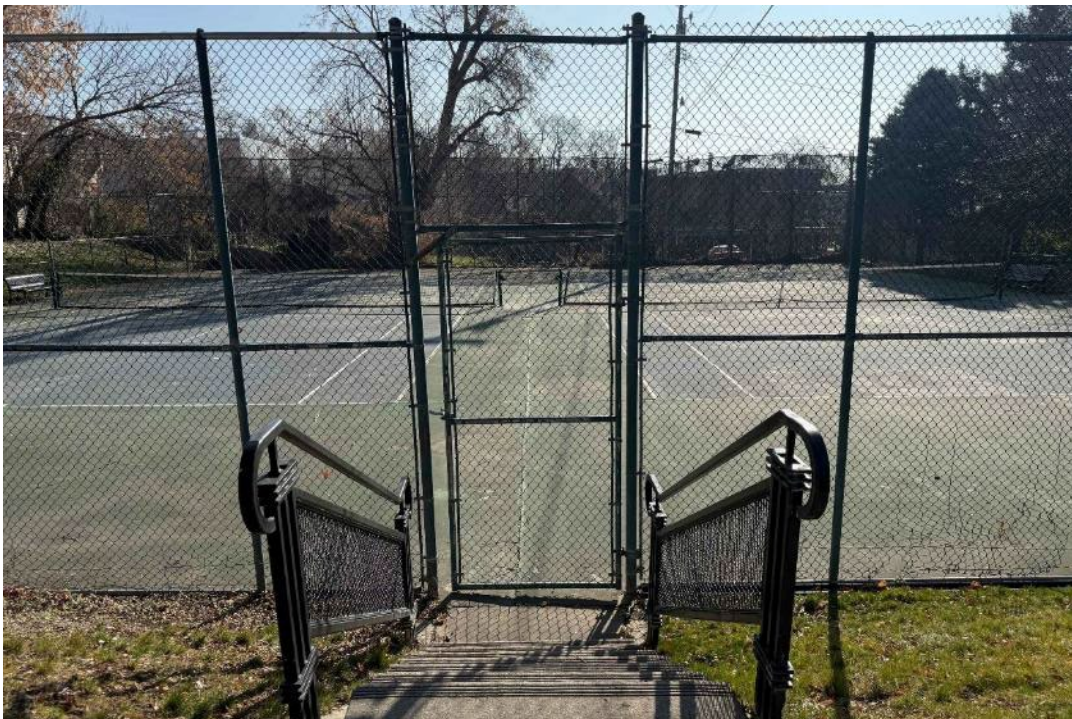
The two tennis courts [Photographs 17–22] are contributing structures because they were likely rebuilt sometime between the late 1960s and the 1970s, within the established period of significance, and they occupy the long-standing location and orientation of the site's earlier courts. Although not original and resurfaced over time, the current courts retain their historic layout and chain-link fencing, preserving the spatial organization and recreational character associated with the property during the period of significance. Despite surface wear, they continue to convey their long-standing role in the site's recreational use and maintain integrity of location, setting, feeling, and association.

Two contributing tennis courts on the Victory Recreation Park parcel. Camera facing east.

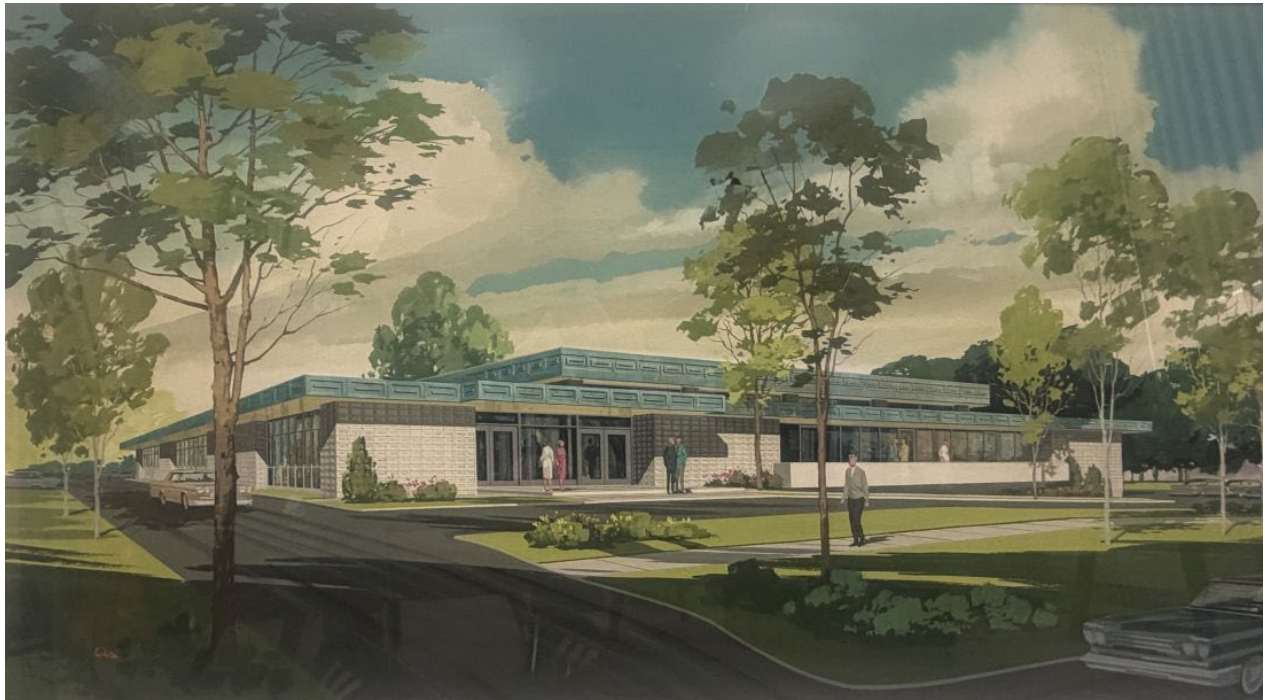
**Figure 13**

Original 1962 color rendering of the Tenth East Senior Center, north and west elevations|  
Salt Lake County Dept. of Aging and Adult Services

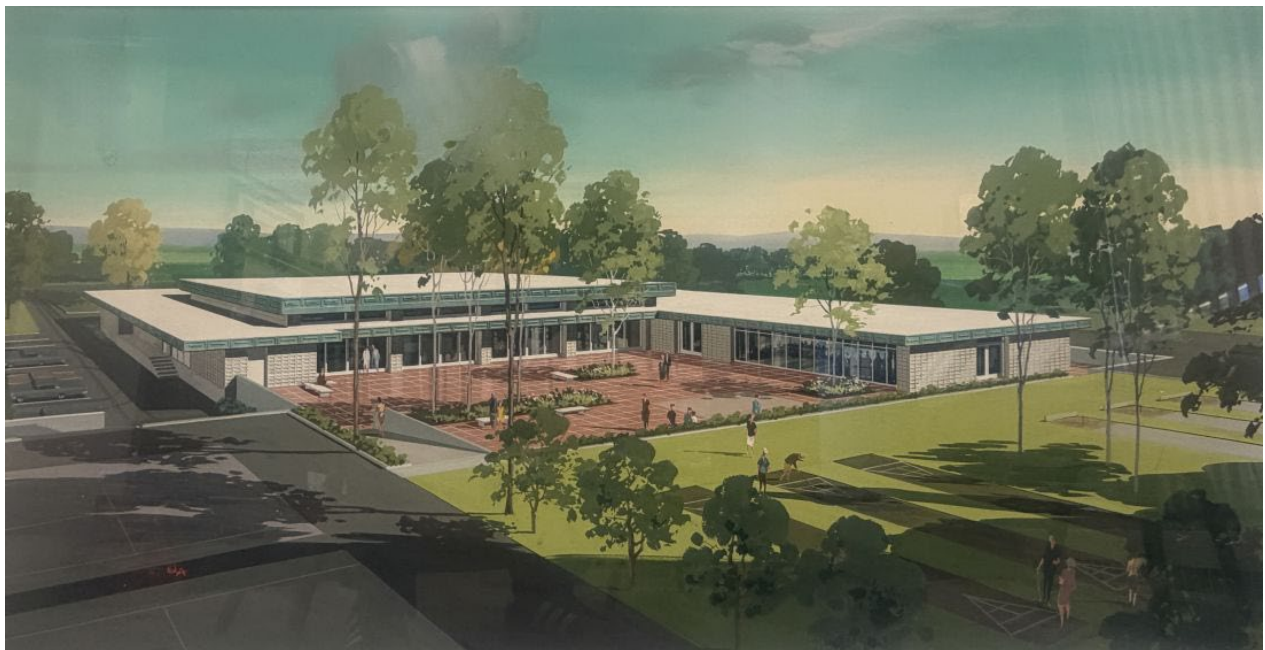
**Figure 14**

Original 1962 color rendering of the Tenth East Senior Center, south and east elevations|  
Salt Lake County Dept. of Aging and Adult Services
